POST-EARTHQUAKE ASSESSMENT AND DOCUMENTATION OF TIMBER ROOFS

Mislav Stepinac¹, David Andić², Juraj Pojatina³

KEYWORDS: Earthquake, Timber Roofs, Assessment, Laser Scanning, UAV

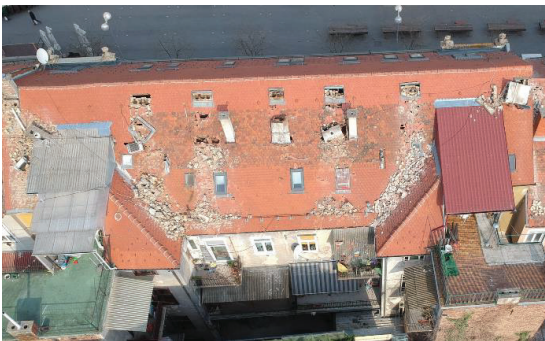
Roof systems often become unstable due to the collapse of individual load-bearing walls beneath them or severe chimney failures (Figure 5 & 6). Post-earthquake inspections showed that many of the chimney failures resulted in direct damage to the roofs. In some locations, the chimneys damaged the supporting roof structure, but in most cases only the rafters broke and the integrity of the roof was maintained (Figures 7 and 8).

Figure 7: Failure of chimneys (from outside) (photo credit: M. Stepinac)

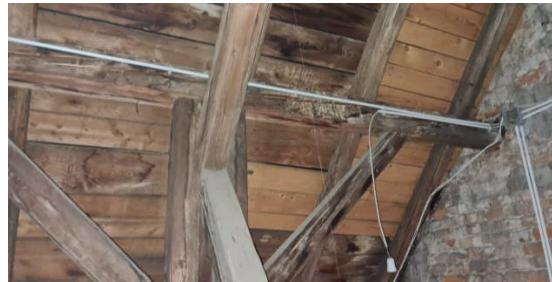
Maintenance was identified as one of the most important aspects that contributed to the condition of buildings after the earthquake. Since a large number of buildings were poorly maintained or not maintained at all, the properties of the masonry deteriorated over the years, and the seismic performance of such buildings was worse [5]. In many cases, water penetration degraded the properties of both masonry and wood elements (Figure 9).

Figure 9: Failure of timber elements due to water leakage and seismic excitations (photo credit: Studio Arhing d.o.o.)
