## ASSESSMENT OF NAILED CONNECTIONS IN EXISTING STRUCTURES

**ABSTRACT:** This paper presents the development of an assessment scheme for a visual qualitative evaluation of nailed connections in existing structures, such as board trusses. In terms of further use and preservation, a quick visual inspection will help to evaluate the quality of a structure regarding its load-bearing capacity and deformation behaviour. Tests of old and new nailed joints in combination with a rating scheme point out the correlation between the load-bearing capacity and condition of a joint. Old joints of comparatively good condition tend to exhibit better results than those of poor condition. Moreover, aged joints are generally more load-bearing than newly assembled ones.

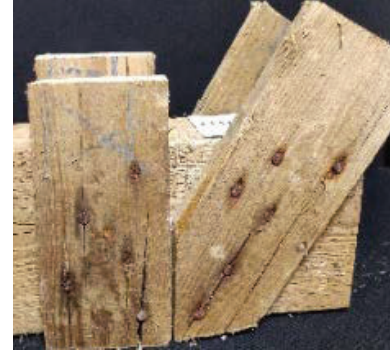
(a)  
side view A:  
post cat.: 4b,  
strut cat.: 4b

The posts for joint B12 in Figures 5a and 5b were classified as category 4b due to nonstandard nailing and cracks larger than 1 mm. The struts on both sides were classified as category 4b because there were also cracks larger than 1 mm and a standard nailing was missing.

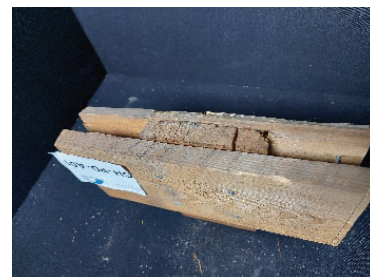
**Figure 6:** Evaluation of Joint Type II A01

bottom view:  
cracks  
→ post cat.: 4

The post for Joint A01 is decisive for the evaluation of the entire joint. It was classified as category 4b due to the bottom view because there was a crack of more than 1 mm (see Fig. 6).

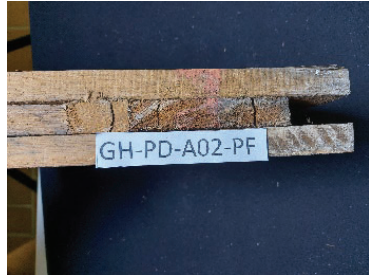
Figure 7: Evaluation of Joint Type II A02

bottom view:  
cracks →  
post cat.: 4,  
strut cat.: 4

The post and the strut were again taken as significant for the evaluation of joint A02. These were classified as category 4 due to the bottom view, since cracks larger than 1 mm were present there (see Figure 7b).

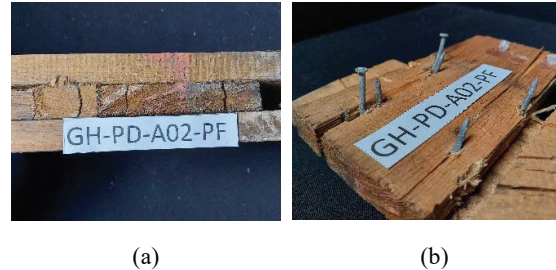
Figure 10: Type II: joint GH-PD-A02 before and after testing

Application examples of the rating scheme show a correlation of the joint and the failure mode. The joints which are depicted in Figure 11a and b, for example, were evaluated in advance with condition 4 and show that not all nails have formed plastic hinges after the execution of the test; the wood was unable to contribute to the embedment strength due to the cracks and, thus, a lower load-bearing capacity of the joint results.

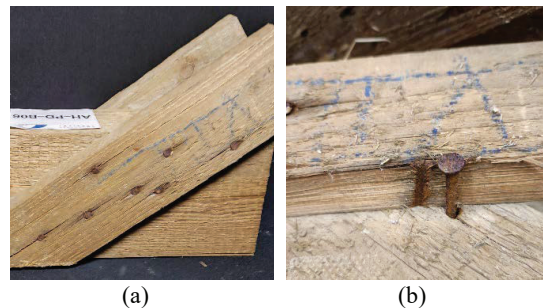
Figure 11: Type I: joint AH-PD-B06 before and after testing

As a further example, Figure 11a and b show a test specimen of Type II before and after the shear test. Here, the rating 4 also indicates a lower load-bearing behaviour. After testing, it can be seen that the specimen could not reach its full load-bearing capacity in the area of the crack, due to the missing yield hinge. Consequently, not all nails reached their capacity.
