ANALYSIS OF THE PREDICTED COLLAPSE DIRECTION TENDENCIES OF HOUSES CAUSED BY THE 2024 NOTO PENINSULA EARTHQUAKE

Yuki Hashimoto¹, Takafumi Nakagawa², Hiroshi Isoda³

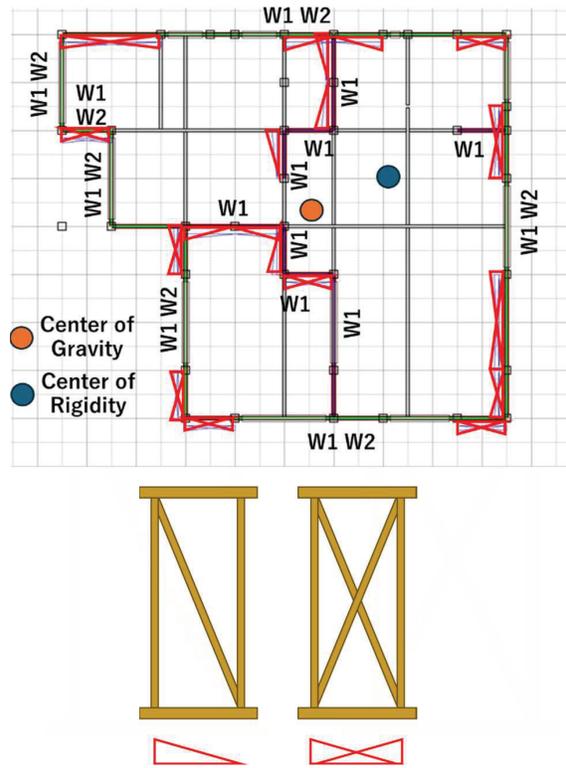
Figure 2. Seismic element layout on 1st floor of House-a

for timber structures: the pre-1981 standard (Old Seismic Code), the 1981–2000 standard (New Seismic Code), and the post-2000 standard (2000 Seismic Code). Each revision introduced different seismic safety objectives, with the current 2000 Seismic Code primarily defining seismic performance based on the quantity and distribution of shear walls. This study aims to analyze the causes of collapse and examine the directional tendencies of structural failure under seismic excitation through a parametric study. The analysis is conducted by applying multiple earthquake ground motions to a computational model created based on architectural drawings obtained from Reference [1][2]. The subject of analysis is a two-story timber-framed house, designated as House-a. The floor plan of House-a is shown in Figure 1, while the arrangement of seismic-resistant elements is shown in Figures 2 and 3. The first floor features a large open-plan living room, with an absence of load-bearing walls directly beneath the shear walls of the upper floor.

Table 1 presents the results of the wall quantity calculation, which assesses the total amount of shear walls, and the eccentricity ratio, which serves as an index of the balance of shear wall distribution. The results confirm that both the first and second floors meet the minimum wall quantity requirements stipulated by the current Building Standards Act. However, the eccentricity ratio in the Y-direction of the first floor exceeds the regulatory limit of 0.3, indicating that the shear wall arrangement is unbalanced. Consequently, it is confirmed that this building exhibits poor seismic balance in terms of wall distribution.

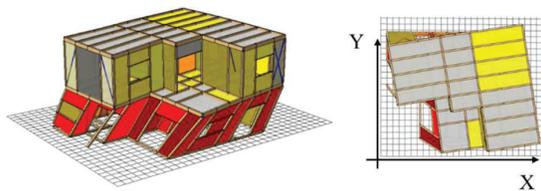
Figure 8. Collapse behaviour of House-a

The time-history response analysis was conducted by incrementally amplifying the observed ground motion from K-NET Wajima, the closest observation station to House-a, from 1.0 times the original amplitude in steps of 0.1. The results confirmed that the building collapsed at an amplitude of 1.2 times. Additionally, the collapse direction was found to be consistent with the actual observed failure. Figure 8 illustrates the collapse behavior of the analytical model at an input scaling factor of 1.2 for the K-NET Wajima record. The colors of the walls and horizontal structural elements indicate the degree of damage, with yellow representing minor damage and red indicating severe damage. Just before collapse, significant damage was concentrated in the first-floor walls, and the second floor exhibited a large twisting deformation as it failed. This behavior is attributed to the unbalanced distribution of seismic-resistant elements. Furthermore, Figure 9 presents the

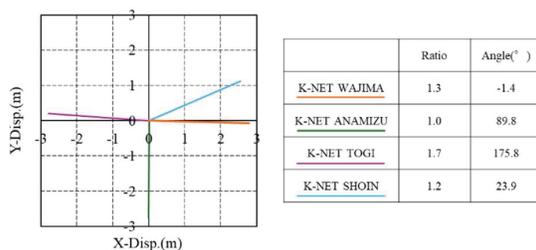
Figure 9. Collapse direction and input scaling factor of House-a

collapse direction of House-a for each ground motion and its corresponding input scaling factor (Ratio). The collapse direction was determined based on the movement of the first-floor center of mass, with angles (°) measured counterclockwise from the positive X-axis. While the center-of-mass movement varied depending on the ground motion, the collapse consistently showed a tendency toward the positive X-axis, with no cases of collapse occurring in the third quadrant. In all cases, the collapse was primarily induced by severe damage to the first floor.

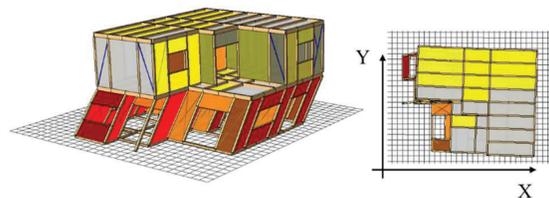
Figure 10. Collapse behaviour of House-an

When the K-NET Wajima ground motion was applied to House-an, the structure collapsed at an input scaling factor of 1.3. The collapse behavior of the analytical model is shown in Figure 10. Similar to House-a, significant damage was concentrated in the first-floor walls, leading to structural failure. However, unlike

House-a, no noticeable twisting deformation of the second floor was observed at the point of collapse. This finding supports the conclusion that House-a's high eccentricity ratio contributed to the twisting of the second floor, ultimately leading to its failure. Furthermore, Figure 11 presents the collapse direction and input scaling factors (Ratio) for each ground motion applied to House-an. As with House-a, the analytical model collapsed in all cases due to severe damage to the first floor. However, the direction of center-of-mass movement varied significantly depending on the ground motion, with a tendency for collapse to occur in both the X and Y directions.

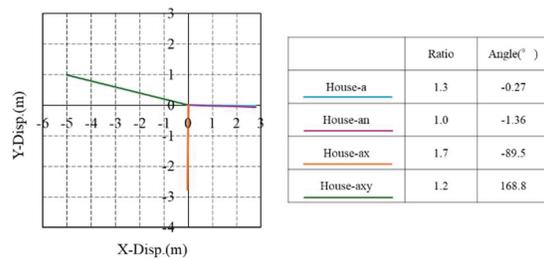
Figure 54. Collapse direction and input scaling factor of all House

The input ground motion was taken from K-NET Wajima, and the analysis was conducted by gradually increasing the input scaling factor from 1.0, following the same methodology as in last studies. Figure 14 presents the collapse directions of House-a, House-an, House-ax, and House-axy. The results confirm that the collapse directions differed approximately by 90° depending on the wall configuration. Additionally, Figure 15 illustrates the movement of the second floor just before collapse. Except for House-a, which has a high eccentricity ratio in the Y-direction, all models collapsed without significant torsional deformation.
