# TIMBER-MASONRY INTERACTION MECHANICS: OLD BUILDINGS, NEW APPROACHES

Douglas La Prairie<sup>1</sup>

**ABSTRACT:** Working on hybrid timber/masonry buildings a number of recurring problems related to the load response of timber diaphragms and flexural members on the masonry gravity load resisting walls have been identified. Structural distress is particularly pronounced on early modern architectural masonry assemblies such as rain walls, for example, from the late 1800s where the form, materials and construction techniques appear to be incompatible.

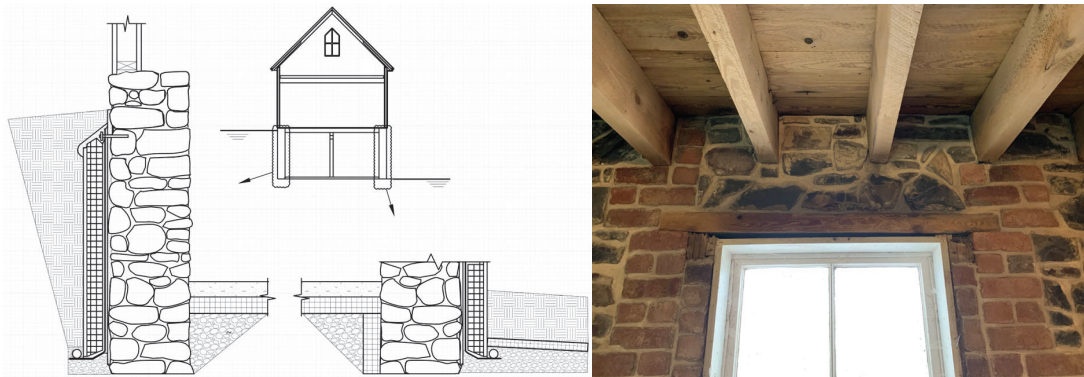
Figure 2. At left, cross section of stone rubble wall supporting wood superstructure framing. At right, timber floor joists and window lintel set into pockets in the stone masonry wall. Brick has been used to build a rectangular window opening.

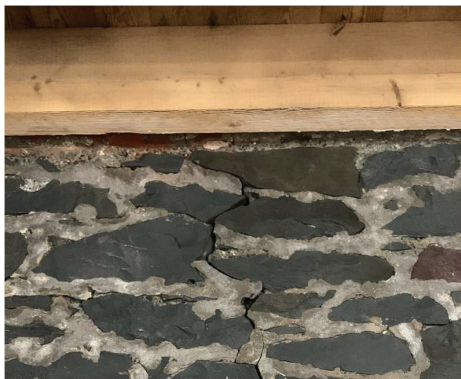
Soft and vapour permeable lime mortars were typically used until the early 20<sup>th</sup> century. They promote evaporation of moisture through walls and, under normal conditions, their softness allows minor moisture and thermal related movements to be absorbed. That is, they breathe and redistribute stress. Conversely, hard mortar traps moisture and local pockets of stiff material concentrate stress. Transferred into adjacent stone this stress can cause fracturing, as shown in Figure 3. The comparatively fast cure times of Portland-based mortars

*Figure 3. Stone masonry fracturing where hard, cementitious mortar has been used for earlier repairs.*

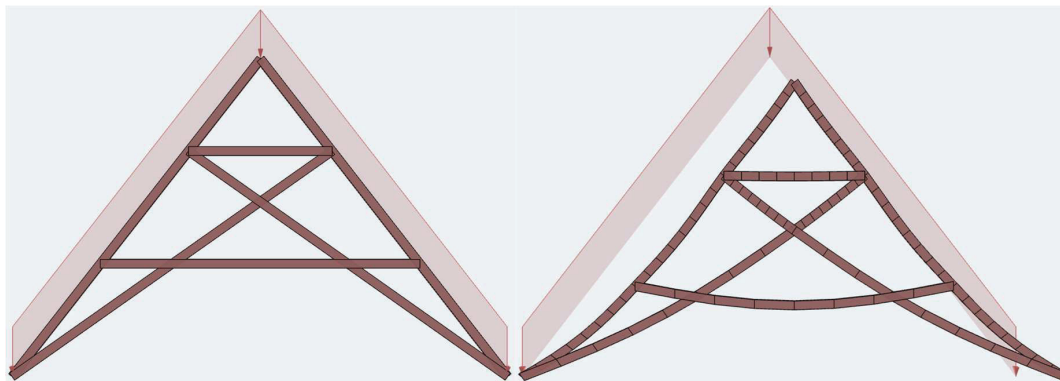
roof splaying, as shown in Figure 4. Through a combination of external loads, creep and ductile connections vaulted timber roofs are susceptible to spreading distortion that imposes lateral load on exterior walls, even with thrust-resisting ties in place.

Figure 4. The demonstrates the splaying behaviour of the scissor trusses at the church. A simple frame stiffness model was developed using SkyCiv software taking as input characteristic self-weight and snow loads. The deflection scale is exaggerated for illustration.

Structural interventions were carried out around 25 years ago to address the splaying of the roof. These include the installation of steel side plates to stiffen the truss connections, the addition of collar ties and tensioning cables at the lower horizontal ties. Even though these interventions were relatively recent, no records exist to give guidance as to their rationale. Site observations and basic truss analysis indicates that these efforts were of dubious value. A simpler and more economical installation of vertical tension ties connecting the peak to crux would have been more efficacious, which calculations can attest. Vertical ties have for centuries been well-tested, regular features in scissor trusses.

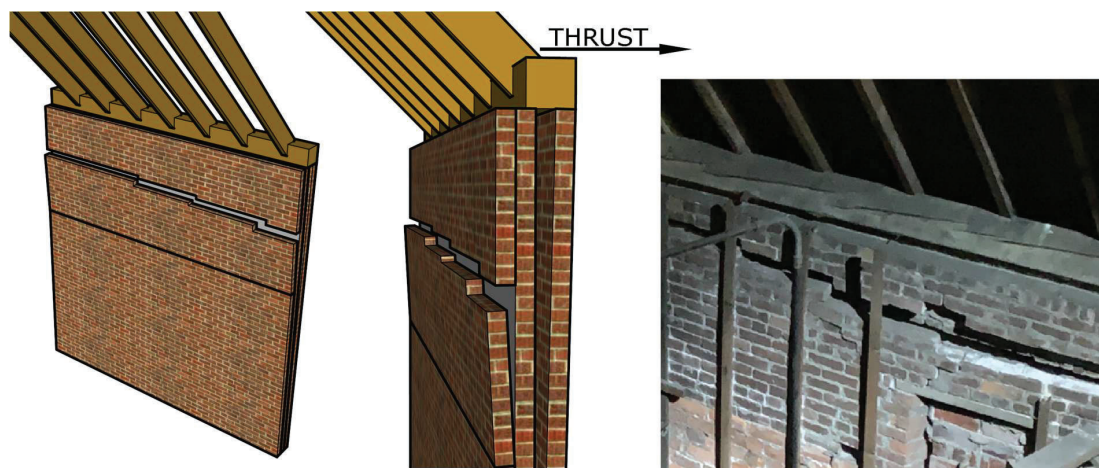
The wall section here is composed of a non-load bearing exterior masonry veneer backed by two inner structural wythes stiffened by wood strongbacks, as seen in Figure 5. The wood strongbacks enhance the wall's out-of-plane flexural properties. The hard, smooth surface of

Figure 5. The left and centre images are graphical illustrations of the effects of thrust from timber rafters on the multi-wythe brick exterior walls. These rafters are above the chancel where there are no trusses. Thrust has caused fracturing of the interior structural wythes and complete separation of the exterior veneer wythe. The photo at right shows the cracked wall with timber strongbacks attached for flexural reinforcement.

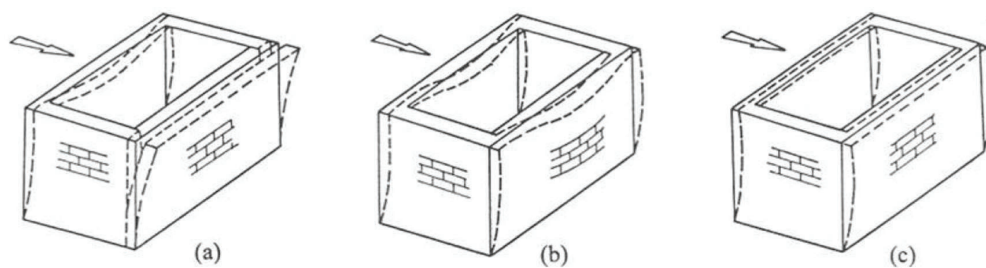
Figure 6. The middle image (b) is representative of the flexural shape of the flexible roof diaphragm. Images (a) and (c) represent no diaphragm and a rigid diaphragm, respectively. The figure above is copied from New Zealand seismic assessment guidelines [16].

The flexibility of the wooden roof diaphragm, as shown in Figure 6, is compounded by lightly nailed connections at the rafter tops that are easily rotated under load. At the top of the building's eastern exterior wall, splaying wooden rafters, rotating about their ridge connections, have pushed the masonry wall outwards as evidenced by substantial deformation and fracturing of the inner structural wythes. The principal loading

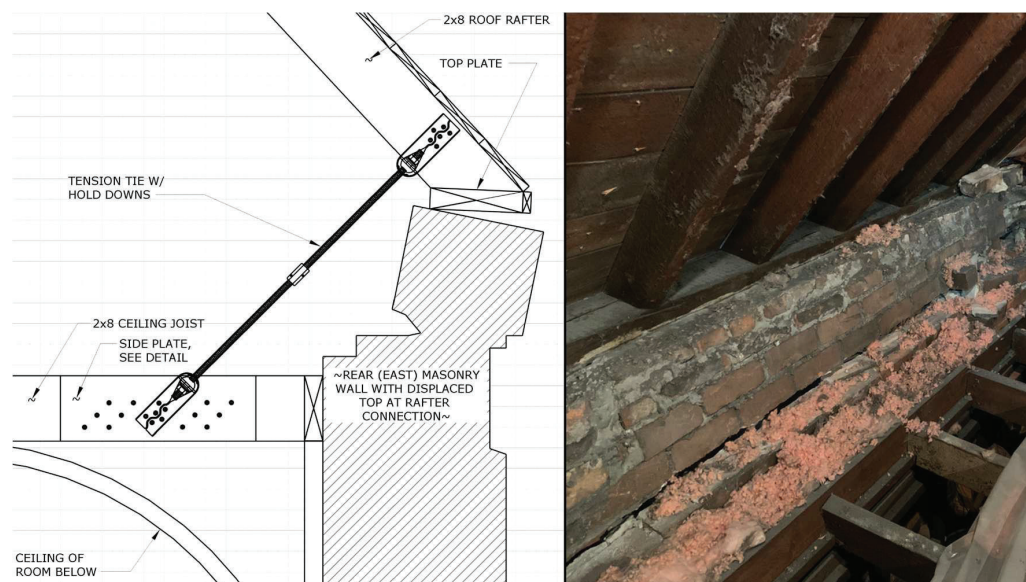
Figure 7. The above shows fracturing at the top of the east wall as a result of lateral thrust from rafters driven by self-weight, snow and creep. To restrain against further movement tension tie assemblies made from threaded steel rod and shear wall hold downs were used. On the compression side of the wall, on the exterior side opposite, the wall gently flares out with no fracturing present.

comes from drifting snow, driven by the prevailing westerly winds, piling along the eastern roof edge, as shown in Figure 7. Taking the roof self-weight and 3 kPa NBCC specified snow load for the location and using reference values in Borri [4] to find wall cross section resistance, hand calculations give a rough estimate of service load (i.e., actual, unfactored) demand to capacity of 468 kN/302 kN, or 1.55. The veneer wythe, on the compression side, has pronounced deformation, but remains intact.

original geometry. In dealing with masonry deformation two options are available: to stabilize masonry in its deformed state; or rebuild. For interim stabilization the roof diaphragm was tied to the splaying rafter tails using off the shelf shear wall hold-downs, as shown in Figure 7. While renovation planning is underway this low-cost measure arrests further movement and if desired can serve for long-term stabilization. In the two years the tie assemblies have been in place, no further deformation has been observed. Early out-of-plane movement data collected as part of a structural health monitoring program (SHM) being carried out by Carleton University in Ottawa is in line with site observations.

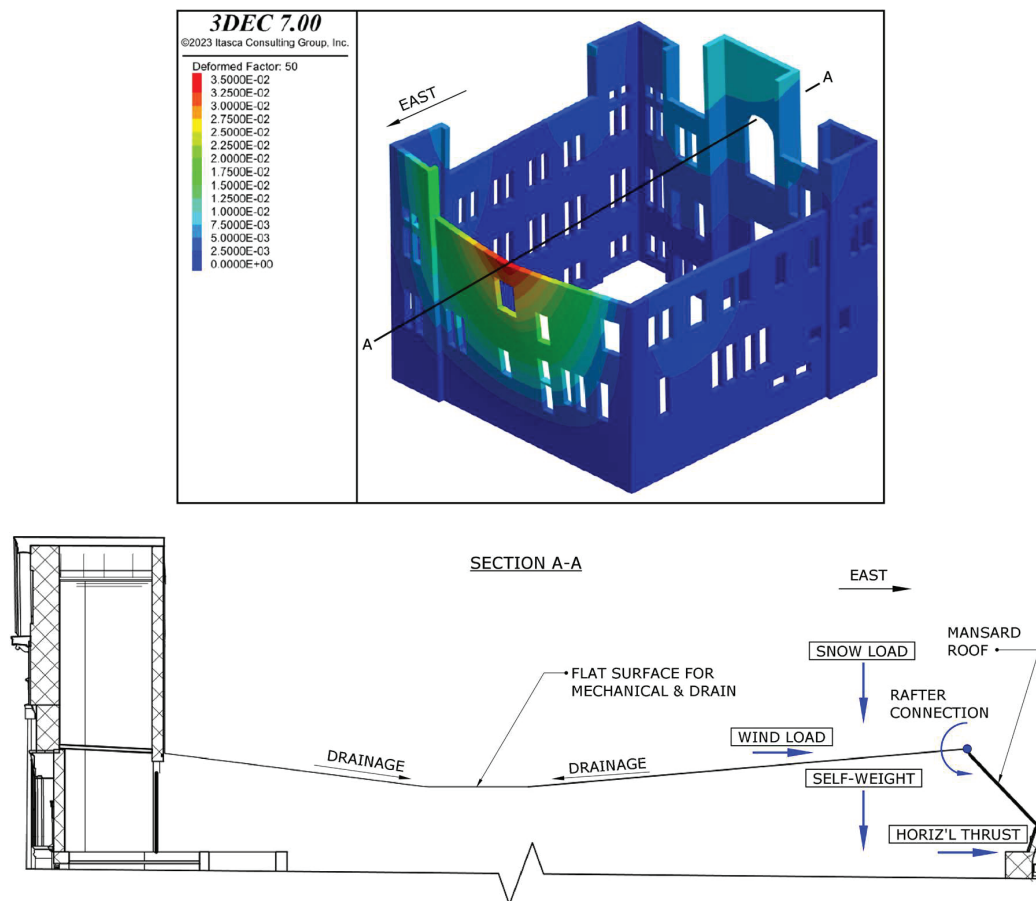
interventions. Earlier modelling with Carleton University as part of a shear capacity assessment of the building gave results that correctly identified the eastern top of wall as an area of concern, as shown in Figure 8, inspiring confidence in our ongoing efforts.

Figure 7. The top image shows predicted displacement fields on the east wall due to wind loading. In general, the modelled pattern agrees with site observations. The bottom image shows a cross section through the roof, denoted A-A in the top image, and the forces acting on the east wall.
