Case Study of IED Incident in Cauca, Colombia – A Review of the Blast Threats and Protection Provided to the EOD Technician

A. Makris, Jeff Levine and J.P. Dionne

Abstract. In June 2022, an Explosives Technician of the Colombia Dirección Central de Policía Judicial e Inteligencia (DIJIN) responded to a suspect Improvised Explosive Device (IED) mounted on a motorcycle, in Cauca, Suarez, Colombia. The local unit of the Policía, responsible for responding to explosives incidents arrived at the scene to investigate. The explosives technician conducted a search and render safe procedure of the suspect device. After a canine unit and a robot could not definitively confirm an explosive device, the decision was made to conduct a manual approach of the motorcycle with suspect device using a Med-Eng EOD 9 bomb suit. During the course of procedures, the IED detonated. The ensuing blast posed a fatal threat that was mitigated by the bomb suit the technician was using. He was launched several meters away and suffered non life-threatening injuries to the extremities. This paper is a case study that analyses the four blast threats (overpressure, fragmentation, impact, heat) related to the parti

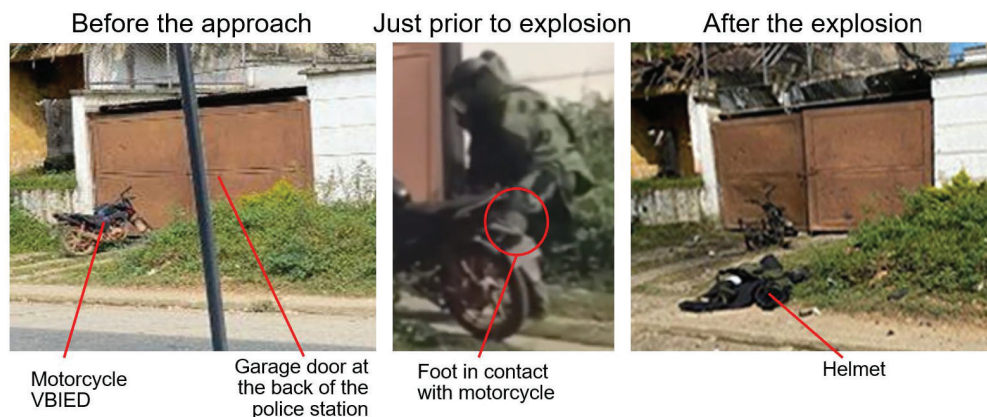
The entire event, up to the moment of the explosion, was captured on video by bystanders and later retrieved online. No visual records exist of the aftermath, except for photos provided by Colombian authorities. The photo on the right of Figure 3 identifies the approximate landing location of the technician, marked by where the bomb suit and helmet were left after first responders rescued

and evacuated the injured operator. Figure 3 also illustrates the severe damage sustained by the motorcycle, as well as minor damage to the garage door and surrounding area.

Figure 3. Left and Centre: Still images extracted from a video of the incident obtained from the Internet, capturing the moment of the explosion. In the centre image, the technician's left foot is resting against the motorcycle while handling the explosive package with no standoff. Right: A post-incident photograph of the scene, showing the aftermath after first responders had removed the injured technician from the bomb suit. The image on the right is provided courtesy of Colombia's DIJIN

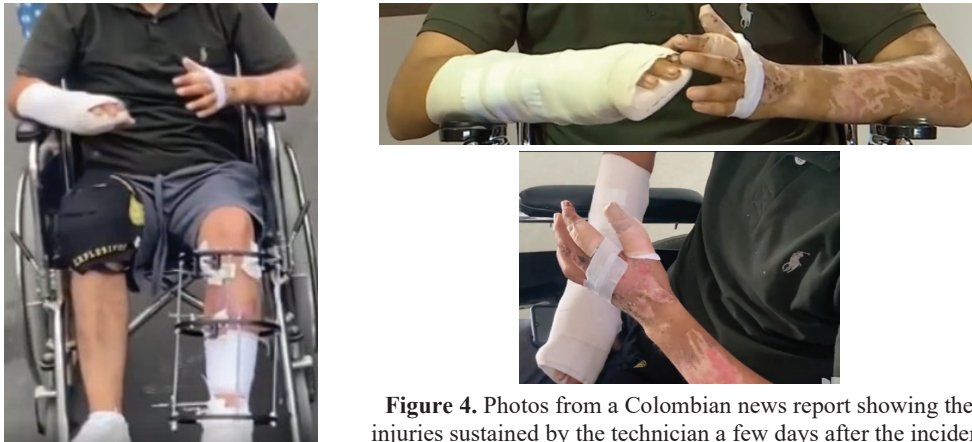
Following the blast, the bomb technician sustained various injuries, including the amputation of his left forefoot, which had been in direct contact with the motorcycle (and underlying explosive), and a fracture of his left tibia. Since he was holding the fabric wrapping the explosive at the moment of detonation, both of his hands were injured, with the right hand being more severely affected, including multiple finger fractures. He also suffered minor burn injuries to his forearms due to flames propagating up the bomb suit sleeves.

Notably, the technician did not sustain any penetrating wounds, blast overpressure injuries (including to the ears), or head trauma. He remained conscious and alert upon arrival at the hospital. Figure 4 shows photos of the technician taken a few days after the incident, highlighting his primary injuries.

Figure 4. Photos from a Colombian news report showing the injuries sustained by the technician a few days after the incident

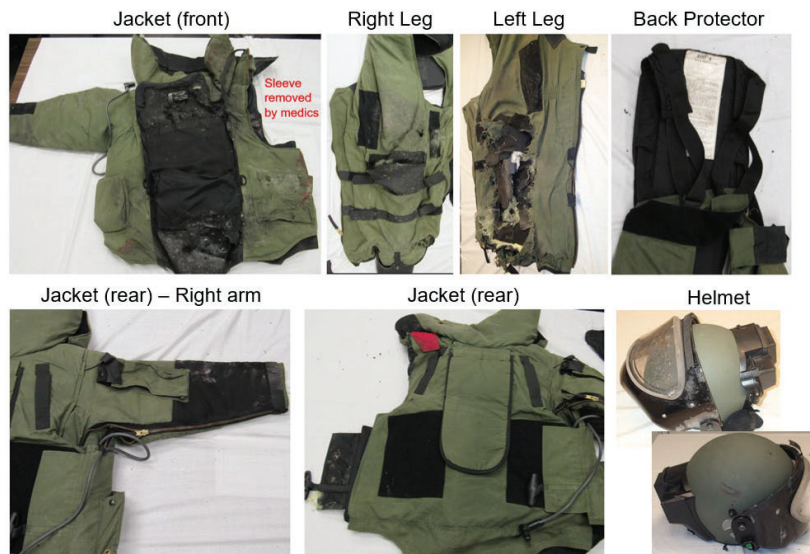
Due to the bomb technician's close proximity to the blast source, the left side of the bomb suit trousers sustained significant fragmentation damage, particularly in the lower exterior portion. This damage exposed the soft armour aramid layers and shattered the shin plate. In contrast, the right side of the trousers, positioned slightly farther from the blast, experienced only minor fragmentation damage. Importantly, no fragments fully penetrated the stack of materials comprising the trousers worn on either leg. See images on Figure 5.

Figure 5. Photos of the bomb suit and helmet after the blast

Similarly, the upper portion of the bomb suit jacket, which directly faced the blast, exhibited concentrated fragmentation damage. Although fragments penetrated the soft armour and some of the rigid armour at the chest and groin levels, none managed to breach the innermost protective layers, thereby ensuring the wearer's safety. Some deformation of the rigid protective plates was observed. The rear portions of the trousers and jacket, which were shielded from the blast, remained largely unaffected. While the left sleeve was removed by medical personnel to facilitate the victim's evacuation, the remaining sleeve showed no significant damage.

Regarding the helmet, a single fragment penetrated the surface of the outer acrylic layer of the visor but failed to breach the innermost polycarbonate layer. The visor primarily exhibited cosmetic fragmentation damage, and the rubber trim housing the LED lights was dislodged during the blast. Despite this, the retention system remained fully functional, and the helmet shell sustained no penetrations. Figure 5 presents photos of the bomb suit ensemble, highlighting the damaged areas.

The images in Figure 5 highlight the significant fragmentation and peppering damage sustained by the bomb suit due to the blast. This resulted in considerable cosmetic damage, along with a few penetrations through the suit's outermost layers and protective plates. For instance, Figure 11 illustrates fragmentation damage to the groin protective plates. However, none of the fragments fully penetrated the innermost composite rigid layer. Similarly, only one fragment damaged the helmet visor without completely penetrating its material layers. The bomb suit ensemble thus provided essential fragmentation protection, effectively preventing fragment penetration to critical areas.

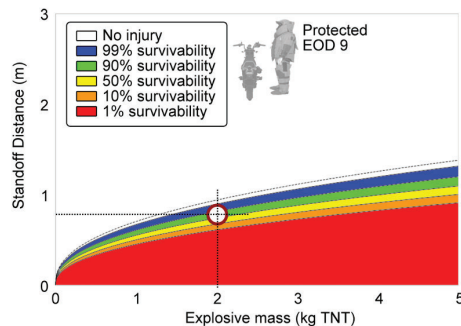
Figure 8. NATO blast injury curves from Figure 7 modified to account for the protection provided by the EOD 9 bomb suit. Data shown for the motorcycle VBIED scenario

Figure 8 presents the NATO injury curves, adjusted to reflect the protective capabilities of the EOD 9 bomb suit (assuming a conservative 85% reduction in overpressure and a fourfold increase in positive phase duration, see [5]). Based on Figure 8, the bomb technician was predicted to have a 90% chance of survival from the blast overpressure threat alone, consistent with the actual survival outcome of this incident. However, it is important to note that the charts in Figures 6 to 8 are intended as general guidance for free-field blasts, and do not provide definitive or fully validated injury predictions.

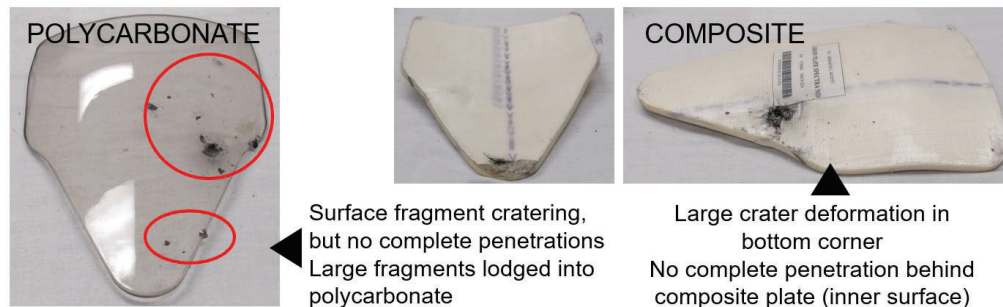
Figure 11. Photos of the innermost groin protective layer showing no complete penetration. No complete penetrations were observed anywhere on the bomb suit

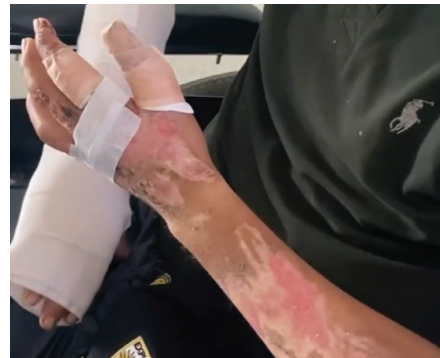
Despite the protection provided by the bomb suit, the technician sustained burn injuries to the forearms (Figure 15) due to the fireball entering through the uncinched sleeve openings around the hands. This occurred because the arms were directly facing the IED at the moment of detonation. Medical documentation provided by DJIN classified these injuries as second-degree (superficial partial-thickness) burns, specifically affecting the anterior and lateral aspects of the right forearm. It is important to note that bomb technicians prefer to work with their bare hands during render-safe procedures, which leaves them vulnerable to such risks. Although the burn damage to the technician's forearms was not extensive, it underscores the inherent dangers faced in such situations. Some clues of burning damage were also visible on the bomb suit itself, visible on the photos from Figure 5. The

Figure 15. Second degree burn injuries suffered by the technician on the forearms

sleeves feature an adjustable strap that permits tightening of the opening at the wrist and minimizing flame ingress; this feature was not used by the bomb technician in this incident.
