# COMPARISON BETWEEN EXPERIMENTAL RESULTS AND DESIGN EQUATIONS OF ARTIFICIALLY DEGRADED SINGLE STEP JOINTS

Daniel F. Lima<sup>1</sup>, Jorge M. Branco<sup>2</sup>, Lina Nunes<sup>3</sup>

**ABSTRACT:** In the case of interventions in existing buildings, the assessment of timber elements and joints, such as the Single Step Joint, is a challenge for engineers, especially when timber presents signs of biological degradation. In this context, many roof structures are subject to unnecessary substitutions due to the lack of knowledge about the behaviour of these types of joints, and specially the consequences of eventual biological attacks. This study aims to evaluate the residual shear strength of Single Step Joints artificially degraded by wood boring insects from the Anobiidae family (e.g. *Anobium punctatum*). To achieve the established objectives, destructive tests were carried out on undamaged (reference level) and artificially degraded Single Step Joint specimens, varying the level of degradation. The results were analysed in terms of degradation level and compared with the results obtained with design equations for this type of joint found in the literature. From the analysis of

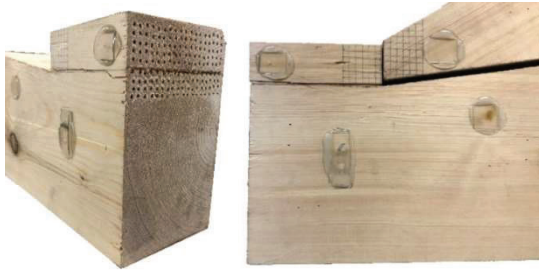
**Figure 4.1:** Characteristic shear failure on the tie beam-end observed in the 40 SSJ specimens tested.

As expected, all 40 specimens presented shear failure without crushing parallel to the grain at the front notch or perpendicular to the grain at the bottom notch (figure 4.1).
