PERFORMANCE OF PASSIVE PROTECTION OF CROSS LAMINATED TIMBER DURING STANDARD FURNACE TESTS AND NATURAL FIRES

KEYWORDS: Fire protection, Gypsum Plasterboard, Mass timber, Cross laminated timber, Natural fire

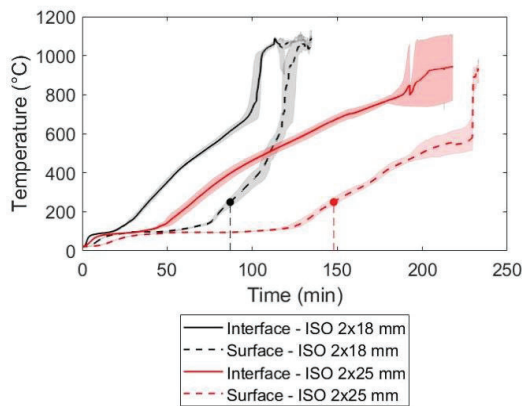
Figure 1. Comparison of ISO exposures with both 2x18 mm and 2x25 mm boards. The symbols indicate the time at which the surface reaches 250°C for each case.

An additional test has been performed to assess the performance of a thicker layer system, i.e. 2 x 25 mm GBs from supplier S2. The interface and surface temperatures of both layouts under the ISO exposure are shown in **Figure 1**. Increasing the thickness of each individual GB layer by 7 mm postpones the time at which an average surface temperature of 250°C is reached by about 55 minutes.

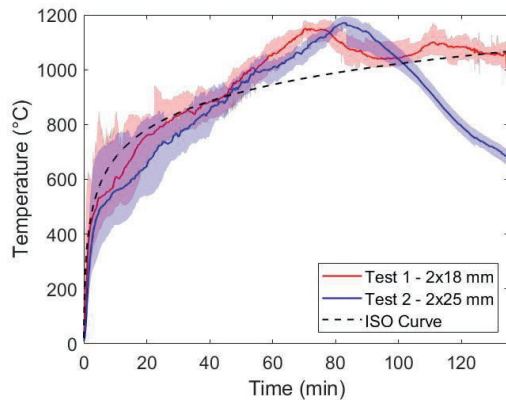
Figure 4: Compartment temperatures (from 11 PTs) under the ceiling for Test 1 (GB 2x18 mm) and Test 2 (GB 2x25 mm) compared to the ISO standard time-temperature curve (shaded areas show the extents of temperature variability).

Figure 4 presents the gas phase compartment temperatures at the ceiling for the two thicknesses of GBs tested. The results seen in *Figure 4* are also compared against the ISO 834 temperature-time curve. Performance is analysed in three representative stages for Test 1: <80min (growth), 80-100 min (decay) and >100min (re-growth); and two stages for Test 2: <80min (growth), >80min (decay). Visual representation of the stages is also presented in *Figure 5* and *Figure 6*.

As indicated in *Figure 4*, after approximately 40-50 minutes the compartment temperatures in the natural tests 1 and 2 rise above the standardised test curve. The second stage marks the beginning of a decay phase at around 80 min for both natural fire scenarios. However, the onset of mechanical failure of the thinner (18 mm) layer of fire protection boards in Test 1 then led to the third stage, with fire regrowth at around 100 minutes. The temperatures inside the compartment remained approximately steady (at around 1000-1100°C). Conversely, in Test 2, the GBs remained in place for the full duration of the fire, and temperatures decreased in the compartment as a result.

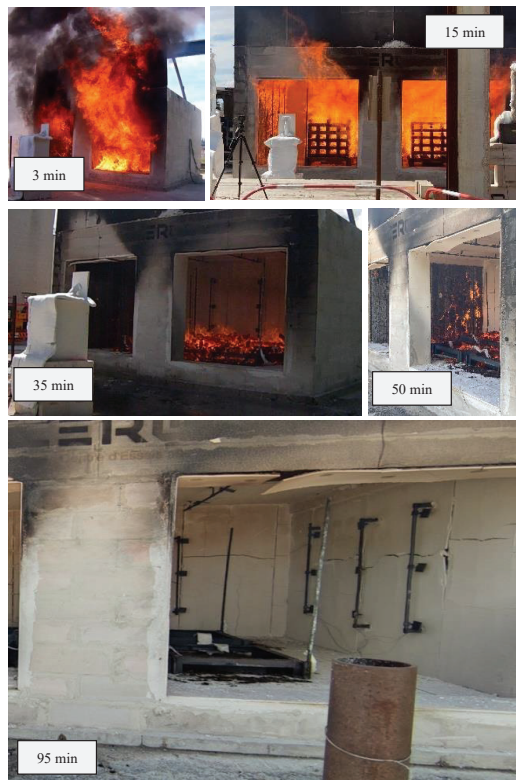
Figure 9. Test 3 stages: growth (1-upper left), steady-state (2-upper right), decay (3-lower left); Continuous combustion of the exposed wall (4-lower right); Cracks after burnout of the moveable fuel load (5- last).

Rapid fire growth in Test 3 leads to a period of approximate steady temperature conditions where the temperature difference ranges between 200 to 600°C higher than compared to Test 1 or standardised furnace test during the first 30 minutes. The third stage of Test 3 is a decay phase where most of the moveable fuel is consumed; after which localised smouldering and flaming combustion of the combustible wall continues (*Figure 9-4*). All of the GBs remained fixed to the ceiling and walls

in Test 3, however many pronounced cracks were visible (*Figure 9-5*). Manual suppression was *not* performed, and eventually continuous smouldering combustion resulted in collapse of the unprotected wall at some unknown point during the following night.

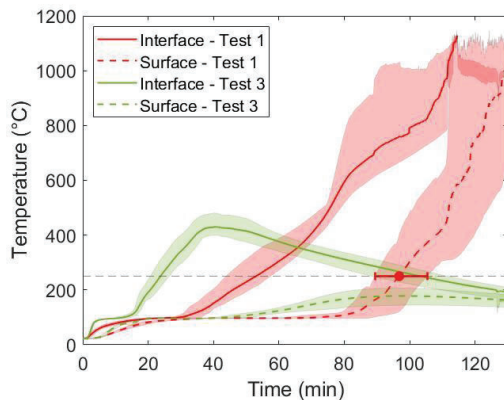
Figure 10. Test 1 and 3 – Ceiling interface and surface temperatures. The symbols indicate the time at which the surface reaches 250°C for each case.

Figure 10 illustrates a more rapid increase in the interface temperatures early into Test 3 compared to Test 1. Test 3 also displays a shorter 100°C temperature plateau due to the more severe heating conditions. Interface temperatures continue to rise 30 minutes into Test 3, after which the compartment temperatures decay (see *Figure 8*).

The interface temperature data presented in *Figure 10* illustrates an earlier increase in the temperature at the interface compared to Test 1 but the surface temperatures for Test 3 were maintained below 200°C throughout the test. These results suggest that the rapid period of fire growth resulted in an earlier thermal wave through the first plasterboard, but the time scales of burning prevented the thermal penetration to significantly affect the second layer of plasterboard.

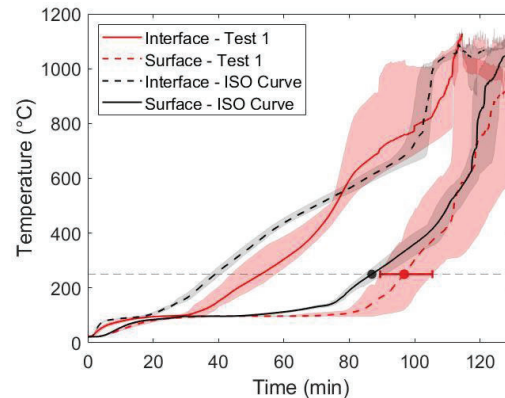
Figure 11. Surface and interface temperatures for Test 1 and furnace test (2*18 mm GBs). The symbols indicate the time at which the surface reaches 250°C for each case.

The under-ventilated fire scenario (Test 1) and the ISO 834 furnace test show similar trends in the temperature developments. The average interface temperatures for the standard fire test and Test 1 follow similar heating rates up to 60 min. At about 75 minutes, a local rapid increase of temperatures was observed in Test 1, leading to local

temperatures of 1000°C as early as 90 minutes (*Figure 11*).

Surface temperatures for Test 1 are comparable to the ISO 834 standard fire results. An average surface temperature of 250°C was reached at 87 minutes for the ISO 834 test and 97 minutes for Test 1, while this was never reached for Test 3.

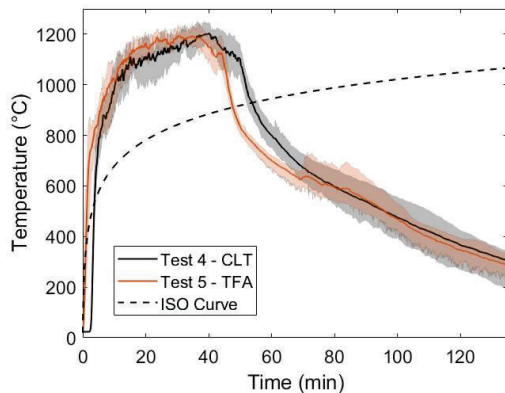
Figure 12. Compartment temperatures under the ceiling (measured with PTs) for tests 4 and 5.

Two additional tests were performed with intermediate ventilation conditions in order to compare a CLT and TFA ceiling in natural fire conditions. Test 4 and Test 5 are in all other respects identical except for the nature of the timber ceiling itself. Test 4 consisted of a CLT ceiling (identical to the one used for the previous tests) whilst the latter included a TFA ceiling. Whilst a detailed analysis of these two tests will be provided in a forthcoming paper, the main outcomes are presented here to illustrate differences that can be observed between the performance of mass timber and timber frame under natural fire conditions. *Figure 12* shows the compartment temperatures for the two tests, with a reasonable similarity. Test 5 was, however, terminated at 250 minutes due to collapse of the TFA ceiling (see *Figure 13*).

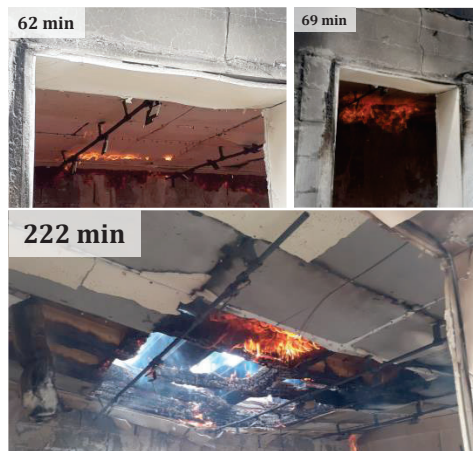
Figure 13. Test 5 failure stages of the protected TFA ceiling.

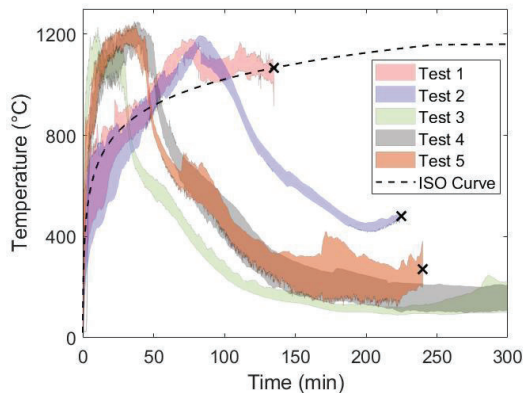
Figure 14. Overview of the compartment temperatures of the five natural fire tests up to 300 minutes with indication of manual suppression times (Tests 1, 2 and 5)

The compartment temperatures leading to manual fire suppression (Tests 1, 2 and 5) or without manual fire suppression (Tests 3 and 4) are given in Figure 14.

In the under-ventilated fire scenarios, the failure of the protection layouts in Test 1 (with 2x18 mm GBs) did not appear for the first 60-80 minutes, but the GBs failure ultimately led to fire regrowth and termination of the test by manual suppression (135 minutes). In Test 2, increasing the thickness of the two GBs by 7 mm each (25 mm layouts instead of 18 mm) significantly reduced the surface temperatures, keeping them below 250°C for the entire duration of the test up to manual suppression. Test 3 was more representative of a fuel-controlled fire and was characterised by a rapid growth and comparatively short fully developed phase. Thus, the interface temperatures in Test 3 were observed to decrease after approximately 40 min and the surface temperatures were found to remain below 250°C for the duration of the experiment. Results for tests 4 and 5, where three openings were used ($O=0.065\text{ m}^{1/2}$), are not part of this discussion but are noted to inform that the results obtained on CLT structures cannot strictly be applied to TFA structures. In the performed tests, an earlier failure of the TFA ceiling was observed compared to the CLT ceiling.
