# DEVELOPMENT OF A STAND-ALONE VIBRATION MEASUREMENT SYSTEM FOR BRIDGE MONITORING

**ABSTRACT:** The quality assurance of timber bridges is currently ensured mainly manually by regular visual inspections over the entire life cycle. To reduce this (cost) effort, the possibility of continuously recording the condition of bridges through monitoring is being investigated. This would also increase the confidence in the long-term load-bearing capacity of timber bridges among planners and public. In addition to the permanent recording of the wood moisture content, conclusions can also be drawn about the condition and even possible damage by recording the natural frequencies which depends on the stiffness. For this purpose, a stand-alone vibration measurement and evaluation system was developed, which is easy to handle and suitable for long-term monitoring due to its energy efficiency. Beside a first application on a low-traffic timber bridge for several months, the system was validated with investigations on various types of artificial damages on the natural frequency of timber components.

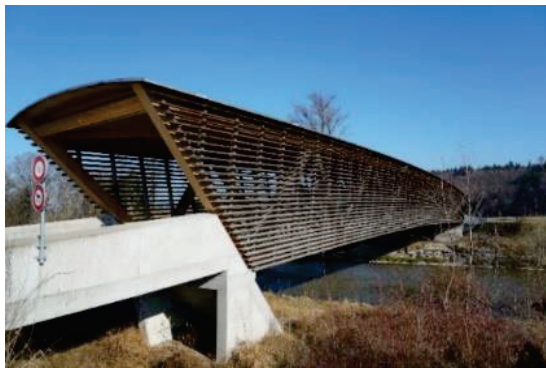
**Figure 11:** Neumattbridge Burgdorf, side view of the timber bridge (top) and location of the measuring sensors and data logging station (bottom)

The developed vibration measurement system was installed on the Neumatt-Bridge near Burgdorf (Figure 11 and Figure 13). The Neumatt-Bridge is a covered truss system bridge made of soft- and hard wood products. With a span of 59 metres, it is the largest free-span timber truss bridge in Switzerland. It is used for slow traffic (mainly pedestrians and bicycles but also agricultural vehicles). With regard to be used at a Swiss Festival in 2013, four mass dampers adjusted to the natural frequency of the bridge were installed in order to limit the vibration accelerations. The new vibration measuring tool was installed at three positions, and each node measures the accelerations in x-, y-, and z-direction. The positions of the sensor nodes on the bridge were chosen to be at the points of maximum deflection of the first and second eigenform, i.e., two at the midpoint (at both trusses) and one at a quarter point of the bridge (see Figure 12). The sensor nodes were attached to the top chord of the trusses so that direct influences from the roadway planking did not falsify the results and the overall structural behaviour could be analysed.

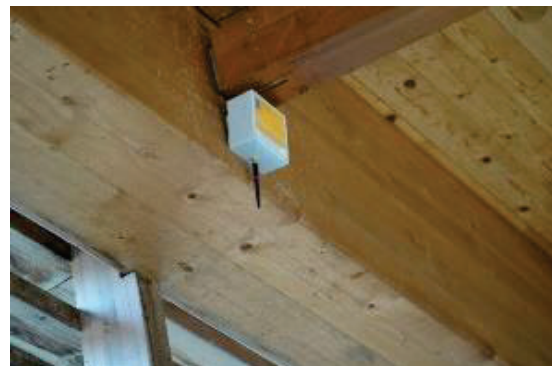
**Figure 13:** One of the sensor nodes of the new vibration tool
