# CONSTRUCTIVE REHABILITATION OF THE FLOOR STRUCTURES OF ZAGREB'S DOWNTOWN BUILT IN THE FIRST HALF OF THE 20TH CENTURY

**ABSTRACT:** The major damage to the buildings in Zagreb's Lower downtown caused by the earthquake is partly the result of the way the timber ceilings were built, which are mostly not connected to the masonry walls on which they rest. In this way, they do not have the properties of rigid diaphragms, which, due to the effect of an earthquake, leads to the loss of the integrity of the construction.

The subject building is a residential building located in the downtown of the city of Zagreb, at the address Medulićeva street 16/3. The building was built in the first part of the 20th century (before 1920).

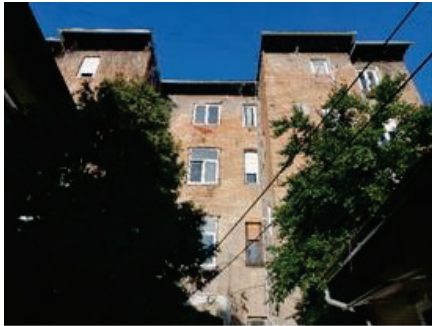
**Figure 2:** The eastern façade (face) of the structure

The vertical bearing structure consists of brick walls, while the ceiling structure is made of timber beams. The residential building has a basement, ground floor and 3 floors [3].
