A MOISTURE MANAGEMENT STRATEGY FOR CLT USING SENSOR TECHNOLOGY TO CREATE A ROBUST NORWEGIAN SCHOOL

ABSTRACT:

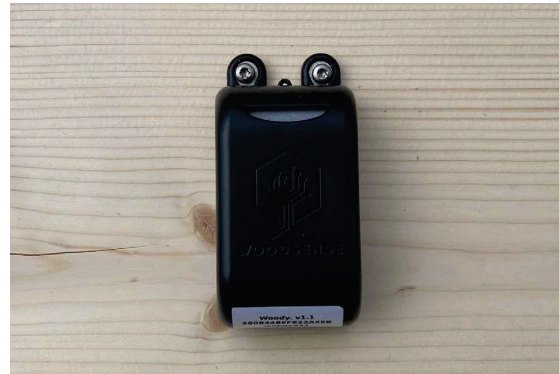
Figure 4: Sensor that monitors wood moisture content, temperature and humidity from Woodsense.

When working with timber in construction, one of the main issues is related to moisture damage. The sensor solution by Woodsense seeks to address that issue by measuring wood moisture, temperature and humidity, and comparing the data with local weather data. By analysing the collected data, it is possible to detect leaks and conditions that can lead to mould and rotting of the wood. Through constant monitoring, moisture damage can be prevented, thus reducing resource waste. The embodied CO₂ emissions associated with a moderate defect in terms of disposing of materials and replacing with new materials amounts to 572.32 Total GWP [kg CO₂eq] equivalent to 2% of the entire buildings embodied carbon emissions [3].

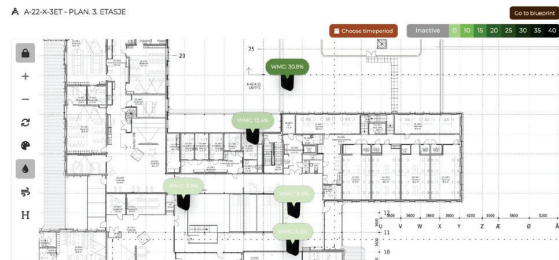
Figure 5: Blueprint from the 3rd floor. Sensor placement on this floor in wet rooms close to the concrete floor to detect leakages, on the balcony under a pavilion to ensure water doesn't get in and under a window to test window is tight during construction,

Sensors were placed on various locations in the main construction to monitor particularly exposed areas, detect critical moisture levels before damage could occur and document moisture management throughout the construction.

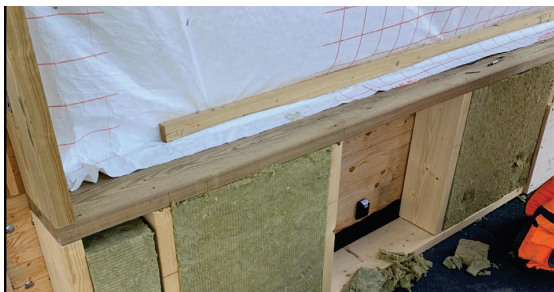
Figure 6: Sensor under window. © Kruse Smith
