# MOISTURE AND TIGHTNESS MONITORING WITH DIFFERENT MEASURING SYSTEMS AND METHODS - EXAMPLE APARTMENT BUILDING

**ABSTRACT:** Moisture monitoring is becoming an increasingly relevant technique to ensure that buildings remain in good quality. Building with wood, whether it is for family homes or mid-rise buildings, is more popular than ever. Rising prices, high-quality requirements and calls for swift construction completion are impacting contemporary modern architecture. These changes are far-reaching: after all, simple, straight structures offer enormous advantages in terms of systemisation, prefabrication and the mounting of buildings. Consequently, there has been a visible change from sloping roofs to flat roofs. In addition, even storey levels offer further advantages: compliance with distance regulations to neighbouring properties is facilitated. These areas can partly be used as terraces, gardens, and also for the installation of building service equipment (heat pumps, ventilation equipment, etc.). Concerning moisture issues, natural building materials must be handled with great care in order to ensure the durability of a building structure. Despite great craftsmanship in the

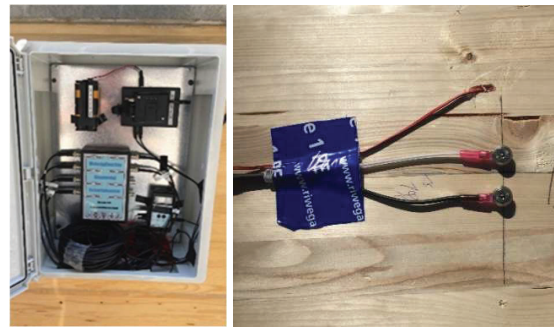
**Figure 2:** The wood moisture measurement equipment, left data storage, transmission modem, right moisture sensors (below) and temperature sensor (above)

The electrical resistance measuring method of the company Scanntronik Mugrauer GmbH is used to monitor wood moisture. Electrodes in the shape of stainless-steel screws of different lengths are mounted to measure the wood moisture distribution. The screw shaft is insulated with a shrink sleeve so that the moisture is only measured at the tip of the screw. This makes it possible to measure the wood moisture specifically at different depths of the wood. The distance between the electrodes is 30 mm. The measuring electrodes are connected to the material moisture meter with shielded coaxial cable, which may

have a maximum length of 15 metres. Up to eight measuring points can be monitored with one device and, depending on the pre-setting, forwarded to a data logger and stored every second, minute or hour. Furthermore, it is possible to record the temperature (e.g. wood, air) and the relative humidity via a data logger in combination with a sensor unit. The measured values stored with the data logger can be received by e-mail. If there is a power connection to the measuring systems the data can be accessed via telephone. Otherwise a specified time interval is set and the data are sent via email. The output value of the wood moisture is provided in percent or in ohm. In addition, the temperature in the wood and the relative humidity in the interior of the building were recorded.

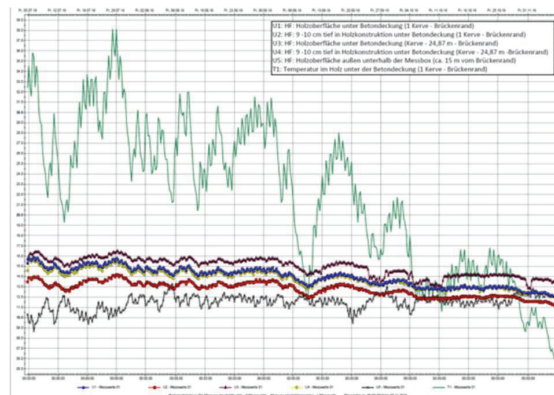
**Figure 3:** Wood moisture data

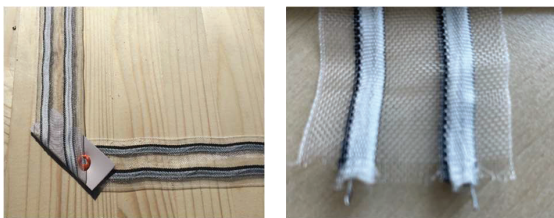
Figure 4: Area sensor measurement

The Optidry® Monitoring System (OMS) is an active building monitoring and warning system for the early detection of hidden water damage. The area sensors are installed on the diffusion-inhibiting or vapour-blocking (warm roof) level as the flat roof covering is attached. Before installing the area sensors, the roof is divided into different zones (edges, main area, risky spots). Installation is straight forward and it depends on the waterproofing membrane used (bitumen, plastic, raw ceiling), whether the area sensors need to be glued or nailed. Up to eight

independent monitoring areas (area sensor units) can be connected via a bus system and the data saved in a control centre. If the specified upper humidity limit, gauged in digits, is exceeded, an alarm is triggered by the central unit and forwarded to the customer. The current moisture status at the sealing level can be accessed and evaluated directly on a smartphone, tablet or PC using the OMS Inspector app. Water ingress can thus be detected at an early stage and localised. In addition to flat roofs and terraces, the system is also used in wet rooms from service class W3. The Optidry Monitoring System can be integrated into smart-home systems or into the building technology equipment.

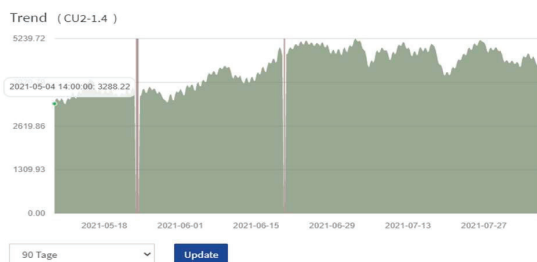
The belt or area sensors are approx. 5 cm wide fabric strips containing two stainless steel wires. The moisture content in digits is determined via the resistance between the two wires.

Figure 5: Area sensor measurement

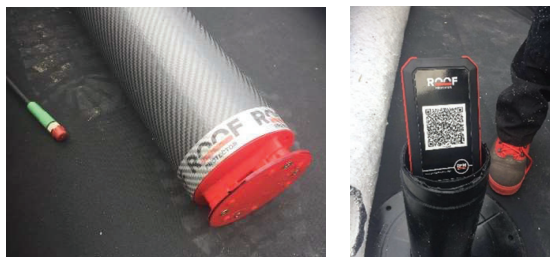
Figure 6: Point sensor measurement

The system used, the RPM ROOF PROTECTOR, is a simple and efficient device to immediately detect moisture in roof structures and to take timely action. Indicators evenly laid out over the roof surface measure the moisture and temperature. This allows gaining insight into the moisture condition of a roof package (insulation package). The measuring system can be applied to all commercially available roof layers (waterproofing, insulation, etc.). The system also fulfils the additional measure required in ÖNORM B 3691 for the monitoring of flat roofs of use category 3. The recorded measurement data are stored on a central server of RPM Gebäude Monitoring GmbH and can be retrieved permanently and at any time via a web browser. The measuring sensor is located in the warm roof structure just above the sealing membrane (vapour barrier). In addition to measuring the humidity, which is indicated in digits, the temperature is

also measured in the area of the vapour barrier and on the outside at the surface of the roof structure. The sensor is usually installed after the top waterproofing layer has been laid. The insulation material in the warm roof structure is drilled out with a so-called box drill, which has the same diameter as the point sensor, and the fully insulated point sensor is inserted there. The system used is battery-powered and is therefore self-sufficient and can be used wherever there is a radio contact for data transmission. The system measures the humidity and temperature in the insulation level and also on the sealing level of the raw ceiling.

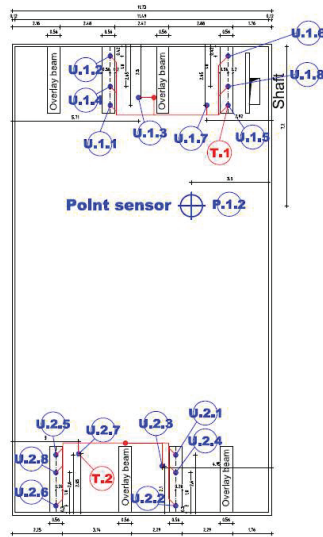
**Flat roof**  
 U.1.1, U.1.2, U.1.3, U.1.4, U.1.5, U.1.6, U.1.7 and U.1.8, point of the wood moisture in the overlay beams and CLT roof on the north side;  
 T.1 and T.2 points of the temperature in the CLT roof on the north and south side  
 U.2.1, U.2.2, U.2.3, U.2.4, U.2.5, U.2.6, U.2.7 and U.2.8, point of the wood moisture in the overlay beams and CLT roof on the south side;  
 P.1.2 point sensor in the insulation layer on the bitumen waterproofing

**Figure 8:** One point sensor and 16 measuring points of the wood moisture and temperature measurement.

The first flat roof plan shows the measuring points for the wood moisture measurement, of which eight measuring points each (label U) were installed on the south and north sides of the roof. The two temperature sensors used are marked T in red. The point sensor is also shown on this flat roof plan. The position was placed slightly outside the centre of the roof surface, in the north-east area. The reason is that the roof slopes to the east (water drainage) and an installation shaft penetrates the roof in the northeast. Thus, this area is considered to be the most vulnerable in terms of possible leaks.

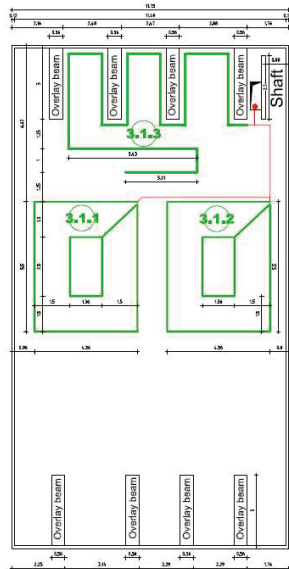
**Flat roof**  
 3.1.1, 3.1.2, 3.1.3, Area sensors on CLT ceiling (green)

**Figure 9:** Three area sensors on the solid wooden roof

This flat roof plan shows three measuring circuits with area sensors mounted directly on the solid wooden roof. This arrangement was chosen because the deflection is greatest in the central area of the roof surface, i.e. in the event of water ingress, this area is likely to be the first to suffer moisture penetration. The measuring circuit on the north side was laid close to the statically required overlay beams. These beams have only a small amount of insulation on the above surface, i.e. the risk of condensation at low outside temperatures below the waterproofing layer is very high. Therefore, it should be monitored whether this minimal insulation also impacts the moisture situation on the surface of the supporting structure (cross-laminated timber) screwed to the overlays.

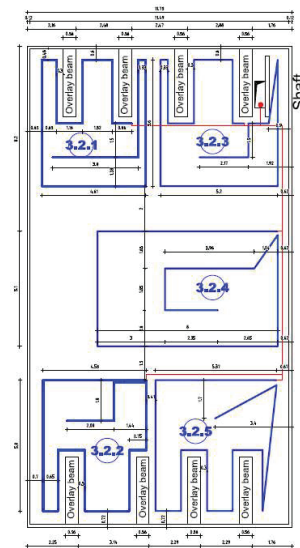
**Flat roof**  
 3.2.1, 3.2.2, 3.2.3, 3.2.4, 3.2.5 Area sensors on waterproofing membranes (blue) on the vapour barrier Riwega DS 1500 Syn

**Figure 10:** Five area sensors on the waterproofing membranes

This flat roof plan shows five measuring circuits with area sensors on the first sealing level (vapour barrier). The arrangement was chosen due to the roof pitch (towards the east) and to be able to monitor the entire roof surface for moisture.

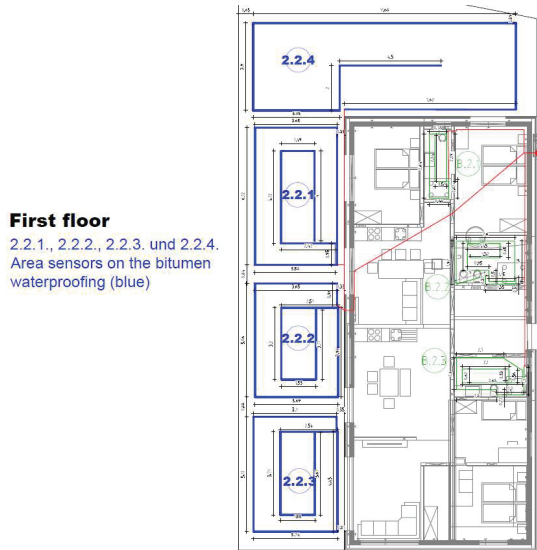
**Figure 11:** First floor - area sensors on bitumen (blue) - sanitation areas sensors on solid wood (green)

On the 1st floor, area sensors were installed on the terraces and in the sanitation facilities. Three measuring circuits were attached to a bitumen seal on the terrace (west side) above the living space below. Further measuring circuits (shown in green) were installed in the three sanitation rooms directly on the raw ceiling made of cross-laminated timber. On the north side there is a roof-covered terrace with a passageway below. The measuring circuit was attached to the bitumen seal. This spot is interesting, because the temperature differences in this part of the building are significantly lower and due to the north-facing orientation little solar radiation can be expected in

the winter months. The investigation aim at this floor level is also to monitor the overall humidity and tightness. Furthermore, the monitoring should also provide information about the influence of the different thermal conditions.

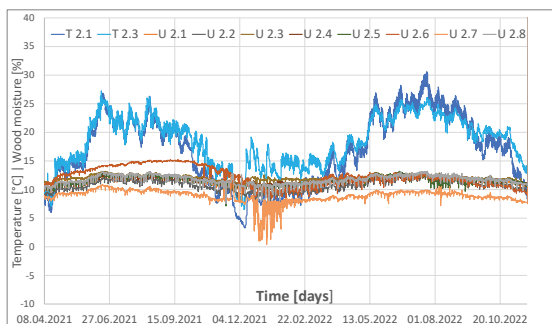
**Figure 13:** Flat roof (south side) - wood moisture measurement U 2.1 - U 2.8; temperature in cross laminated timber - T 2.1; temperature interior 1st floor - T 2.3;

The measurement diagram from the south side of the flat roof (Fig. 13) shows the wood moisture content of the eight measurement points (U 2.1 - U 2.8) as well as the temperature curve in the wood (T 2.1) and in the living room area of the first floor (T 2.3) where the data logger is located. The Y-axis of the diagram shows the temperature and wood moisture and the X-axis depicts the time progression. All other diagrams have the same

structure. The measuring system was put into operation on 08 April 2021. The measurement data in the diagram show the course of the wood moisture from the time of commissioning until 31 January 2023. The course of the wood moisture lies in the normal range between approx. 8% and 15%. The differences in the wood moisture content can be explained by the different depths of the inserted measuring electrodes. At measuring point U 2.6, a steady increase in the wood moisture content of up to 15% can be seen from May 2021 to the beginning of October 2021, before it drops again in the winter months. At low temperatures, it is noticeable that the measuring system repeatedly experiences disturbances in data storage, as can be seen at measuring point U 2.7 from mid-December 2021 to mid-February 2022. The measured values have a high fluctuation range due to the temperature changes. It is also noticeable that in the winter months the temperature in the cross-laminated timber drops below 10°C, i.e. into the dew point range, despite the external insulation.

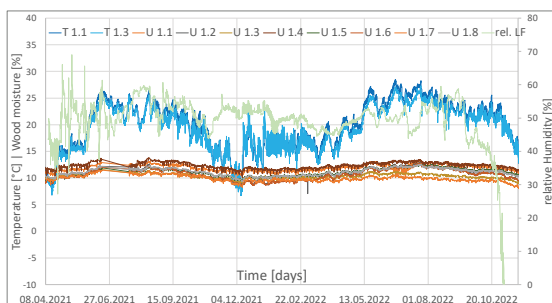
**Figure 14:** Flat roof (north side) - wood moisture measurement U 1.1 - U 1.8; temperature in cross laminated timber - T 1.1; temperature and relative humidity in interior 1st floor - T 1.3 and relative humidity;

The measurement period on the north side of the flat roof is the same as described for the south side (Fig.14). The wood moisture content is very even and inconspicuous over the entire measurement period. It can be seen, however, that the wood moisture content decreases somewhat over the course of time shown (April 2021 to

November 2022). This also corresponds in principle to the behaviour of wood: The material becomes drier when professionally installed under the typical living room climate of 22°C and approx. 40 % relative humidity in the heated and occupied interior. In contrast to the south side, to check the indoor climate, the relative humidity in the interior of the 1<sup>st</sup> floor is also measured at this measuring station. In the period from 16-06-2021 to 15-08-2021, there was an interruption in the measurement recordings, because a cable was unintentionally detached from this measuring device during construction work.

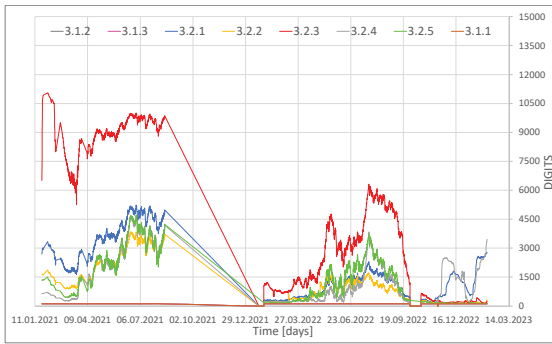
**Figure 15:** Flat roof area sensors 3.1.1 - 3.1.3 on the cross laminated timber ceiling; area sensors 3.2.1 - 3.2.5 on the first sealing level (vapour barrier - plastic sheeting)

Not all area sensors on the flat roof, on the 1<sup>st</sup> floor and on the ground floor could be installed and commissioned at the same time due to the construction progress. This explains why for some measuring circuits the basic voltage is 120 digits. During commissioning, a steep increase in humidity can be seen in some cases, as in the case of measuring circuit 1.2.1 in Fig. 17. In each of the three diagrams (Fig. 15-17) it can be seen that there is one or more measuring circuits at each monitored floor level where there is already a high moisture content at the sealing level from the start. The reason for this is that water ingress occurred during the installation of the roof superstructures due to rain and snowfall and therefore the specified limit range of 11500 digits (laid on waterproofing membranes) was exceeded in some cases. Furthermore, it should be mentioned that there was no network connection from mid-September 2021 to the end of January 2022 and therefore no online access was available. However, it can be seen that the moisture content in the building components became significantly lower over the winter months. In spring, from around mid-March 2022, the moisture content on the waterproofing membranes (vapour barriers) begins to rise again. However, the increase is significantly lower than in the first year of monitoring in 2021. In the autumn months from September 2022 onwards, a clear reduction in moisture on the waterproofing layer is again evident. With the increase in outdoor temperatures, the moisture content on the sealing levels also increases in February 2023. In the coming months and years, monitoring will show which level the moisture content will adjust to over the course of the year (summer, winter). The measuring circuit 1.2.1 in Fig. 17 should be mentioned separately, as it shows a moisture behaviour that is not yet comprehensible. From about April 2022, there is a strong increase in humidity to about 10000 digits. This remains almost constant until the beginning of November 2022, after which the moisture content of this measuring circuit drops to approx. 1000 digits within 2.5 months. Measuring circuit 1.2.1 will therefore be monitored in particular over the next few months to find out whether the increase in humidity is possibly related to leaks in the upper sealing level. If the strong moisture fluctuations continue, the sealing level in the area of this measuring circuit will be opened, dried and resealed

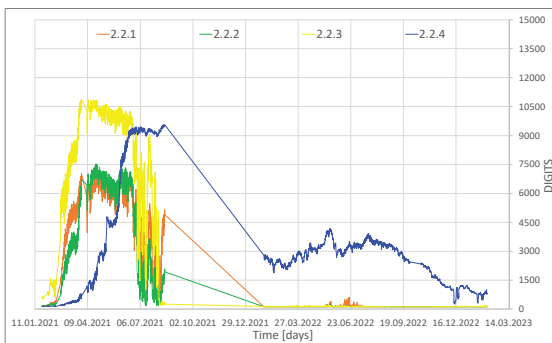
**Figure 16:** First floor - area sensors 2.2.1 - 2.2.4 mounted on bitumen sheeting

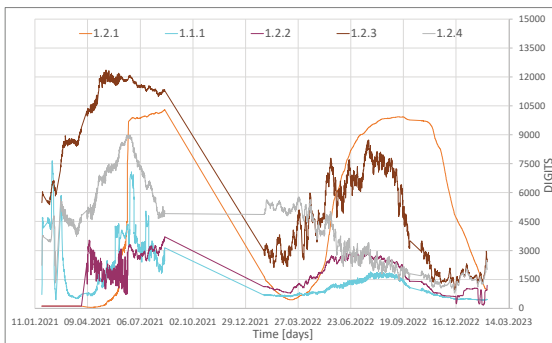
**Figure 17:** Ground floor - area sensors 1.1.1 mounted on reinforced concrete ceiling; 1.2.1 - 1.2.3 mounted on bitumen sheeting; 1.2.4 mounted on plastic sheeting - vapour barrier

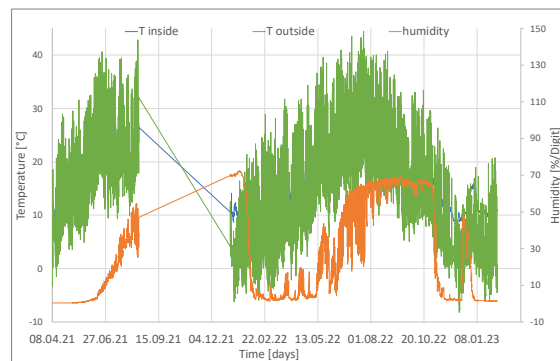
**Figure 18:** Point sensor 1.2. on the flat roof

The point sensor on flat roof 1.2 (Fig. 18) is installed near measuring circuit 3.2.3 (area sensor). In the area of this measuring circuit, moisture penetration occurred when sealing the top sealing level. The increased moisture content is also indicated by the point sensor. At the end of January 2022, however, a very rapid drop in moisture occurred within a few days. This means that there must have been a strong drying process within this short time

in the insulation level and on the sealing level. If we look at the moisture curve one year later, in February 2023, there is again a sudden sharp drop in moisture. This time, however, it is already in November. In December 2022, there is a brief intensive rise followed by a sharp drop in the measurement curve. The moisture behaviour in the insulation level is difficult to interpret using the point sensor as the measurement period is still relatively short. Questions as to how these very rapid increases in humidity and drying phases can occur still need to be investigated in detail. For point sensor 1.1 (on the green roof of the single-storey existing building), no changes in moisture or conspicuous moisture occurrences can be detected in the first year of monitoring. From June 2022 to mid-October 2022, there is a slight increase in moisture of up to 20 digits. Compared to the area sensors, the limit value for liquid water for the point sensors is 80 digits. Therefore, the value of 20 digits is considered a dry component. However, the reason for this slight increase in moisture has yet to be determined. One reason could be that the measuring device is subject to fluctuations. Otherwise, no other abnormalities can be detected in the insulation level of the green roof.

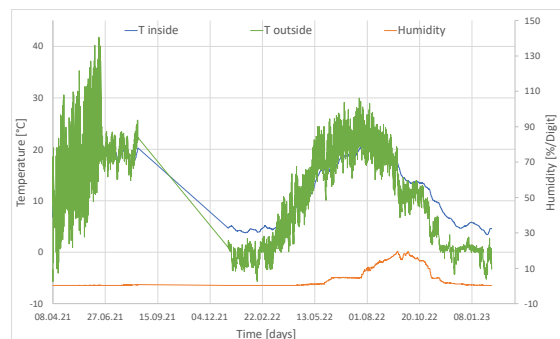
**Figure 19:** Point sensor 1.1 on the green roof surface of the existing single-storey building
