COMBINATION OF NDT AND DESTRUCTIVE TESTS FOR GRADING THE STRENGTH CLASS OF TIMBER TO REHABILITATE STRUCTURES

Marcel Vilches-Casals¹, Eduard Correal-Mòdol¹, Carles Labèrnia Badia¹, M.P Giraldo¹

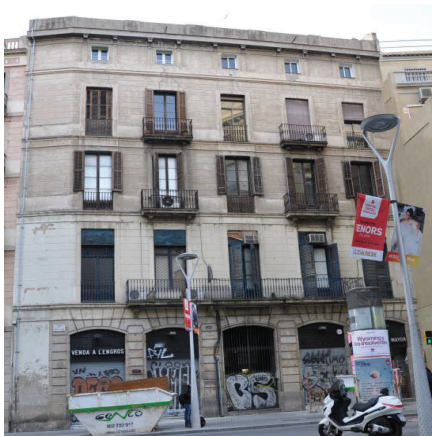
Figure 1. Façade of the building on Trafalgar Street

The case study is the timber structure of a five-storey building placed at 26 Trafalgar Street in Barcelona built in 1878 (Figure 1). Its constructive system was very typical in late 19th and early 20th centuries in the cities of Catalonia: masonry walls, wrought iron pillars and timber beams. The species of the beams was not determined but the gender was *Pinus* sp. The most common species used by that time in Barcelona was Scots pine (*Pinus sylvestris*) from the Pyrenees, but the authors also found in other contemporary buildings different common local species like Black pine (*Pinus nigra* subsp. *salzmannii*) and poplars (*Populus* sp.). In addition, also the American southern yellow pines from overseas were very common. The timber structure was in a generally good condition

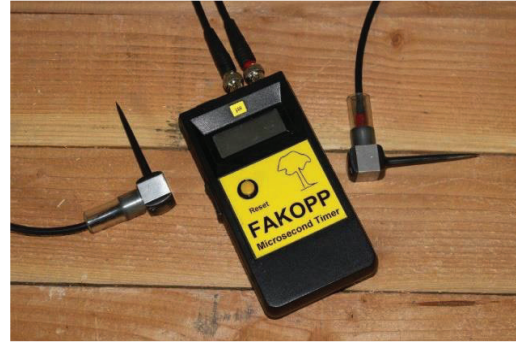
The microsecond timer generates impact waves with a frequency of resonance of 23 kHz and measures the time of flight between the transmitter and the receiver sensor (Figure 3). Impact waves are generated by hitting the transmitter with a hammer. Both sensors are metal nail alike transducers, they must be nailed into the wood, and the distance between them must be measured. In this case, the transducers were placed underneath the beams (Figure 4). The principle of this technique is based on the different propagation speeds of the impact waves depending on the soundness of the wood.

Figure 3. FAKOPP Microsecond timer used in the study

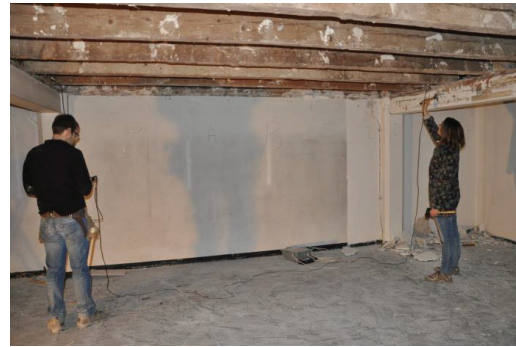
Figure 4. Beam inspection with acoustic waves in the building

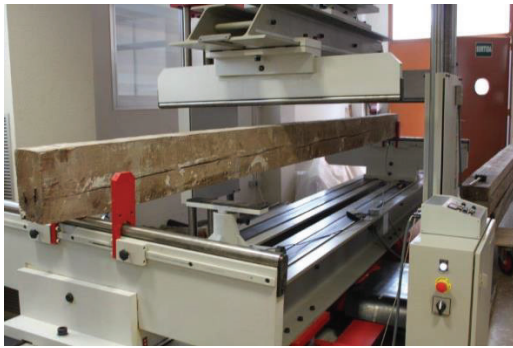
Figure 6. Bending test machine at INCAFUST-CTFC

The specimens were chosen randomly between those to be removed due to the new distribution of the building. Several minor modifications and a new staircase were planned to connect the ground floor with the first floor. Five timber beams were selected for being tested at the laboratory. Three were from the new staircase on the ground floor, one was from the first floor and the other was from the second floor. The beams of the first and second floors were chosen randomly among those easier to extract. No beam was selected depending on its apparent state of conservation and all were representative of the batch. All the beams were of the same species, there were no abnormal density deviations, and the dimensions were 220×100×4000 mm. MOR, MOE, density, moisture content and stress wave tests were performed. The four-point bending test was done according to UNE EN 408:2011+A1:2012 [4] on a Hoytom bending test Machine. The test samples were symmetrically placed with a span eighteen times the depth (3960 mm) and the two load points were at six times the depth from the support point (1320 mm) (Table 2 and Figure 6).
