PRACTICAL DESIGN CONSIDERATIONS FOR TCC-ELEMENTS WITH CLT-SLABS

Thomas Moosbrugger¹, Harald Krenn²

ABSTRACT: The timber-concrete composite (TCC) construction method is looking back to a long period of use in construction and with the availability of planar elements like cross-laminated timber (CLT), also flat TCC-elements are being used increasingly in construction practice. These TCC-elements may be designed according to CEN/TS 19103:2021 [1] or other provisions [7] when notches are used to transfer the shear forces between the two parts of the composite element. One of the most debated and controversial issues regarding this design method is the uplift force acting in the notched connection. This paper attempts to evaluate the uplift force acting in real design situations.

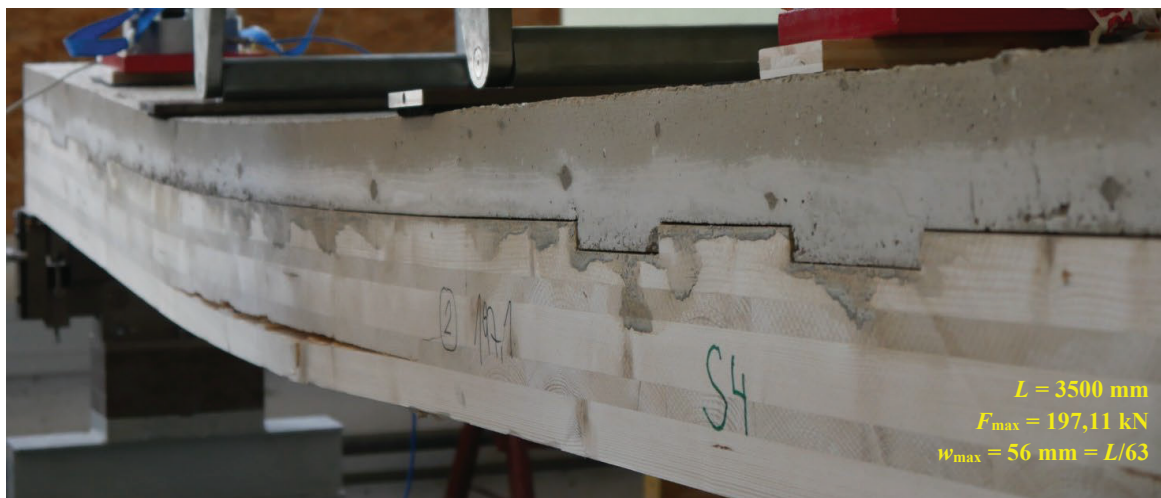
Figure 1. Largely deformed concrete composite test specimen with CLT [6] failed in tension at the bottom lamination

When TCC elements are tested in the laboratory, the ultimate failure mechanism observed is quite often tension failure of the wood fibers at the bottom of the CLT element (see Fig. 1). In this test, the failure occurred at a very large deformation (56 mm = $L/63$) with an ultimate load of 197 kN (corresponding to ca. 128 kN/m²).

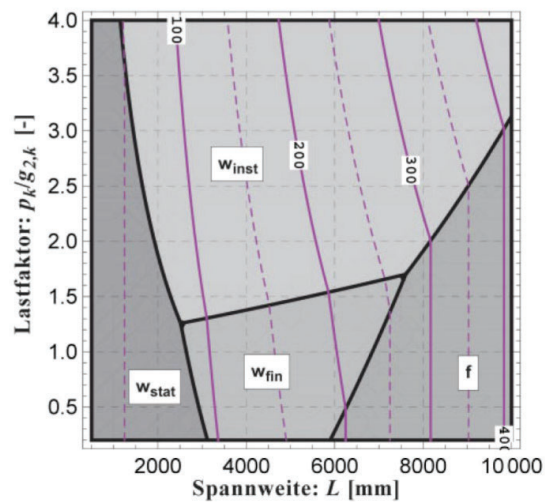
Figure 4. Design chart for CLT slabs in floor performance level I [10]

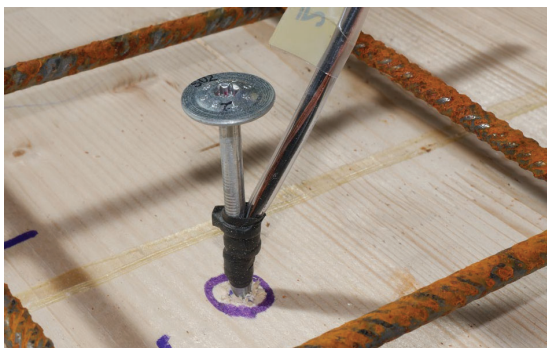
Figure 7. Measuring screws with applied strain gauges in the CLT surface and reinforcement mesh

To investigate the uplift effect, measuring screws were made from commercially available pan head screws with a nominal diameter of 8 mm. To attempt to measure the axial forces, two opposing strain gauges were attached to the screw shafts (see Fig. 7).

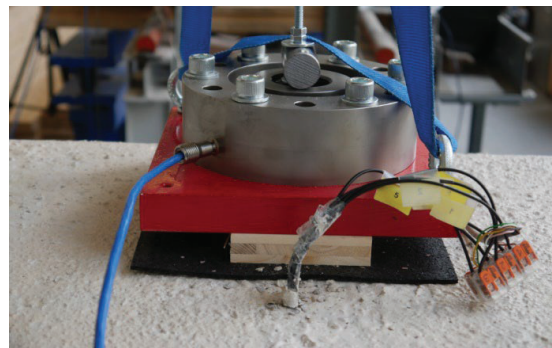
Figure 8. Load cell to qualitatively measure the uplift force curve in the notch

In addition to the determination of the internal uplift force by means of the measuring screws, an additional external measurement equipment (see Fig. 8) was installed on some test specimens using load cells and threaded rods in a casing tube (see green boxes marked [D] in Fig. 6). The

elastic bearing should reflect the flexibility of the adjacent measuring screw as good as possible and the equipment should be able to qualitatively confirm the load-displacement behaviour of the measuring screws.
