RESEARCH ON THE DURABILITY OF ORTHOGONAL GLUED CROSS-LAMINATED TIMBER UNDER GROUND CONDITIONS

Yuko Mizobuchi¹, Tadashi Hara², Masaki Harada³, Makoto Imai⁴

ABSTRACT: Industrially, cross-laminated timber (CLT) has become a popular building material because it is environmentally friendly, looks good and is easy to install. CLT is made up of 30mm thick sheets of wood called laminations. CLT is manufactured by gluing the lamellas together in the direction of the fibers, orthogonally to each other. Since its invention in Europe in the 1990s, the use of CLT has grown worldwide, gaining popularity for its potential in architectural and civil engineering applications, including soil stabilization and paving. As CLT is primarily composed of wood, its use will play a significant role in meeting the 2050 global carbon neutral targets. However, the use of CLT in civil engineering is hampered by a lack of awareness of how long CLT will last in different climatic conditions. Compared to its use in buildings, where it remains mostly in an air environment, CLT for civil engineering is often exposed to soil, water and fluctuating climatic conditions. This study examines the degradation characteris

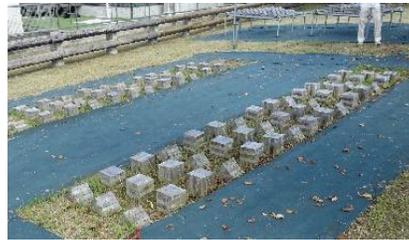
Photo2. Ground installation conditions (Buried the test piece under the blue sheet)

Samples were positioned at varying depths about the ground level to simulate different exposure conditions: (Fig.3,4) (photo2,3)

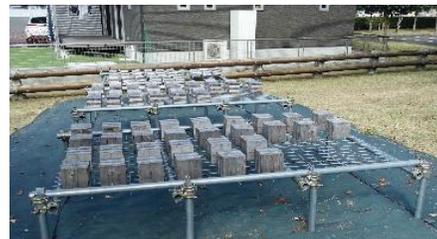
Photo3. Installation status in the air

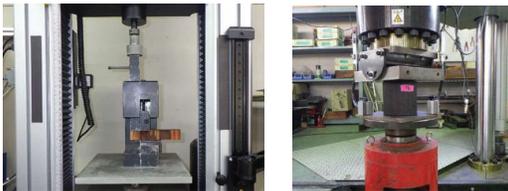
Photos 8&9. block shear test (Left)
Longitudinal Compression Test (Right)

To assess the deterioration of CLT specimens exposed to various environmental conditions since 2021, a subset of the specimens was retrieved at two intervals: one year and two years after initial placement. The deterioration status was examined through visual observations and mechanical strength assessments, including longitudinal compression and block shear tests (Photos 4–9).

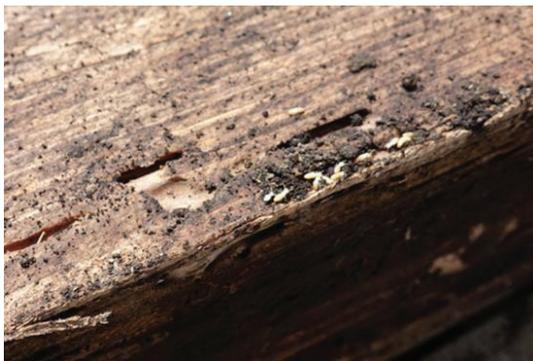
Photo 10. Termites found in the subtropics (on board)

Biological degradation was negligible in the subarctic, but significant in the subtropics. This is probably due to temperature and humidity conditions suitable for fungal and insect activity. In particular, it was termites that were activated by suitable temperatures in the subtropics, confirming that termite damage was occurring. Photo 10 shows the conditions that support the presence of termites in the subtropical zone. In this study, CLT boards were buried in the ground in an upright position, separate from the specimens of the blocks in this study. When the buried board was excavated at the same time as the block specimen, termites were found to be living on the board only in the subtropical zone.

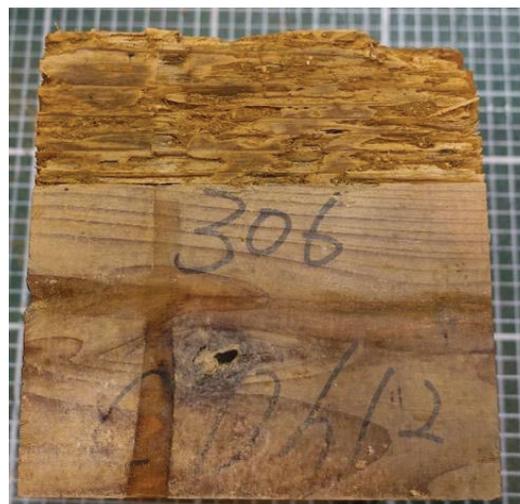
Photo 11. Surface decay (Temperate × APT × GL-0.5m)

Regarding decay, we note that for the specimens deeper than GL-0.5 m in the temperate zone, all six specimens only in RF had decay. However, all of them decayed only on the surface layer and did not reach the adhesive layer (Photo11) .

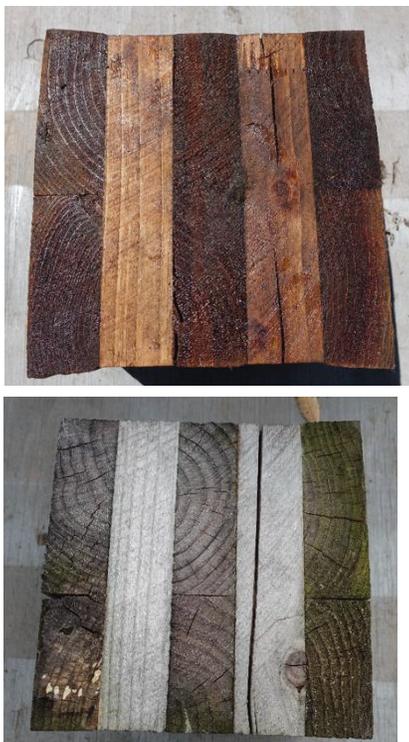
Photo12 &13. Cracking of laminae under the same conditions in subtropical × API Top : GL-0.1m Bottom : GL+0.5m

Compared with specimens retrieved after one year, lamina and adhesive joint cracking development was visible under all climatic exposures. With regard to the cracking of the laminae, the cracking of the specimens buried in the ground was generally smaller than that of the specimens in the air (Photos12, 13) .

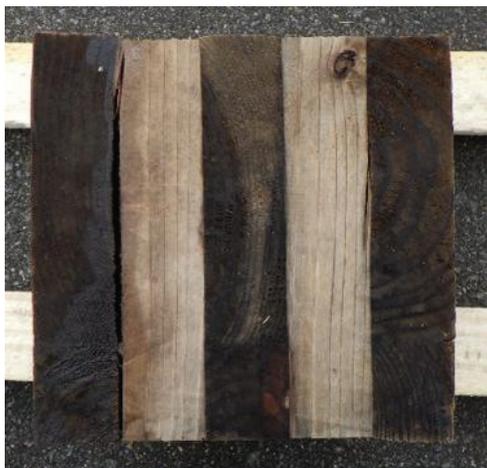
Photo14. Cracking at the adhesive layer Subarctic × API × GL-0.5m

Cracking at the adhesive joints was a degradation mode specific to CLTs, resulting from the difference between shrinkage and expansion of the lamina, exacerbated by moisture-related cyclic stresses. The results of the current study were highly variable and did not confirm any trends due to the established variables (adhesive, installation site, and climatic conditions). Continued monitoring is needed to evaluate changes in climatic and location factors over time (Photo14) .
