ENVIRONMENTAL, ECONOMIC AND MOISTURE RELATED ASPECTS OF LARGE SPAN TIMBER STRUCTURES IN HIGHLY CORROSIVE SURROUDINGS

ABSTRACT: This paper will address the material design strategy of designing a large roof structure in corrosive surroundings like swimming hall facilities. The paper will give an insight into the moisture measurement approach chosen for the wooden parts of the innovative roof construction. Furthermore, the paper will explain the follow up process and on-site moisture-measurements during the building construction phase, revealing the moisture impact on the material and the process of documenting and approving the roof structure after a heavy water leakage during the construction.

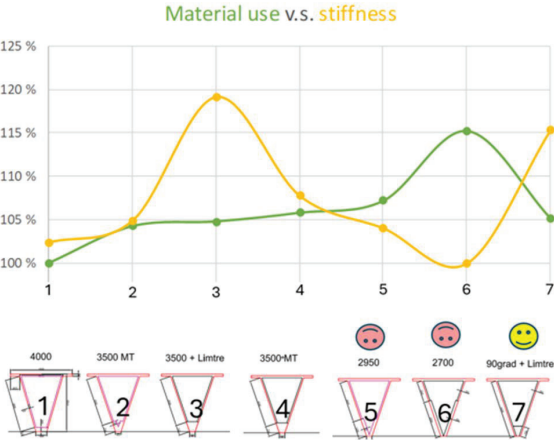
The design primarily focused on achieving flexural stiffness, balancing the client's economic demands with the market's production capabilities. A parametric study was conducted to determine the final section. Seven different configurations were assessed based on material usage and stiffness. To facilitate comparison, the values were normalized as illustrated in Figure 3: the lightest section was set at 100% (green line), and the least stiff section was set at 100% (yellow line).

Figure 3: Rendering of the initial design compared to the final result.

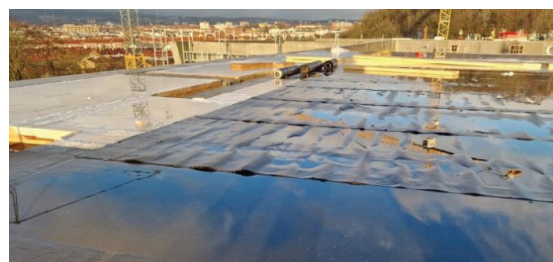
Figure 9: Shows that the bitumen membrane did not bond to the fabric.

Persistent heavy rainfall significantly impacted the effectiveness of the temporary weather protection during a period of the construction. Despite efforts to dry the surface of the self-adhesive membrane before applying the tape between joints of elements, adhesion issues to the tape arose. In addition primer was not used between the self-adhesive membrane and the asphalt membrane, leading to poor adhesion. This resulted in improper bonding between the membrane and the fabric, allowing air pockets to form. Subsequent rainfall and snowmelt resulted in water infiltration beneath the asphalt membrane, causing the tape securing the weather protection fabric to loosen. This ultimately led to free-flowing water penetration through the construction joints, posing significant challenges to moisture control.

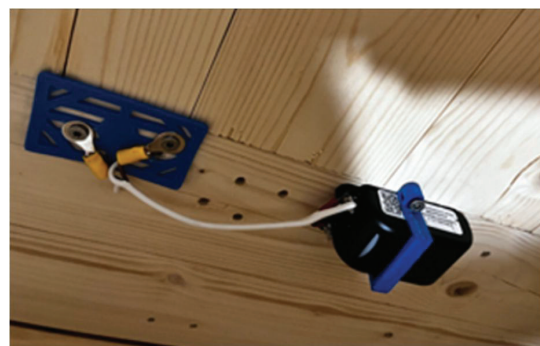
Figure 13: distribution of moisture sensors on the blueprint of the roof (extract from cloud service interface).

An equilibrium moisture content of 12 % is expected in the roof structure during operation of the swimming pool. The drying of the roof plate to this target moisture content as soon as possible is desirable to avoid the risk for mold growth and corrosion of fasteners. With the roof structure closed and watertight from above, drying of the CLT-panels is limited to the lengthy water transport from the cross-section of the CLT panels to the lower surface of the CLT-panels. Permanent moisture logging in different depths in the CLT-panels has been established to allow monitoring and documentation of the drying process (Figure 12). The moisture content in defined depths in the CLT-panels is measured by electrical resistance method and reported to a cloud service where it can be accessed by decision makers and consultants (Figure 13).

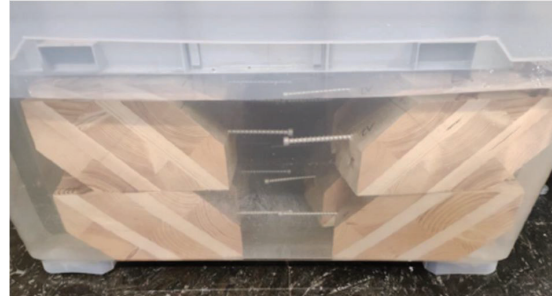
Figure 15: Heavy weathering test specimens totally immersed in water.

Experimental testing was conducted by Rothoblaas to evaluate the withdrawal resistance of fully threaded self-tapping screws used in timber-to-timber connections within CLT structures subjected to significant moisture variations. Two moisture scenarios were investigated: a light weathering condition, where only the top 40 mm lamella was wetted to a moisture content above 30% and a heavy weathering condition, where the entire sample was saturated. Screws of two diameters VGZ EVO

Ø7 mm and VGZ EVO Ø9 mm were inserted at a 45° angle using pre-drilled guides, and their tensile withdrawal resistance was measured after a single cycle of wetting and drying to service class one.

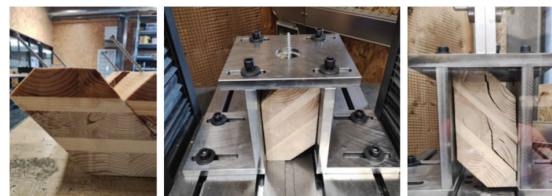
Figure 16: Test specimens (left), system for testing the withdrawal resistance (middle) and specimens with timber failure (right).

The results showed that in the light weathering scenario, timber swelling around the connector enhanced the friction, allowing both screw types to retain withdrawal capacities well above the declared TDS values - with VGZ EVO Ø7 mm screws even exhibiting a slight increase in resistance. In contrast, under heavy weathering, the timber's mechanical properties diminished notably, leading to timber failures (for example splitting, Fig. 16) and a significant reduction up to 34% in the characteristic withdrawal resistance for the VGZ EVO Ø9 mm screws.
