# Fire safe design of hybrid steel-timber construction systems

**ABSTRACT:** As part of the research project "BraStaHo" (Fire Safety of Hybrid Steel-Timber Construction Systems), two hybrid steel-timber construction systems were investigated under fire exposure using the standard fire curve. One objective was to assess the fire protection capacity of timber linings for steel beams over various time periods and identifying key factors influencing their effectiveness. As another objective, the project examined slim floor type construction systems with steel and timber elements. Experimental investigations provided valuable insights into the combustion behavior of these systems, with particular emphasis on support conditions and cavities, as these elements pose the highest risk for structural failure and smoke propagation. The deformation behaviour of the floor under fire exposure and mechanical load has also been analyzed, which showed an influence on the charring rate in the support area. Different methods to protect the steel beam from direct fire exposure and their influence on the thermal behaviour have been tested. The ultimate goal of these tests was to develop fire-safe suppo

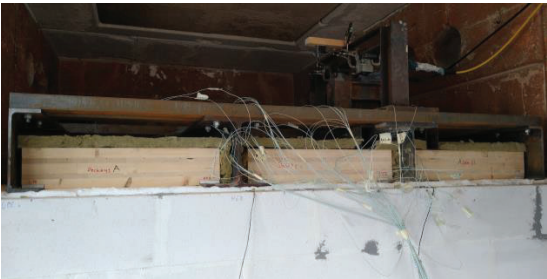
Figure 2: View of the specimen on the furnace without encapsulation from the outside

Fig. 2 shows the view of one specimen after placing it on the furnace, while Table 1 gives an overview of the testing setup.

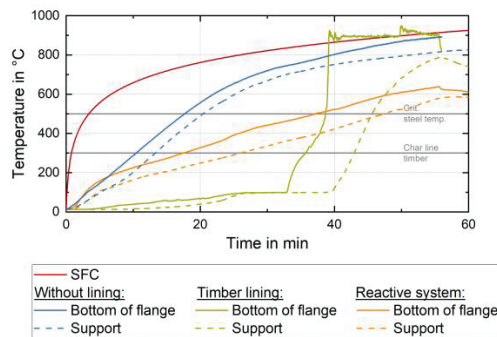
Figure 4: Temperature profiles for different protection systems

In Fig. 4, a distinction can be made between an unprotected beam (blue), a protected beam with a 22 mm thick three-layer timber board (green), and a beam with an intumescent fire protection coating (orange). For comparison purposes, the SFC is shown in red.

The unprotected beam exhibits a rapid temperature increase, reaching the charring line of timber on its underside after approximately 10 minutes. The heat penetration through the bottom flange takes another three minutes, meaning that ignition of the CLT in the support area is expected after 13 minutes. The critical steel temperature of 500 °C is exceeded for the flange after about 18 minutes.

In comparison, the beam with fire protection lining shows significant differences in its temperature curves. The bottom side forms a plateau at 100 °C after approximately 25 minutes. This temperature level is maintained for six minutes until all bound water in the timber evaporates. After this phase, a sudden temperature rise occurs as the lining deteriorates due to advanced charring and falling off. The designated fire protection duration of 30 minutes is reached.

For the beam with an intumescent fire protection coating, the initial temperature rise is similar to that of the unprotected beam. However, at around 200 °C, the temperature curves begin to flatten. This indicates the expansion and beginning of isolation for the steel beam from thermal exposure. As a result, the char line of timber is reached later, at approximately 25 minutes, on the top side of the bottom flange.

Overall, both fire protection systems effectively reduce the temperature increase. However, the timber lining maintains temperatures below 100 °C for an extended period. Once the lining deteriorates, a sudden temperature rise occurs because the beam is unprotected in an environment exposed to high temperatures. In contrast, the intumescent coating gradually reduces the rise of the beam's temperature once it expands. However, since this system is specifically designed for steel, the 300 °C isotherm in the support area is exceeded earlier than with the timber lining, leading to an earlier onset of charring in the CLT element.

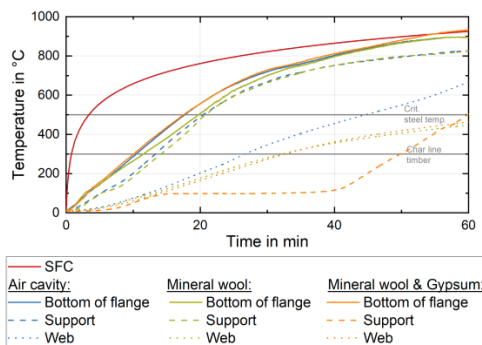
In Fig. 6, the blue curves represent the test specimen with an air-filled cavity. The green curves represent a specimen where the cavity was filled with mineral wool insulation. In contrast, the orange lines also featured an additional lining of the narrow side of the CLT element with gypsum fiberboard panels. The comparison focuses on three measurement points: the bottom side of the flange, the transition between the CLT element and the steel beam (or between the CLT element and the backing layer) and the beam's web.

Figure 6: Temperature profiles for different cavity designs

The unprotected bottom flange shows a similar temperature increase for all three test specimens, exceeding the critical steel temperature after an average of 19 minutes. The mineral wool insulation does not provide a noticeable protective effect in the support area. The 300 °C isotherm is reached after approximately 20 minutes for both specimens with the unprotected cavity and the cavity filled with mineral wool, but without additional backing at the support.

In contrast, the protective effect of the backing layer is clearly visible, as it creates a temperature plateau at 100 °C for 25 minutes. The temperature development in the steel web varies depending on the cavity insulation.

The char line and the critical steel temperature are reached earlier for the uninsulated test specimen. The mineral wool insulation reduces heat transfer by blocking radiative exchange between surfaces and convective heat transfer within the cavity. Since charring of the CLT element can be expected from minute 13 onward, the cavity insulation protects the steel web from the resulting thermal exposure.

For the insulated test specimens, it can therefore be assumed that the temperature increase is primarily due to heat conduction. This is confirmed by the test specimen with the additional narrow-side lining, where charring of the CLT element does not begin until minute 50. At the same time, the temperature development in the steel web remains similar to that of the test specimen with just mineral wool insulation.

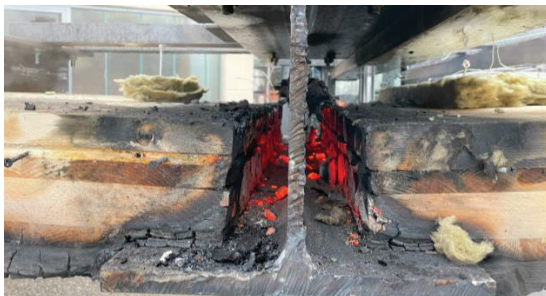
Figure 7: Temperature profiles after turning off of the furnace

After the furnace burners were turned off, the test specimens were lifted from the furnace and subsequently extinguished with water. The extinguishing process initially focused on the bottom side of the floor specimens. Afterwards, the upper structure was removed, exposing the CLT elements. It was observed that even after extinguishing the bottom side, temperatures within the construction remained above 100 °C. On the one hand, water evaporated from the steel beam, forming bubbles, and the surface dried quickly. On the other hand, after opening the test specimen, open flames and glowing embers were still present in the support area (see Fig. 7).

Some specimen's temperatures were still recorded after the burners were turned off. The measurements clearly show that an extinguishing attack from below is ineffective due to the construction design, making it challenging to reach ongoing charring in the support area. Since the extinguishing water cannot penetrate the construction, immediate suppression of the affected areas is not possible. An extinguishing attack from above is also not feasible in a typical floor construction.

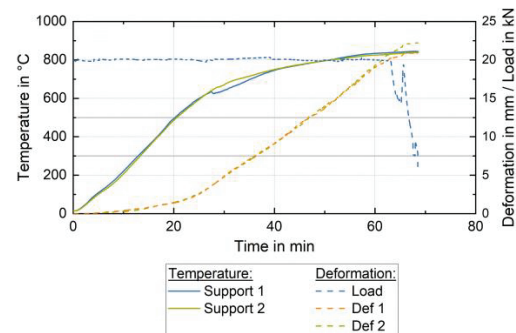
The unprotected test specimen reached the charring threshold in the support area after approximately 13 minutes, marking the onset of charring (see Fig. 9). no significant deformation was yet measurable. A minimal increase in deformation was observed after 11 minutes, which can be attributed to shrinkage effects in the wood as well as deformation of the steel flange. Once the charring threshold was reached, the formation of the charcoal layer led to a more pronounced increase in deformation, which progressed almost linearly from minute 25 onward. The deformation increased to 22 mm, at which point the hydraulic system was fully extended. This resulted in a sudden loss of force, making further adjustments impossible, and the test had to be terminated. The linear increase corresponds to a deformation rate of approximately 0.38 mm/min.

Figure 9: Temperature and deformation curves for loaded CLT elements

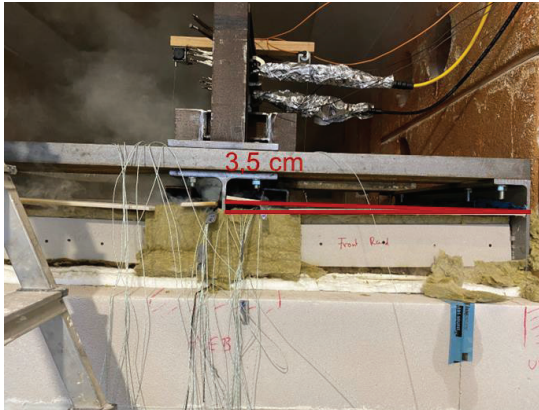
The deformation observed during the test was also clearly visible (see Fig. 10). Due to the progressive compression in the support area, the test specimens tilted toward the loaded beam.

Figure 10: Deformation of the specimen during the test

After the test, the difference in the height of the charcoal layer was particularly evident when the test specimens were opened. This suggests that under normal service loads, significant deformations of the floor can be expected if a fire occurs in the support area.

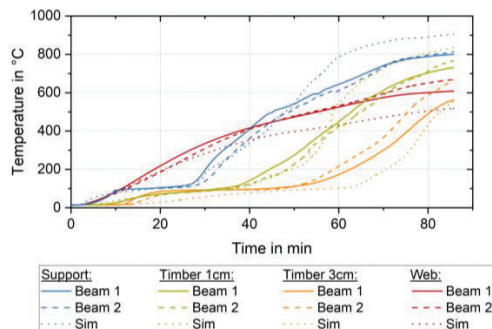
Figure 13: Comparison of simulation and results for 18 mm backing

The simulated graphs are shown as dotted lines in Fig. 12 - Fig. 15, while solid or dashed curves represent the measured values. A total of four specific measurement locations were compared.
