EXPERIMENTAL STUDY ON ROTATIONAL BEHAVIOR OF CLT SHEAR WALL-I STEEL LINK BEAM CONNECTIONS

ABSTRACT: This paper presents the experimental results of rotational behavior of CLT shear wall-I steel link beam connections. Three full-scale connection specimens were prepared and tested under monotonic and reversed cyclic loading. Test results indicated that the typical failure modes of the specimens were tensile fracture failure of the flange at the bottom of the I-beam and shear failure of the web. No obvious damage occurred in the CLT shear wall. This demonstrated that the steel link beams can effectively reduce seismic damage to the CLT shear walls and serve as the first line of seismic defense. At the initial stage of loading, the bending moment-rotation angle curve of each specimen showed a linear stage. Different from the rotational performance of the bolted glulam beam-to-column connections, there was no obvious low-stiffness slip section in the specimens during the initial loading period. When the load level was over 60% of the peak load, the specimen entered the nonlinear stage. When the tensile fracture failure of the flange occurred, the moment bearing capacity of the specimen

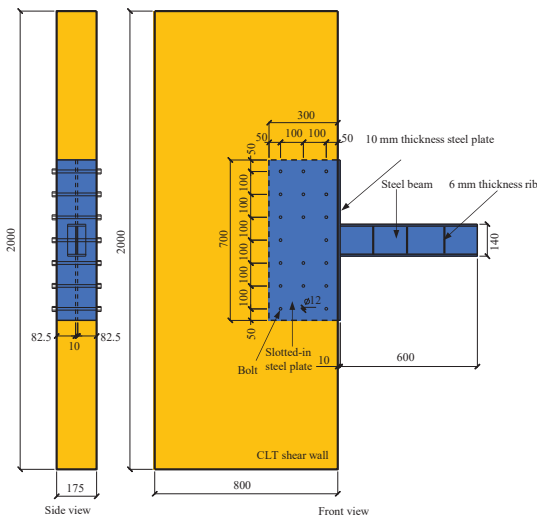
Figure 1. Detailed specimen geometry (Unit: mm)

Detailed specimen geometry is shown in Figure 1. The specimen included one CLT shear wall and one I steel link beam. The CLT shear wall had five layers of dimension lumber with each layer thickness of 35 mm. The height and cross section length of the CLT shear wall

were 2000 mm and 800 mm, respectively. The I steel link beam had a total length of 600 mm. The section height, width, web thickness and flange thickness were 140 mm, 80 mm, 5.5 mm and 9.1 mm respectively. The steel link beam were connected to the CLT shear wall by using steel plates perpendicular to the I-beam section, slotted-in steel plates and bolts. The steel plates were connected by welding, and the leg size of the fillet weld was 10 mm. The cross-sectional dimensions of the steel plate perpendicular to the I-beam section and the slotted-in steel plate were 175 mm × 700 mm and 300 mm × 700 mm, respectively. To facilitate processing, the thickness of both steel plates was 10 mm. The slot size of the shear wall was 12 mm. To avoid premature failure of the slotted-in steel plate bolt connection, the number of bolts in bolt joints was increased to 20. This design can ensure that the bolt joints would not be damaged, and at the same time reduce the influence of factors such as the initial clearance of the bolts, and maximize the initial stiffness of the connection. Bolt diameter and spacing were 12 mm and 100 mm respectively.

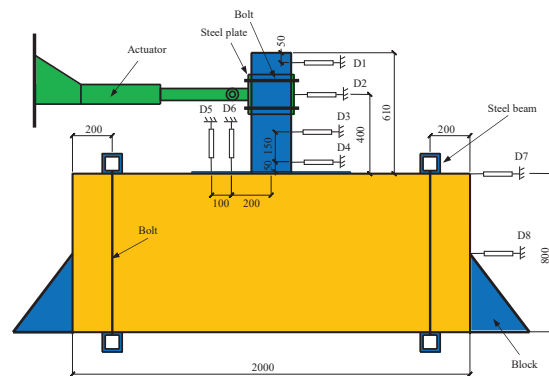
(a) Test setup and data measurement scheme

Test setup and data measurement scheme is shown in Figure 2. The specimen was initially rotated 90° and placed on the test platform, and the CLT shear wall was fixed through steel beams, bolts and steel blocks. Then the free end of the link beam was loaded by using a horizontally placed actuator. Considering that the clear span of connecting beams in the CLT shear wall was relatively limited, the vertical distance from the center of the loading point to the top surface of the CLT wall was 400 mm. The loading rate was controlled at 5 mm/min.

Test measurement items included horizontal loads and link beam angles. Among them, the horizontal load was measured by the force sensor built into the actuator. The rotation angle of the link beam was calculated from the horizontal displacement distribution of the coupling beam along its height direction during the loading process measured by the displacement meter. The layout of the LVDTs is shown in Figure 2a. D1 and D2 were used to measure the horizontal displacement of the top of the link beam and the actuator; D3 and D4 were used to measure the rotation angle of the link beam; D5 and D6 were used to measure the rotation angle of the steel plate perpendicular to the I-beam section; D7 and D8 were used to monitor the horizontal displacement of the CLT shear wall.

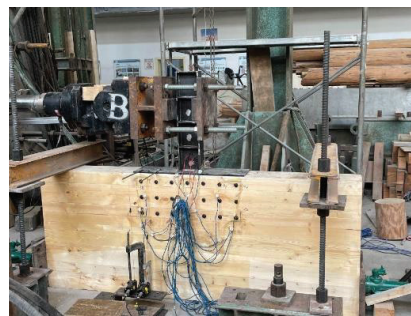
(b) Testing view

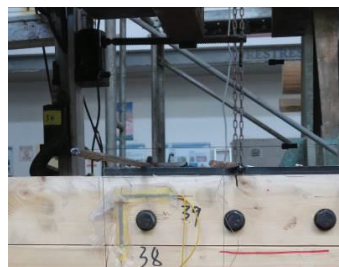
(a) Compression between steel plate and CLT

Typical failure modes of all specimens are similar, therefore specimen S2 was used to illustrate the failure process of the connections, as shown in Figure 3. As the horizontal displacement reached 6 mm, one side of the steel plate perpendicular to the I-beam section compressed with the top surface of the CLT shear wall (Figure 3a), and there was a separation between the steel plate and the CLT shear wall (Figure 3b). When the horizontal displacement was up to 18 mm, there was a gap between the steel plate perpendicular to the I-beam section and the CLT shear wall at the middle part of the connection (Figure 3c). When the horizontal displacement was up to 24 mm, tensile fracture failure occurred in the weld between the I-beam and the steel plate perpendicular to the I-beam section due to the large bending moment (Figure 3d). As the displacement increasing, the tensile cracks propagated through the I-beam cross section. Finally, the total cross section of the

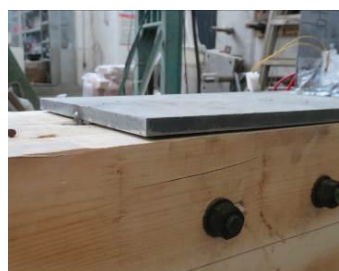
(b) Separation between steel plate and CLT

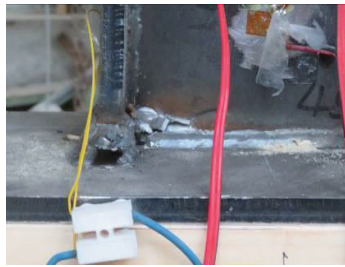
(e) Crack propagation

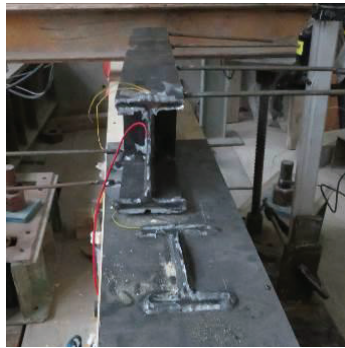
(f) Tensile fracture failure

I-beam fractured (Figure 3f). No obvious damage occurred in the CLT shear wall. This implied that the steel link beams can effectively reduce seismic damage to the CLT shear walls and serve as the first line of seismic defense.

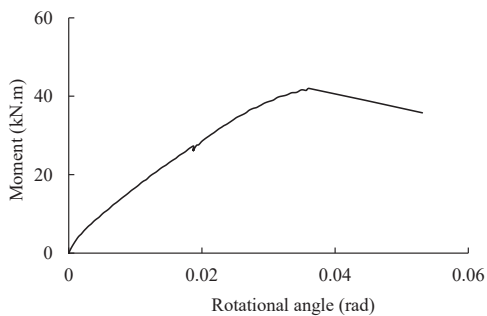
(a) Specimen S1

Moment-rotational angle curves of all specimens are shown in Figure 4. At the initial stage of loading, the bending moment-rotation angle curve of each specimen showed a linear stage. Different from the rotational performance of the bolted glulam beam-to-column connections, there was no obvious low-stiffness slip section in the specimens during the initial loading period. When the load level was over 60% of the peak load, the specimen entered the nonlinear stage. When the tensile fracture failure of the flange occurred, the moment bearing capacity of the specimens reduced significantly.

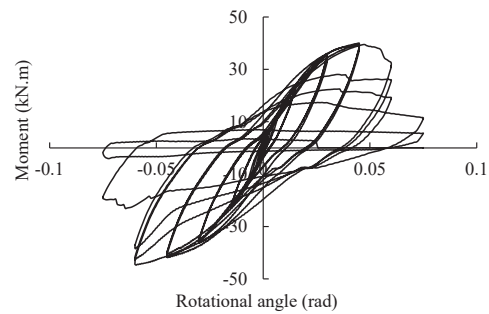
(b) Specimen S2

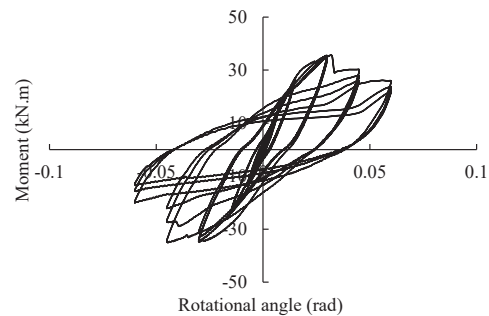
(c) Specimen S3

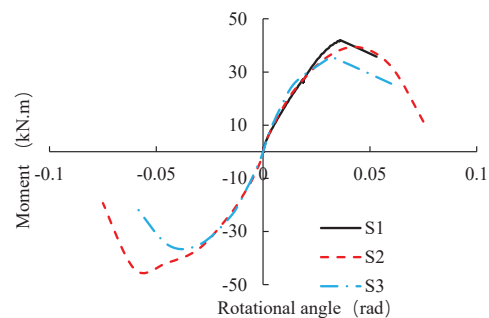
(d) Skeleton curves

Key mechanical parameters of all specimens are listed in Table 2. More specifically, maximum bending moment M_{max} and its corresponding rotational angle θ_{max} were determined by the peak points of the skeleton curves. Ultimate failure bending moment M_u and its corresponding rotational angle θ_u were determined by 85% of the maximum bending moment after peak points and its corresponding rotational angle. Initial stiffness k was determined by the ratio of 40% of the maximum bending moment to its corresponding rotational angle. Yielding bending moment and its corresponding rotational angle was determined by equivalent Energy Elastic-Plastic
