ANALYSIS OF STRESS DISTRIBUTION IN CONTACT AREA OF CROSS LAMINATED TIMBER SHEAR WALL TO FLOOR CONNECTION

KEYWORDS: cross laminated timber, shear wall, anchor, compression perpendicular to plane, stress distribution

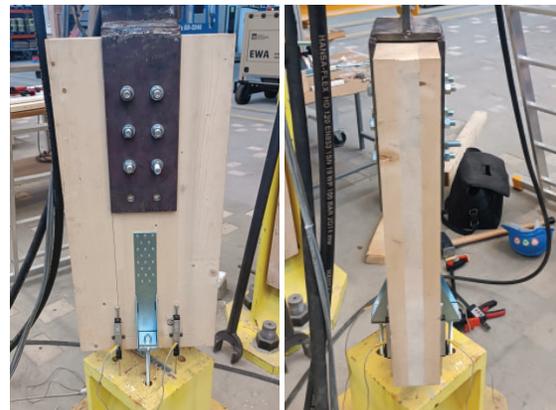
Figure 6. Loading diagram of the tension connection tests (left), test specimen under loading during the experiment (right).

The loading was force-controlled, following a stepped loading diagram based on an initial estimated capacity (F_{est}) of 95 kN, as shown in Fig. 6 (left). All specimens were loaded at a constant rate of 0.3 kN/s.

Photographs of the specimens under tensile load are shown in Fig. 6 (right). During testing, both the applied tensile force and the resulting displacement at the anchor interface were continuously recorded using potentiometric displacement sensors. Four sensors were

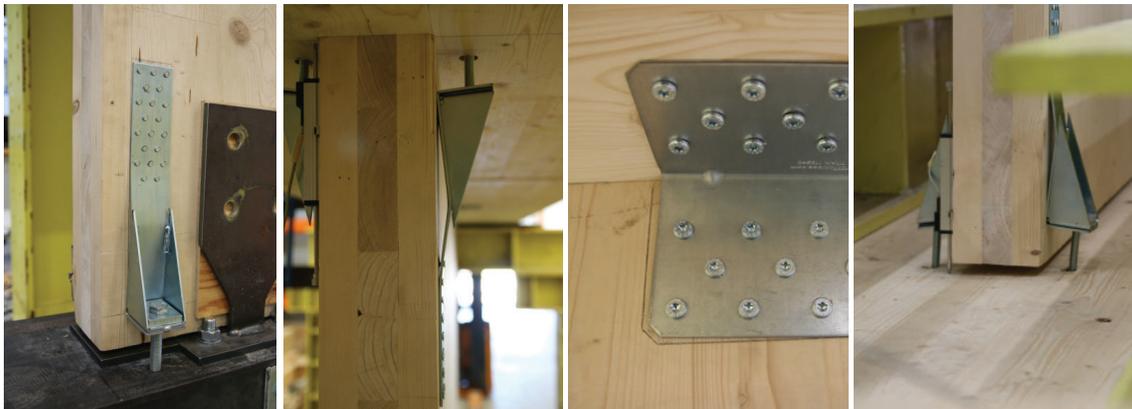
Figure 7. Observed failure of tension anchor and shear brackets in the connections of the full-scale test specimen.

Failure of the test specimen occurred due to deformation of the tension anchor plates and local embedment deformation of the wood around the nails connecting the anchors to the panels. This type of failure was observed to a similar extent at the connection between the lower wall panel and both the foundation and the floor slab, as well as at the connection between the floor slab and the upper wall panel (see Fig. 7).

In the shear brackets, horizontal displacement and slight rotation were recorded. The failure mode of both types of anchors was similar to that observed in the accompanying tests. The test was terminated due to the out-of-plane buckling of the horizontal actuator.
