## ASSESSMENT OF NAILED CONNECTIONS IN EXISTING STRUCTURES

**ABSTRACT:** This paper presents the development of an assessment scheme for a visual qualitative evaluation of nailed connections in existing structures, such as board trusses. In terms of further use and preservation, a quick visual inspection will help to evaluate the quality of a structure regarding its load-bearing capacity and deformation behaviour. Tests of old and new nailed joints in combination with a rating scheme point out the correlation between the load-bearing capacity and condition of a joint. Old joints of comparatively good condition tend to exhibit better results than those of poor condition. Moreover, aged joints are generally more load-bearing than newly assembled ones.

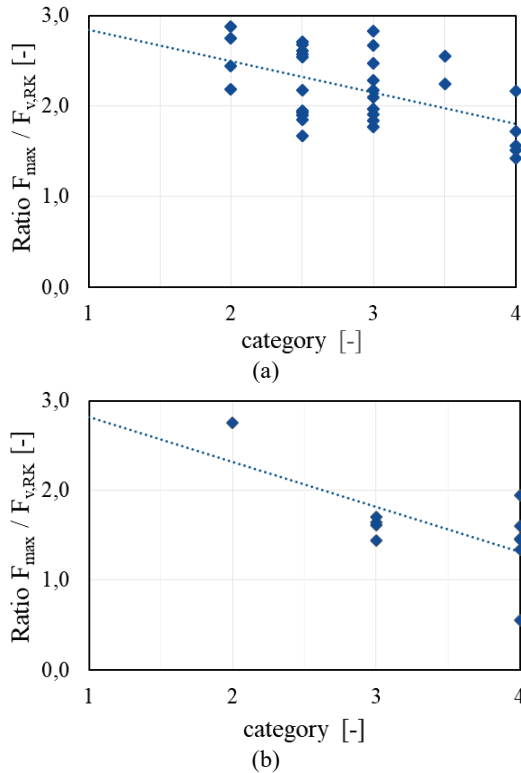
**Figure 12:** Load-bearing capacity per nail depending on the category, (a) Type I, (b) Type II

Figure 12a shows the graphs for Type I. Based on the shear tests, it was possible to establish a trend line showing a clear tendency for a decreasing quality to correspond to a lower load-bearing capacity (see Figure 12). On average, a ratio of 2.6 between experimental and analytical results can be obtained for Category 2, 2.2 for Category 3 and 1.7 for Category 4.

Figure 12b shows the graph for Type II. By assigning the load-bearing capacities to the pre-rated categories, a trend line could again be generated here. This supports the hypothesis of the correlation of the assessed category and capacity. The average ratio of category 2 is 2.8, of category 3, 1.6 and of category 4, 1.4.
