ANALYSIS OF THE PREDICTED COLLAPSE DIRECTION TENDENCIES OF HOUSES CAUSED BY THE 2024 NOTO PENINSULA EARTHQUAKE

Yuki Hashimoto¹, Takafumi Nakagawa², Hiroshi Isoda³

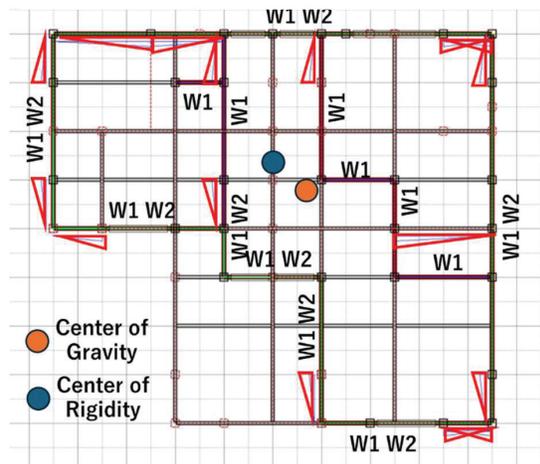
Figure 3. Seismic element layout on 2nd floor of House-a

for timber structures: the pre-1981 standard (Old Seismic Code), the 1981–2000 standard (New Seismic Code), and the post-2000 standard (2000 Seismic Code). Each revision introduced different seismic safety objectives, with the current 2000 Seismic Code primarily defining seismic performance based on the quantity and distribution of shear walls. This study aims to analyze the causes of collapse and examine the directional tendencies of structural failure under seismic excitation through a parametric study. The analysis is conducted by applying multiple earthquake ground motions to a computational model created based on architectural drawings obtained from Reference [1][2]. The subject of analysis is a two-story timber-framed house, designated as House-a. The floor plan of House-a is shown in Figure 1, while the arrangement of seismic-resistant elements is shown in Figures 2 and 3. The first floor features a large open-plan living room, with an absence of load-bearing walls directly beneath the shear walls of the upper floor.

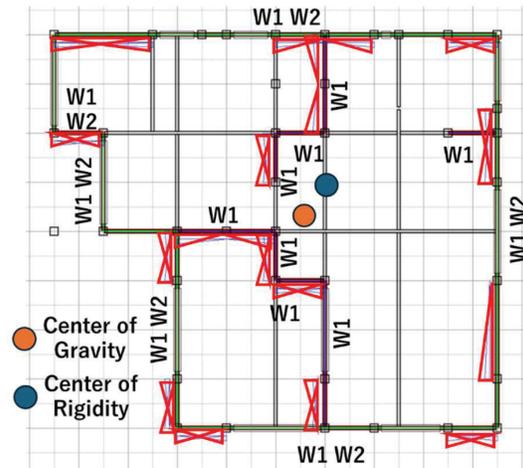
Figure 6. Seismic element layout on 1st floor of House-an

To examine how the damage characteristics change when the eccentricity ratio in the Y-direction of the first floor of House-a is reduced to comply with the Building Standards Act, the distribution of shear walls was adjusted in the structural layout shown in Figure 2 to ensure that the Y-direction eccentricity ratio remains below 0.3. This modified building is designated as House-an. The seismic element layout of the first floor is presented in Figure 6, while the wall quantity and eccentricity ratio are summarized in Table 3. The analysis follows the same methodology as for House-a, focusing on identifying the predominant collapse direction.

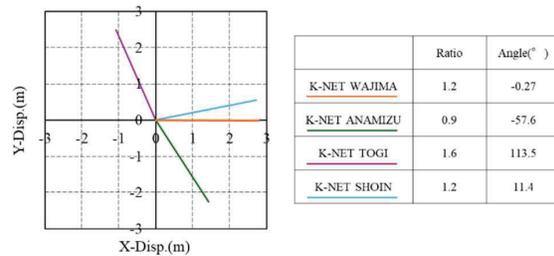
Figure 11. Collapse direction and input scaling factor of House-an

House-a, no noticeable twisting deformation of the second floor was observed at the point of collapse. This finding supports the conclusion that House-a's high eccentricity ratio contributed to the twisting of the second floor, ultimately leading to its failure. Furthermore, Figure 11 presents the collapse direction and input scaling factors (Ratio) for each ground motion applied to House-an. As with House-a, the analytical model collapsed in all cases due to severe damage to the first floor. However, the direction of center-of-mass movement varied significantly depending on the ground motion, with a tendency for collapse to occur in both the X and Y directions.

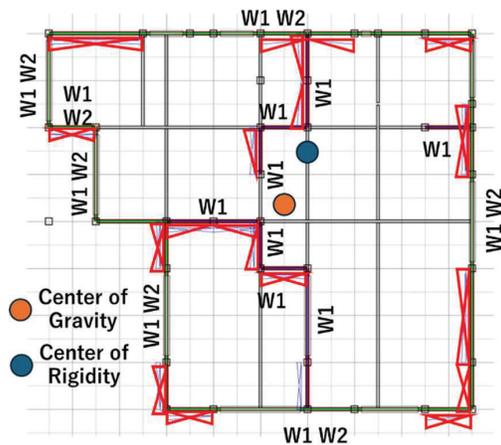
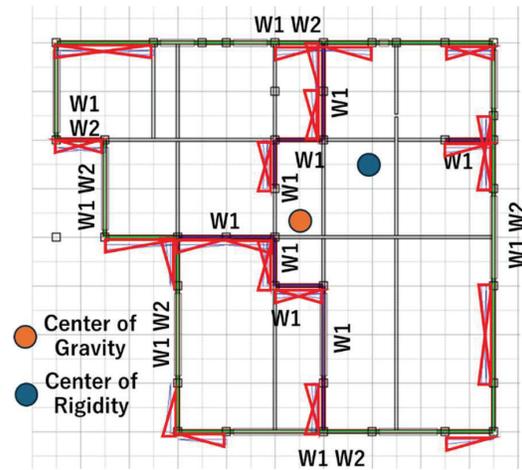
Seventy percent of timber-framed houses in the Noto Peninsula were constructed under the pre-1981 seismic code, and many of these buildings likely exhibit higher eccentricity ratios compared to those built under the current standards. To further investigate general collapse tendencies, additional analytical models were developed with intentional eccentricity. The fundamental distribution of seismic-resistant elements was kept consistent with House-a and House-an. Two new models were introduced: House-ax, which has a high eccentricity ratio in the X-direction, and House-axy, which has high eccentricity ratios in both the X and Y directions. The arrangement of seismic elements is shown in Figures 12 and 13.

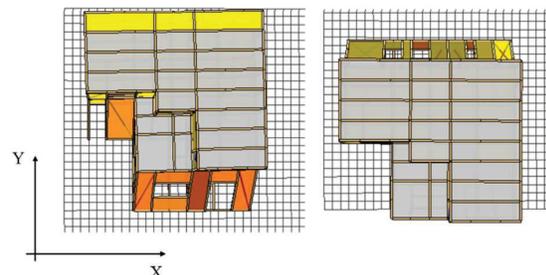
Figure 55. Collapse behaviour of House-ax and House-axy

The input ground motion was taken from K-NET Wajima, and the analysis was conducted by gradually increasing the input scaling factor from 1.0, following the same methodology as in last studies. Figure 14 presents the collapse directions of House-a, House-an, House-ax, and House-axy. The results confirm that the collapse directions differed approximately by 90° depending on the wall configuration. Additionally, Figure 15 illustrates the movement of the second floor just before collapse. Except for House-a, which has a high eccentricity ratio in the Y-direction, all models collapsed without significant torsional deformation.
