Case Study of IED Incident in Cauca, Colombia – A Review of the Blast Threats and Protection Provided to the EOD Technician

A. Makris, Jeff Levine and J.P. Dionne

Abstract. In June 2022, an Explosives Technician of the Colombia Dirección Central de Policía Judicial e Inteligencia (DIJIN) responded to a suspect Improvised Explosive Device (IED) mounted on a motorcycle, in Cauca, Suarez, Colombia. The local unit of the Policía, responsible for responding to explosives incidents arrived at the scene to investigate. The explosives technician conducted a search and render safe procedure of the suspect device. After a canine unit and a robot could not definitively confirm an explosive device, the decision was made to conduct a manual approach of the motorcycle with suspect device using a Med-Eng EOD 9 bomb suit. During the course of procedures, the IED detonated. The ensuing blast posed a fatal threat that was mitigated by the bomb suit the technician was using. He was launched several meters away and suffered non life-threatening injuries to the extremities. This paper is a case study that analyses the four blast threats (overpressure, fragmentation, impact, heat) related to the parti

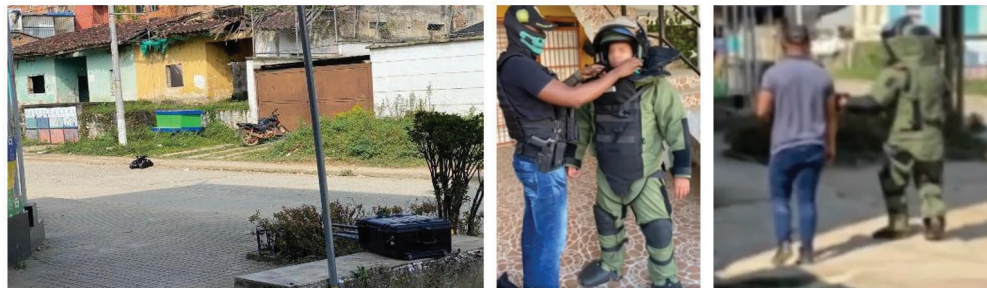
During the initial assessment, a canine unit was deployed to inspect the area; however, no suspicious indicators were detected. Next, a small EOD robot was sent to examine the motorcycle, but it could not confirm the presence of an explosive device (Figure 2). Wearing the Med-Eng EOD 9 bomb suit ensemble, the bomb technician proceeded with a manual approach to determine whether there was indeed a suspect device located beneath the motorcycle seat. While attempting to dislodge a possible suspected package wrapped in fabric and appearing stuck under the seat, the technician braced his left foot against the motorcycle and pulled on the package. At 9:17 AM, the suspected IED detonated while the technician was in this position (Figure 3, centre). The force of the blast propelled the technician approximately three meters from the motorcycle.

Figure 2. Pre-explosion images. Left: The suspected motorcycle VBIED positioned near the garage door. Centre: The bomb technician being suited up by an assistant. Right: The technician advancing toward the scene for manual inspection. All images courtesy of Colombia's DIJIN

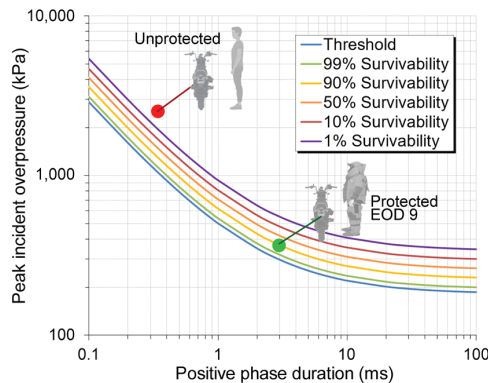
An estimation of survivability based on blast overpressure can be derived from the work of Van der Voort et al. [2], which updated the original survivability curves developed by Bowen et al. [3]. These curves, referred to here as the "NATO curves", presented in terms of peak overpressure and positive phase duration (Figure 6), estimate the probability of survival for an unprotected individual. Similarly, Figure 7, inspired from previous work [4] translates these survivability predictions into a format based on explosive charge and standoff distance, using free-field blast calculations. For the current scenario—2 kg of TNT detonated at an approximate standoff distance of 80 cm—the corresponding data points are marked on both figures. The predicted survivability level (<1%) highlights the unfavourable outcome expected for an unprotected individual *not* wearing a bomb suit.

Figure 6. NATO blast injury prediction curves [2] along with data points corresponding to the motorcycle VBIED scenario

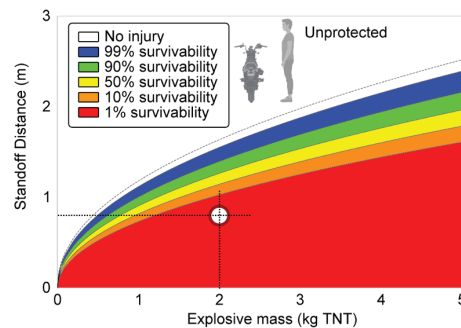
Figure 7. NATO curves expressed in terms of explosive charge mass and standoff distance, with the motorcycle VBIED scenario data point for an unprotected scenario

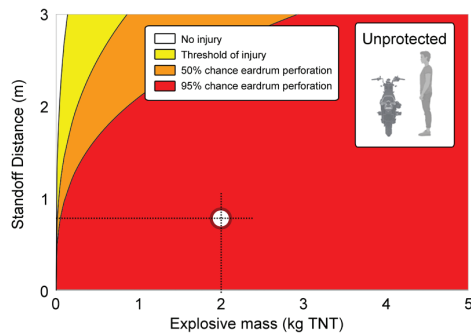
The threshold for eardrum perforation is as low as 35 kPa. At 100 kPa, there is a 50% probability of perforation, increasing to 95% at 200 kPa [6]. Figure 9 illustrates the potential for eardrum perforation based on these thresholds, shown in terms of explosive charge mass and standoff. Figure 10 presents the same data for an individual wearing the EOD 9 Helmet, which provides a conservative 90% reduction in overpressure at the ear. In the current scenario, the unprotected probability of eardrum perforation exceeds 95%, while the helmet reduces it to 50%. Notably, the bomb technician did not sustain any ear injuries during this incident.

Figure 9. Ear overpressure injury chart (unprotected case)

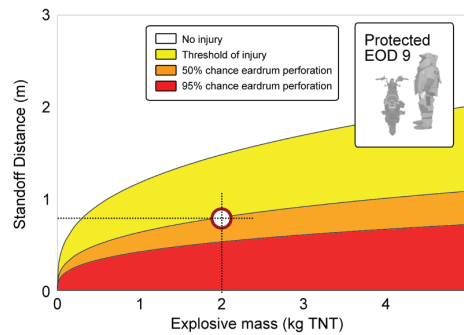
Figure 10. Ear overpressure injury chart (protected case – EOD 9 Helmet)

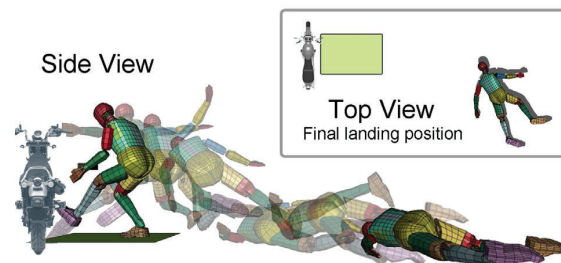
Beyond the direct impact of the blast wave on the head, the technician's head could have also impacted the ground as the body was propelled by the blast force. To explore this further, an LS Dyna (Ansys Inc., Canonsburg, PA) computer simulation was performed to model the technician's motion following the blast, inspired from earlier work [10]. A Hybrid III model was adapted to account for the additional mass of the bomb suit. The mannequin was positioned at the representative distance and in a posture similar to that of the technician during the motorcycle VBIED incident and subjected to a 2 kg TNT explosion. The simulation results (see Figure 13) were successfully validated against the technician's final landing position. While the figure includes the motorcycle for reference, it was not part of the simulation itself. The simulation suggests that the technician's head may have impacted the ground, potentially with a frontal impact. However, it must be noted once again that no head injuries were reported for the technician following the incident, based on the helmet protection provided.

Figure 13. LS Dyna simulation of the blast event using a Hybrid III mannequin whose weight was adjusted to account for the weight of the bomb suit

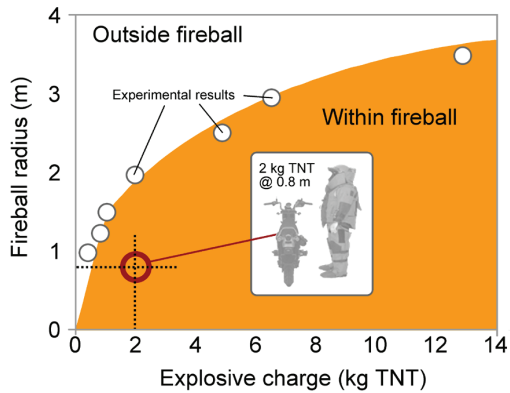
When an explosive detonates, it generates a fireball composed of extremely high-temperature gases. Although this intense thermal hazard only persists for a few milliseconds, it can cause severe burns to unprotected skin if an individual is within the fireball's radius. Figure 14 illustrates the estimated size of the fireball in free-field experiments as a function of the explosive charge, based on high-speed video analysis of blast events [11]. For the 2 kg high explosive charge used in this motorcycle VBIED incident, the graph suggests that the bomb technician—whose foot was in contact with the motorcycle and whose chest was approximately 80 cm from the explosive centre—would have been positioned within the fireball.

Figure 14. Estimated fireball size as a function of the explosive charge, indicating that the bomb technician was within the radius of the fireball [11]

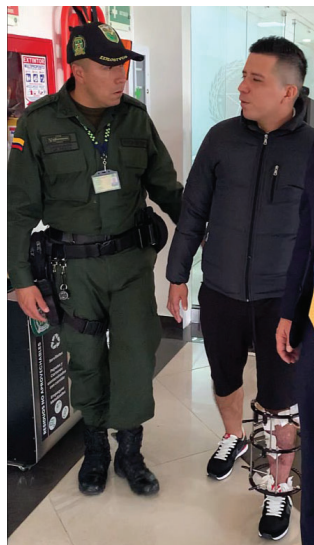
Figure 16. Injured bomb technician (right) in November 2022 (5 months after the explosion)
