POST-FIRE STRUCTURAL REHABILITATION OF MASS TIMBER ELEMENTS

ABSTRACT: Post-fire rehabilitation of modern mass timber buildings has seen little research attention. Developing clear methodologies to rehabilitate char-damaged mass timber elements is crucial since mass timber buildings are becoming considerably more common and as such, the risk of having fire-damaged mass timber buildings is increasing. Preliminary investigation was performed in 2023 to quantify the amount of wood that needs to be removed beyond the char layer. Following this study, full-scale bending test of char-damaged mass timber glue-laminated timber decking elements reinforced with laminated veneer lumber were evaluated. The main objective of this study is to quantify the effect of different reinforcing methodologies and to validate calculation methodologies. From the test campaign, it is found that the mechanically jointed beam theory (gamma method) predicts well the level of composite action when fully threaded screws are used. When partially threaded screws are used, the friction between timber elements is sufficient to create an almost perfect composite action under low loading conditions.

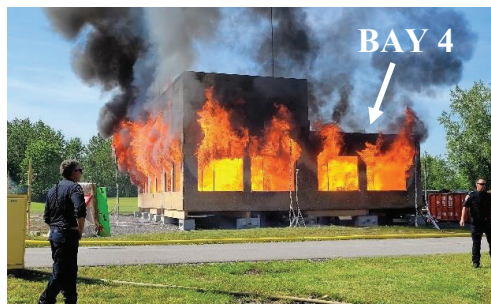
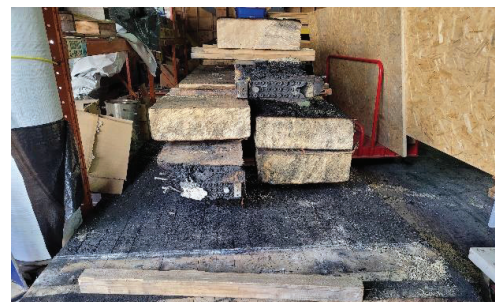
Figure 1: Char-damaged elements from Test 5 of the MTDFTP

a) Floor plan of the MTDFTP

b) View of the glulam decking (ceiling)

c) Fire test 5 (open-space office)

d) Char-damaged elements at FPInnovations

Char-damaged mass timber elements were dismantled from the Canadian Wood Council Mass Timber Demonstration Fire Test Program (MTDFTP) completed in 2022. Glulam decking panels forming the ceiling in Bay 4 of the MTDFTP Test 5 were used for this rehabilitation methodology (Figure 1).

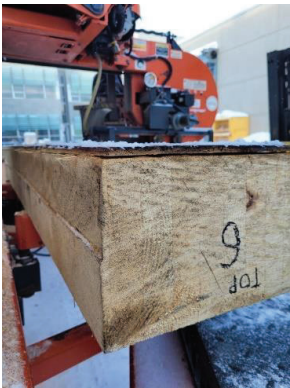
Figure 3: WoodMizer used to reduce the thickness of the char-damaged glulam elements

As indicated in the project objectives, the methodology for preparing the surface of the char-damaged elements was not intended to simulate actual building conditions after a fire incident. For the benefit of this study, a portable WoodMizer bandsaw was used to shave down the 8 specimens to the desired thickness indicated in Table 1

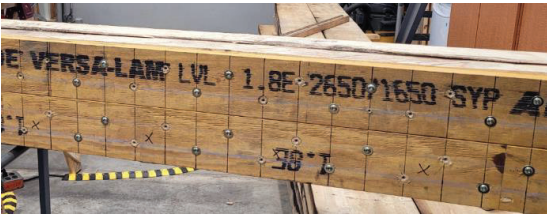
Figure 4: LVL used as reinforcing tension lamination

Laminated veneer lumber (LVL) conforming to ASTM D5456 [4] were purchased from a local supplier and used as reinforcing tension lamination (Figure 4). The LVL were initially 38 mm x 140 mm x 6.1 m (1½” x 5½” x 20’) with the specified strengths of 30.6 MPa in bending, 17.2 MPa in axial tension and an apparent and true modulus of elasticity of 11 721 and 12 411 MPa, respectively, for use in limit states design following CSA O86-19 [3,5]. They were all cut down to a length of 4.42 m (14.5’) and one face was sanded to remove the protective wax coating, down to a thickness of approximately 35 mm.

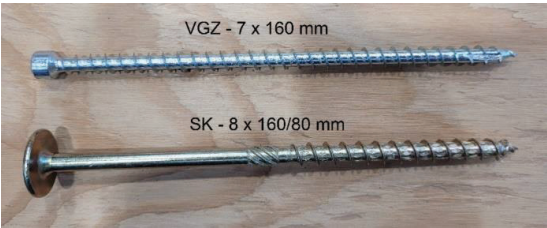
Figure 5: STS used to fasten the elements

Self-tapping screws were used to attach the reinforcing LVL to the char-damaged glulam elements. Two types of structural self-tapping screws were used to assess their respective composite performance. A fully threaded screw with a cylindrical head VGZ 7 x 160 mm [7] and a partially threaded screw with a washer head SK 8 x 160/80 mm [8] were used, as shown in Figure 5.

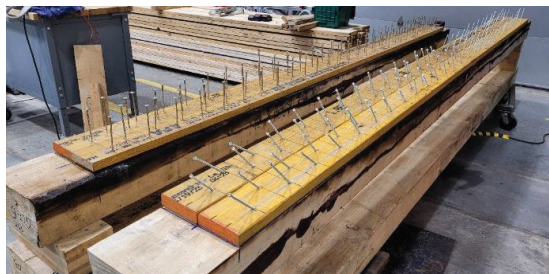
Figure 6: Installation of SK (left) and VGZ (right) screws

VGZ screws were installed at a staggered spacing of 150 mm (6”) on center, at an angle of 45° from the surface of the reinforced elements, with the assumption that the fully threaded screws would allow to maintain a close

contact between the elements during the bending tests, but not necessarily to press the elements together during the adhesive curing period. Screws were positioned at either $+45^\circ$ or -45° , depending on their position relative to mid-span. The SK screws were also installed at a staggered spacing of 150 mm (6") on center, driven perpendicularly (90°) to the surface with only the threaded portion being in the glulam and not in the reinforcing element for which, with the washer head, may provide some level of pressure between the elements during both the adhesive curing period and bending tests. Figure 6 illustrate the installation pattern for both the SK and VGZ screws.

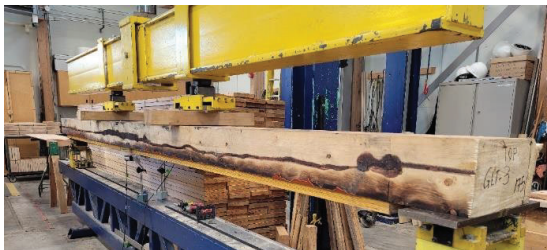
Figure 9: Bending test at FPIInnovations' laboratory at Quebec City

Bending tests were then performed on the reinforced specimens following the same procedure; that is characterizing the MOE by limiting the mid-span deflection to 8 mm for the first few specimens (GLT-1, 2 and 6), and to 12 mm for the subsequent specimens. Specimens reinforced using both screws and adhesive were also evaluated for their bending stiffness by removing half of the screws (removing one every other screw – thus a 300 mm (12") staggered spacing). Once the maximum deflection criterion was reached after the 3rd replicate, the displacement sensors, lasers, were removed and the specimens brought to failure to evaluate their bending resistance. For all tests, the load was applied at a loading rate of 8 mm/min when evaluating the bending stiffness and increased to 20 mm/min for the bending resistance. The mid-span displacement was measured using 2 lasers positioned at the bottom level of the glulam element. The same position was used for the reinforced elements, where the lasers were positioned at the interface between the LVL and glulam. Figure 9 shows the full-scale bending test configuration at FPIInnovations' laboratory in Quebec City.

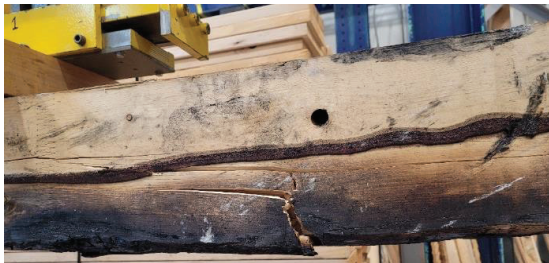
Figure 10: Failure in tension zone of GLT-1, between the loading points

The results of the characterization of the char-damaged glulam elements are given in Table 4. The average modulus of elasticity (MOE) of all specimens is 9 364 MPa, which is slightly lower than the design MOE of 9 500 MPa, as published by the glulam manufacturer and conforming to CSA O86 [3] for vertically glued-laminated timber beams. The lowest MOE was 8 581 MPa, which is 10% lower than the published value of 9 500 MPa. Figure 10 shows the failure mode of GLT-1.

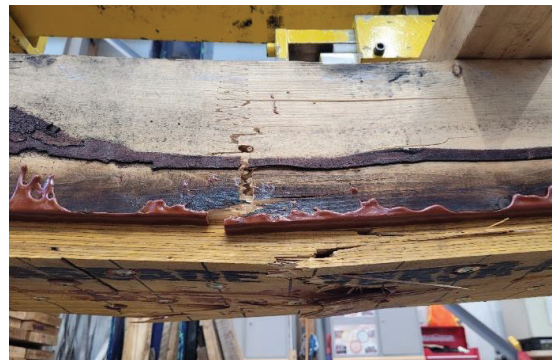
Figure 11: Failure mode observed for the specimen 3-Glue

Figure 11 show the failure mode for GLT-3 where tension failure was observed in the reinforcing LVLs as well as in the tension zone of the glulam.
