MOISTURE INTRUSION PATTERNS IN SMALL-SCALE MASS PLY PANEL FLOORS

ABSTRACT: Mass timber elements have gained increased global interest as builders seek more carbon neutral materials. These products are primarily intended for interior uses where the risk of wetting is minimal. Moisture can have many detrimental effects on engineered wood products including swelling, cracking, delamination and, if prolonged, fungal decay. These products are manufactured using dry wood (<15 % depending on the product), but wetting can occur in between manufacturing and final building closure. Understanding the rates and degree of moisture intrusion can guide moisture management strategies to mitigate the risk of wetting and ensure performance. Water uptake was assessed over 24 days in Douglas-fir mass ply panels. Moisture contents exceeded 40 % in the upper four plies after 1 day of wetting but increased more slowly further inward. Prolonged wetting (24 days) resulted in moisture levels above 20 % deeper in the panel. The results highlight the speed with which wood moisture content can increase in MPP with rainfall and can be used to develop mitigation methods to minimise the risks of wetting.

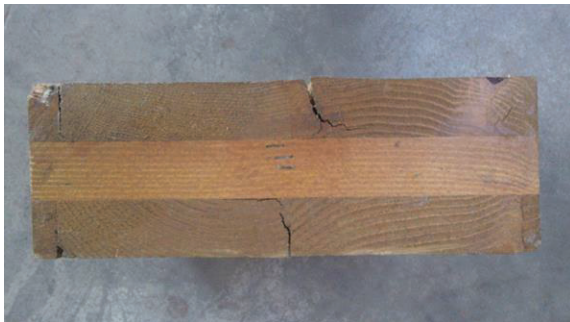
Figure 2. Example of a Douglas-fir CLT panel section exposed to natural rainfall for 30 days and allowed to dry for 2 years showing checking and delamination.

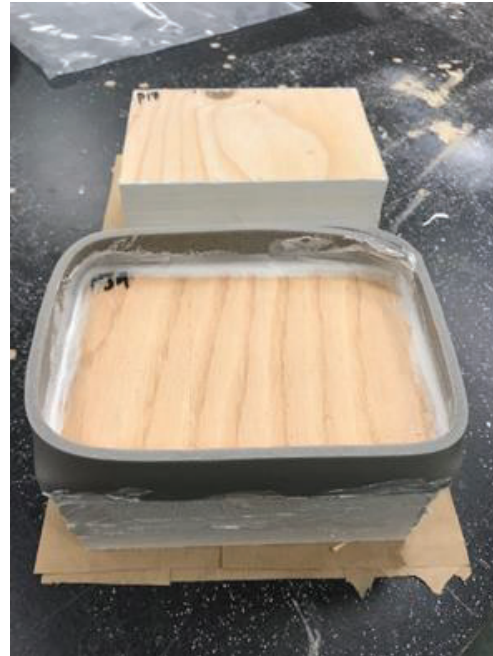
Figure 3 Examples of an MPP block prior to sealing and one sealed with the water well.

MPP (75 mm thick with 27 plies) were cut into 100 mm by 153 mm long sections that were conditioned to stable mass at 23 °C and 65 % relative humidity. A test matrix is shown in Table 1. The exposed veneer edges were sealed with an elastomeric coating to retard moisture loss. A 25 mm wide closed cell gasket was attached around the sides with caulking to create a well at the top. The gasket was also secured with staples to minimise leakage. Later versions eliminated the elastomeric as there was little evidence of leakage from the sides of the blocks (Figure 3).

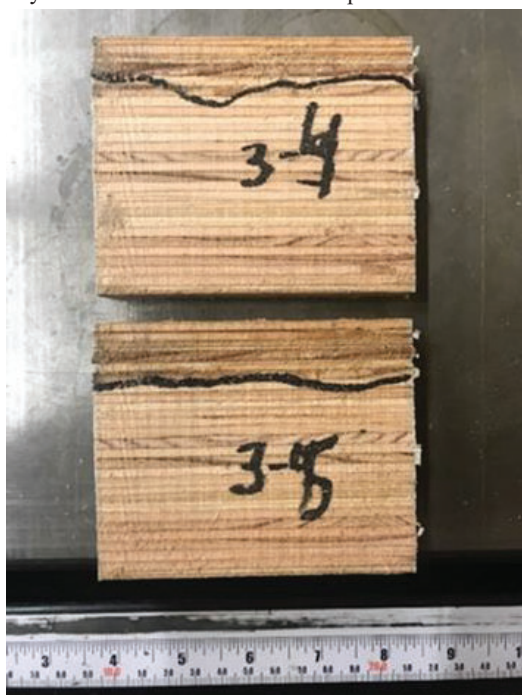
Figure 5. Cross cuts of an MPP panel showing moisture intrusion (darkened area above the marker) after 7 days of wetting.

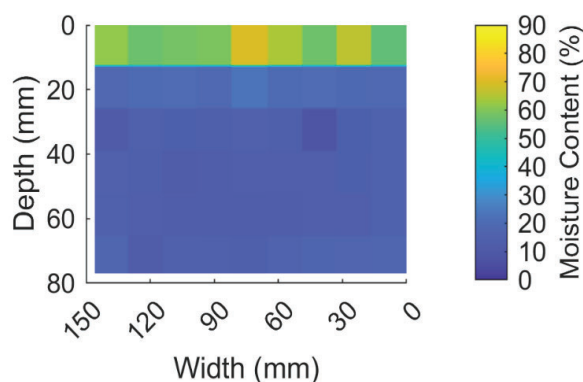
Figure 6. Examples of moisture distribution in MPP subjected to wetting for a) 1 (top), b) 7 days, c) 18 days, or d) 24 days (bottom) where increasing yellow signifies higher moisture levels.

The data were averaged by distance from the surface for the nine crosscuts from each block then maps were created showing moisture distribution by depth. These maps are primarily visual and intended to show the rate and degree of moisture penetration inward when subjected to overhead wetting.

It is useful to visualise moisture movement into the substrate. The panels were composed of a mixture of Douglas-fir heartwood and sapwood and there was no way to easily determine whether a particular veneer was contained either material. However, this species has a relatively thin sapwood, meaning that most of the veneers will be composed of heartwood. Sapwood is fairly permeable and easily penetrated by liquids. Douglas-fir heartwood is usually much less permeable and should resist moisture movement. The combination of heartwood and the presence of gluelines should slow moisture

movement from the surface inward. Thus, while moisture ingress into the first four veneers was relatively rapid, further movement inward was more limited. Moisture levels were elevated in the next zone after 18 days with further increases 30 to 45 mm inward from the surface after 24 days of wetting. Increased moisture levels further inward from the surface will complicate drying after the building is completed and increase the risk of internal stresses that lead to bond failure. It is unclear what effect any internal stress will have on the panel once in service.
