TRAVELLING FIRES IN COMPARTMENTS WITH EXPOSED CROSS-LAMINATED TIMBER SURFACES

Andreas Sæter Bøe¹, Kathinka Leikanger Friquin²

KEYWORDS: Cross-Laminated Timber, Compartment fire, Fire spread, Travelling fire

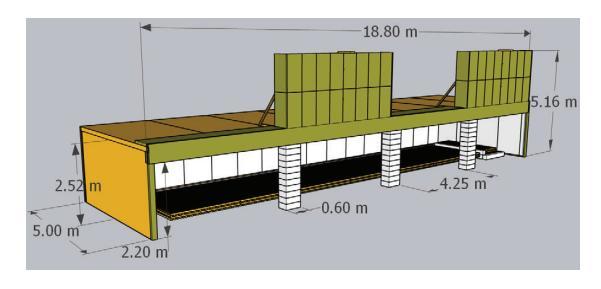
Figure 1 Sketch of compartment with dimensions.

Two experiments were conducted. The first, #FRIC-01, had an exposed CLT ceiling, while in the second, #FRIC-02, the CLT was exposed in both the ceiling and the back wall. The compartment is shown in Figure 1-Figure 3.

The inner geometry of the compartment was 18.8 m x 5.0 m x 2.52 m (1 x w x h). The compartment was well ventilated with four large window openings in the front wall, with a total opening of 17.0 m x 2.2 m (1 x h). This corresponds to an opening factor of $0.18 \text{ m}^{1/2}$. A 2.45 m high inert façade wall was mounted above two of the windows to study the external flame. The beam in the front wall protruded 350 mm below the ceiling.

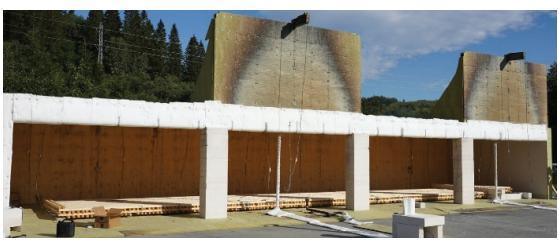
Figure 2 Compartment with exposed ceiling and back wall in #FRIC-02.

The compartment was built of a CLT roof and three CLT walls, while the front wall with large openings was made of a glue-laminated timber beam and three Siporex columns. The CLT in the roof and back wall was 140 mm thick, with 5 layers (40-20-20-20-40 mm), made of Norwegian spruce, and glued together with a regular polyurethane (PUR) adhesive. The CLT in the end walls were 80 mm thick with 3 layers (30-20-30 mm).

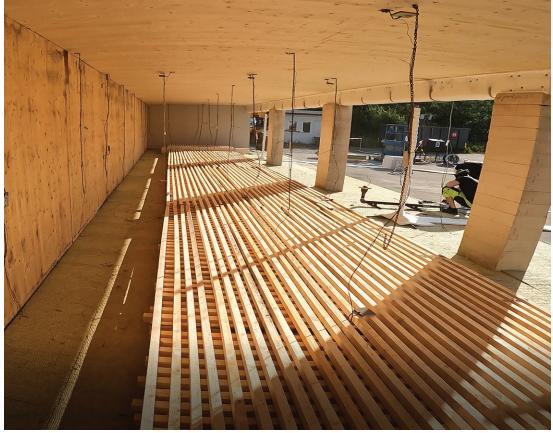
Figure 3 Inside compartment before ignition in #FRIC-02, with exposed CLT in ceiling and on back wall. Wood crib on the floor, TC-trees hanging from the ceiling. #FRIC-01 was identical except for gypsum boards covering the CLT back wall.

The fuel load density was 373 MJ/m^2 per floor area and was chosen to represent a typical office building. The fuel load was represented by a 2.8 m x 15.5 x 0.2 m continuous wood crib and a 2.8 m x 1.0 m x 0.2 m wood crib positioned on a scale. The wood crib was made of four

alternating layers with wood sticks with a 50 mm x 50 mm cross-section. The wood crib is shown in Figure 2 and Figure 3.

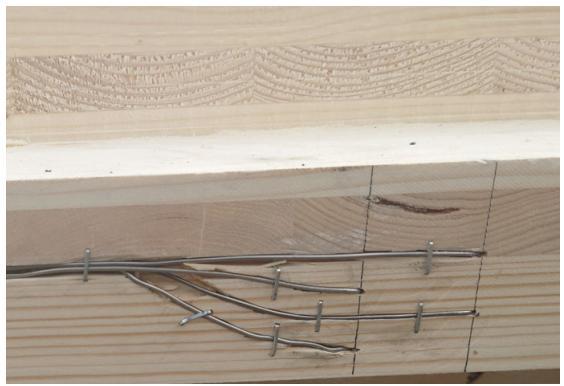
Figure 4 TCs were embedded into the CLT from the rebate joint.

Charring rates of the CLT were determined based on temperature measurements. Embedded TCs were installed into the CLT elements from the sides, parallel to the isotherm, at depths 0, 10, 20, 30 and 40 mm into the CLT (Figure 4), at three different locations in the compartment.

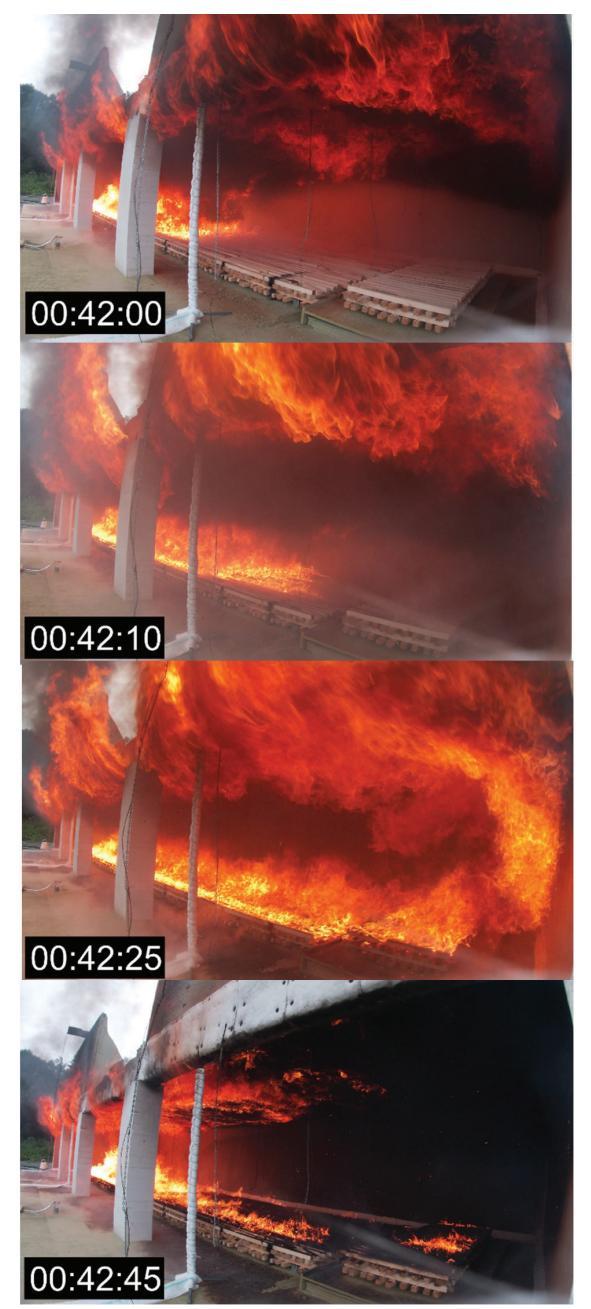
Figure 5 #FRIC-01: Fire spread and retraction of 3rd flashing wave. Time (hh:mm:ss).

After ca. 33 minutes the CLT in the ceiling ignited. This occurred from a combination of radiation and convection, as the flames did not impinge the ceiling After this the fire spread across the entire room in approximately 12 minutes. Within these 12 minutes, the fire travelled back and forth in four distinct waves or cycles (Figure 5). We have chosen to call them *flashing waves* in this article.

The flashing waves were recognized by a rapid flash fire along the ceiling, followed by a spread along the top layer of the wood crib, triggered by the radiation from the ceiling. Each wave caused external flaming from the window openings. After a short intense fire of 30-60 seconds, the flames gradually reduced in the ceiling, and the radiation-controlled fire in the top layer of the wood crib was reduced or even extinguished. The wood crib fire grew in size after each wave, and spread to the right end of the compartment in the the 3rd and 4th wave, in which the full flashover occurred at the end of the 4th wave at 45:30 (mm:ss).

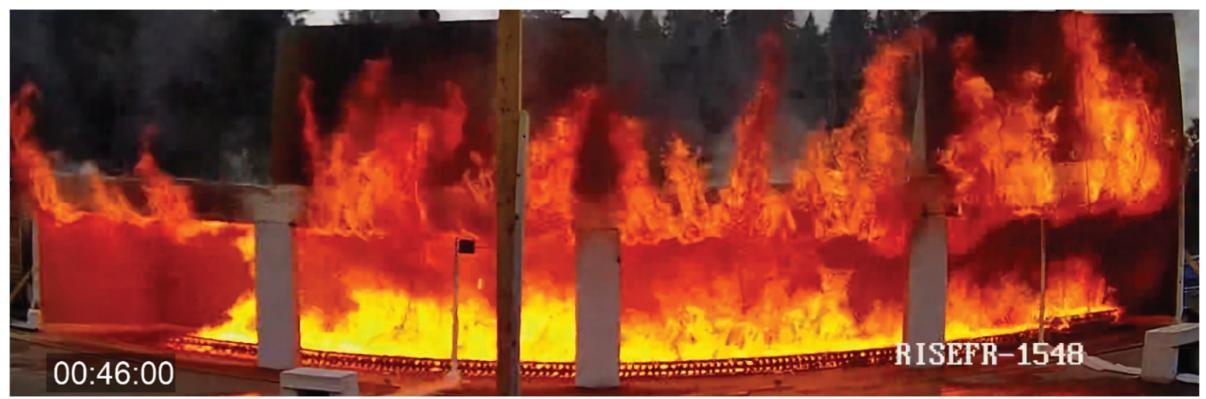
Figure 6 #FRIC-01: Most intense phase of burning shortly after flashover.

After the flashover, the fire burned intensely for about a minute (Figure 6), and then gradually decreased in intensity. From 49 minutes, the fire was clearly most intense at the far end from ignition, and external flames were only present from the far end window. Selfextinguishment of flames in the CLT ceiling started at around 50 minutes, from the left end of the compartment towards the right end over the next 10 minutes. The wood crib fire was continuous until about 60 minutes into the fire. From 60 to 95 minutes, the wood crib fire became increasingly discontinuous, starting from the left end of the compartment and moving towards the right end. Visible flames in the wood crib self-extinguished at 95 minutes. The compartment was observed for a total of 4 hours. At this point, very little of the wood crib was left. A few lamellae of the outer layer of the CLT in the centre of the compartment were hanging down from the ceiling. Hot spots were present around these loose lamellae. Manual extinguishing was then conducted. No reignition occurred after the manual extinguishment.

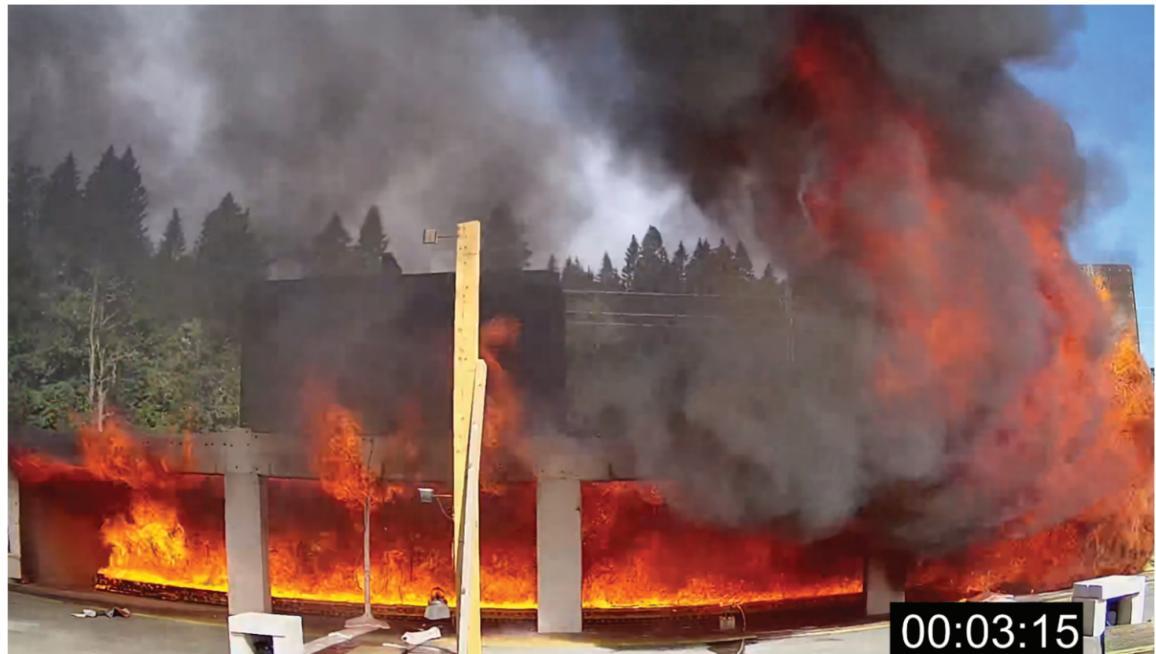
Figure 7 #FRIC-02: Most intense phase of burning shortly after flashover. Time (hh:mm:ss).

In #FRIC-02, the amount of heptane used to ignite the wood crib was increased to avoid the risk of selfextinguishment, based on the experience from #FRIC-01. The extra heptane caused both the ceiling and the wall to ignite at 2 minutes. From this point on, the fire spread extremely fast, and flashover occurred at 3 minutes and 15 seconds (Figure 7).

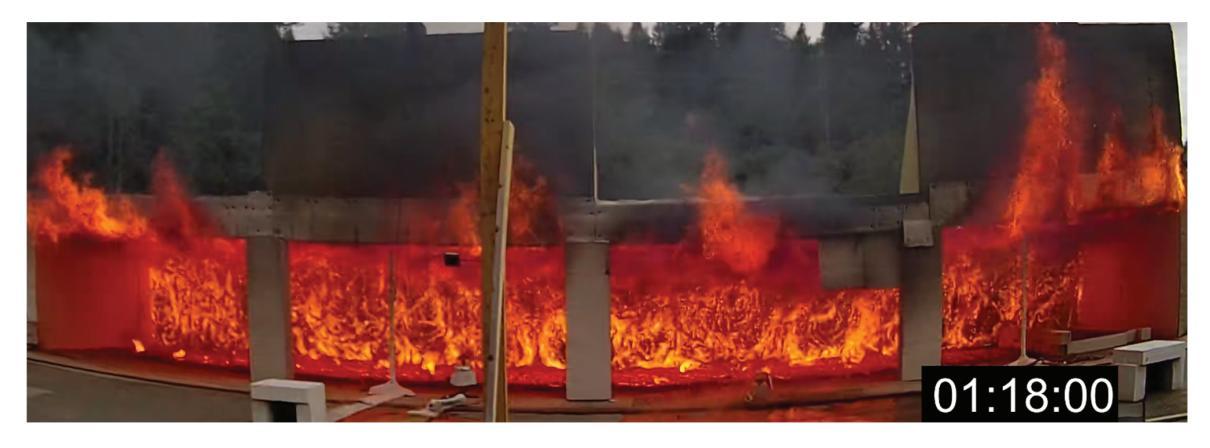
Figure 8 #FRIC-02: A 2nd flashover developed about an hour after the flames in the CLT had self-extinguished. Time (hh:mm:ss).

From around 25 minutes, the crib was burning with discontinuous flames, and the last flames extinguished after 40 minutes. However, after 75 minutes a 2nd flashover was seen with flames on the entire back wall and the ceiling (Figure 8). The fire continued until 175 minutes (Figure 9), when it was manually extinguished.

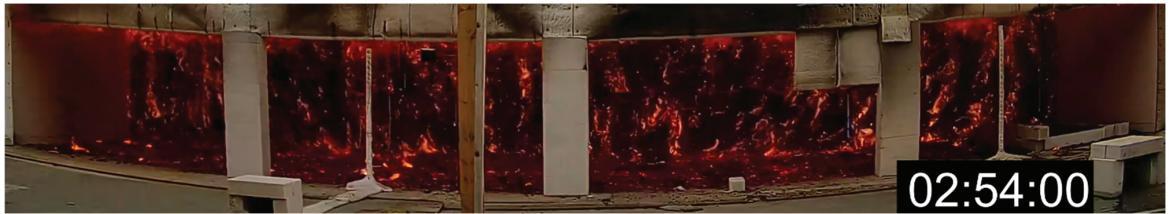
Figure 9 #FRIC-02: The fire was still burning strongly just before it was manually extinguished.

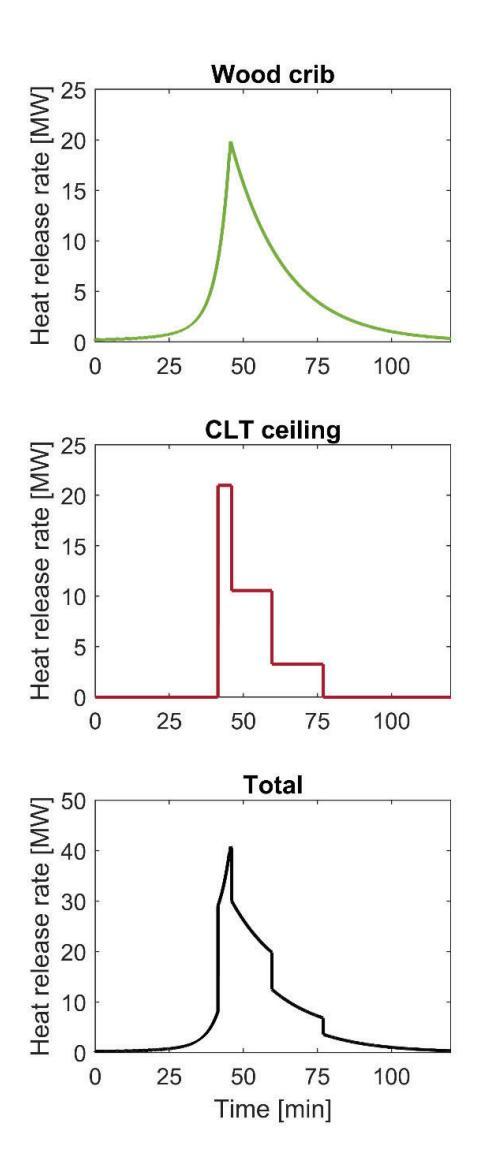
Figure 10 #FRIC-01: Estimated heat release rates of the wood crib and the CLT ceiling

The HRR of the CLT was estimated to be 21 MW at maximum, while the estimated HRR of the wood crib was 20 MW. Combined the total HRR was estimated to 41 MW, see Figure 10.

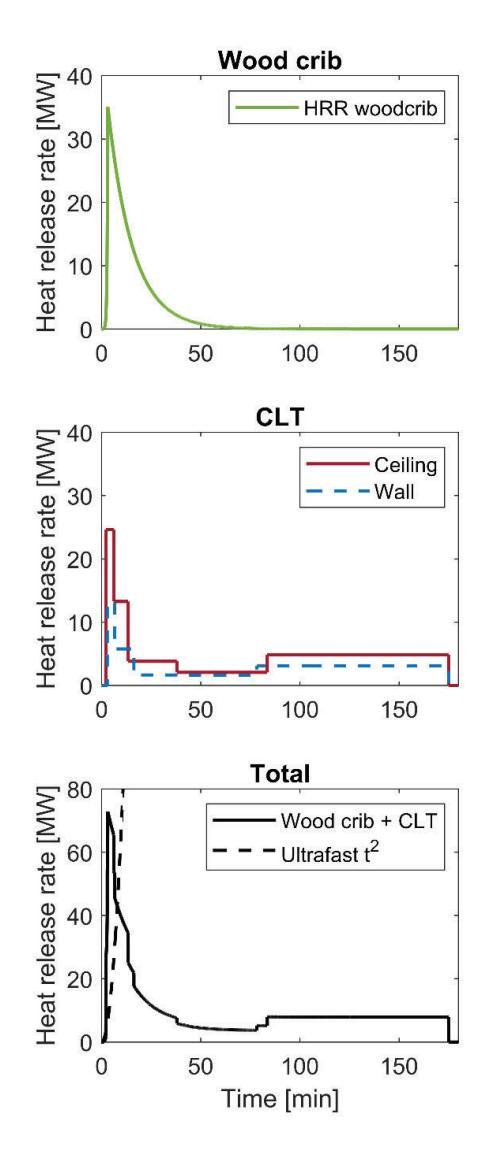
Figure 11 #FRIC-02: Heat release rate of wood crib and CLT in the ceiling and on the back wall

The HRR of the CLT was at maximum 24.5 MW for the ceiling, and 13 MW for the wall. The estimated HRR of the wood crib was 35 MW at maximum. The total HRR was at maximum approximately 73 MW. This is 32 MW (78 %) higher than in #FRIC-01.

However, the contribution from the CLT wall was only 13 MW. The additional 19 MW, compared to #FRIC-01, is due to an increased HRR from the wood crib, which was 15 MW higher than in #FRIC-01, and from the CLT ceiling, which was ca. 4 MW higher.
