World Conference on Timber Engineering Oslo 2023

LESSONS LEARNED FROM A DECADE OF RESEARCH ON WOOD ASSEMBLIES UNDER BLAST LOADING

Ghasan Doudak¹, Christian Viau², Daniel Lacroix³

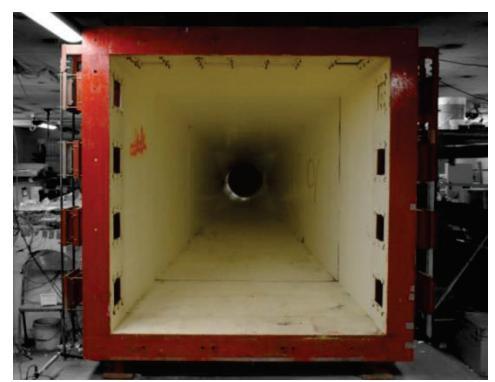
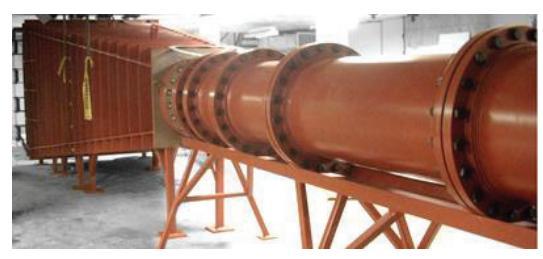
Figure 1: University of Ottawa Shock Tube

The Shock Tube (Figure 1), used in the experimental campaigns, is a test apparatus capable of simulating shock waves similar to those found in far-field explosions, on small-to-full-scale structural and non-structural components. A wide range of pressure and impulse combinations, representing different charge-weights and stand-off distances can be simulated.

(a) Expansion section and end-frame (front view)

(b) Driver section (back view)

The Shock Tube consists of three main components: driver, spool, and expansion sections. The shock wave is created by the release of compressed air stored in the driver section. This forms a shock front that travels along the 6096 mm expansion section and interacts with the specimen mounted at the end-frame (Figure 1b). The reflected pressure can be measured by two dynamic piezoelectric pressure sensors. Strain gauges are typically used to obtain strain data and determine the dynamic failure point for each test. Linear variable displacement transducers (LVDTs) are used to measure the specimen deflection. The data acquisition system is also connected to a full colour high-speed camera, capable of recording videos at a rate of 2000 frames per second.

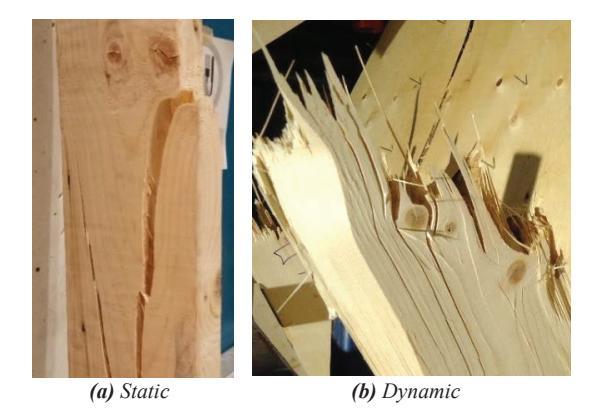
Light-frame stud walls of various configurations have been studied experimentally, involving various types and thicknesses of sheathing, stud size, and fasteners. Fullscale flexural tests on lumber elements have shown that the characteristics of the failure often shift from that of splintering failure when loaded under static loading to a brash "cut-through" failure when loaded dynamically (Figure 2).

Figure 2: Representative failure modes for studs

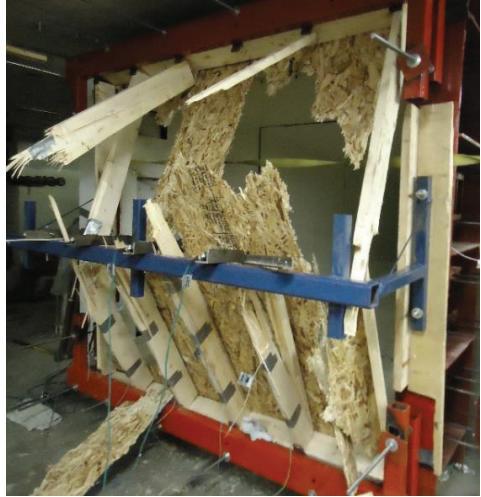
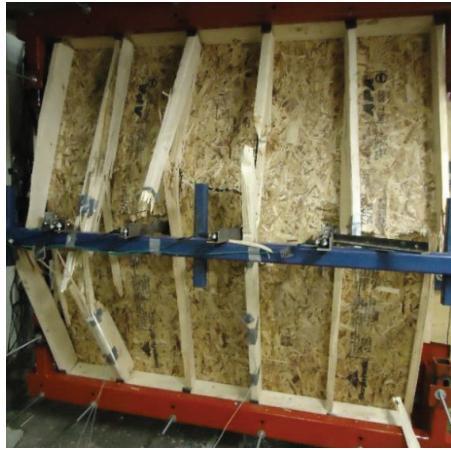
Results also showed indications of premature failure in some sheathing panels prior to achieving full flexural failure in the stud elements (Figure 3a). When sheathing failure occurred, debris was also produced, with some pieces being as large as the gap between the studs. Detachment of failed stud fragments was caused by the weak withdrawal capacity of the nail connections between the sheathing and the stud. While nails behave efficiently in shear when in-plane loads are imparted on the wall (i.e., shearwall), nails involved in out-of-plane motion are eventually loaded in withdrawal, where they are known to be very weak. The use of screws was found to significantly limit debris throw (Figure 3b), which has been shown to be the principal cause of injuries and deaths during blast events [17].

(a) Sheathing failure and debris throw

(b) Wall specimen with thicker sheathing and screws

Figure 3: Light-frame wall specimens after testing

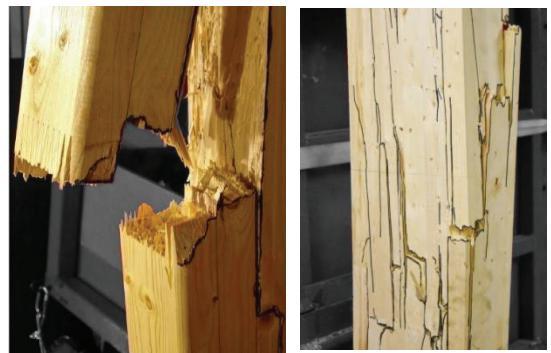
Failure of glulam members have been observed to consistently initiate at a tension-side finger joint or natural defect. In some instances, glulam specimens with localized concentration of finger joints on the tension-side laminate (Figure 4a) lacked the increase observed in specimens containing no finger joints in the middle onethird span (Figure 4b).

(a) Concentrated

(b) Staggered

Figure 4: Glulam finger joints

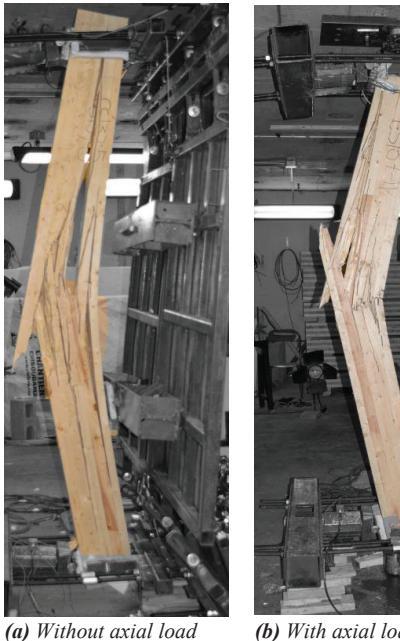
The effect of axial load on the dynamic behaviour was also investigated. Three different axial load ratios were considered. The addition of axial load reduced the resistance of the column and contributed to concentrating the damage at midspan when compared to the case without axial load (Figure 5). It should be noted, however, that the contribution of axial loads in actual structures would highly depend on the connection detailing between the columns and the elements they support.

(b) With axial load

Figure 5: Effect of axial load on glulam specimens

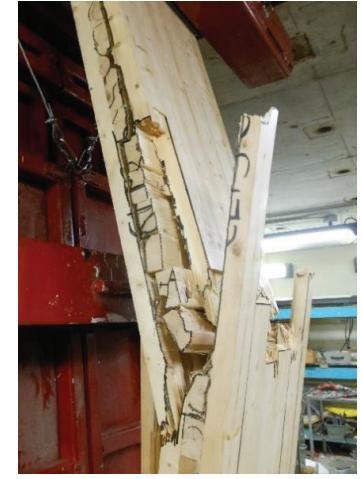
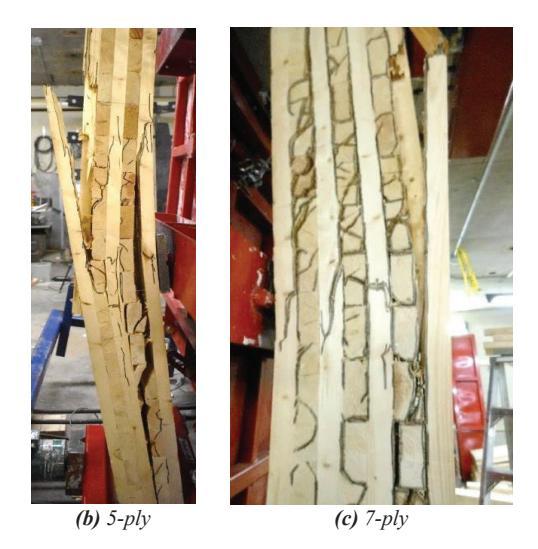
Two experimental programs investigating the out-ofplane behaviour of CLT under static and simulated blast loading of twenty-two panels, with different panel thicknesses was undertaken [7, 16]. The dynamic behaviour of CLT panels under bending consisted of a primarily flexural failure mode, accompanied by rolling shear damage in the transverse layers, particularly in specimens with low span-to-depth ratios. The overall behaviour of CLT panels can be generalized as a progression of failure of the longitudinal layers, initiating at the outermost longitudinal laminate, and crack propagation within the transverse laminates due to rolling shear (see Figure 6).

(a) 3-ply

Figure 6: Representative failure modes for CLT panels

The CLT panels were observed to have significant postpeak resistance [7]. The initial drop in resistance represents the loss of the tension longitudinal and transversal laminates. For example, for a 7-ply specimen, which consist of four longitudinal and three transverse layers, this failure mechanism implies that the specimen would now behave as a 5-ply member, consisting of three longitudinal and two transverse layers.

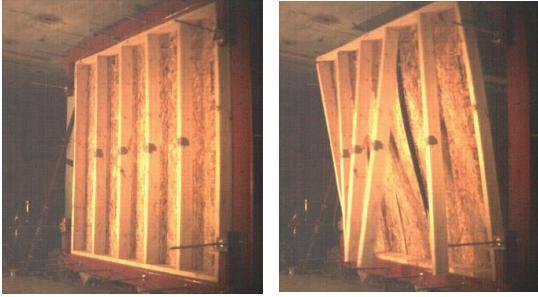
Premature failure of the wall connections to the roof and the foundation has been identified as the cause for most collapses [18]. A research study was undertaken to investigate the behaviour of typical nailed boundary connections, designed according to the National Building Code of Canada's prescriptive design guidelines [19]. The results showed that such detailing was not adequate to withstand the blast pressure and resulted in premature connection failure occurring at the top and bottom plates, as shown in Figure 7.

(a) Arrival of blast wave

(b) Top connection failure

Figure 7: Failure of nailed stud wall boundary connection

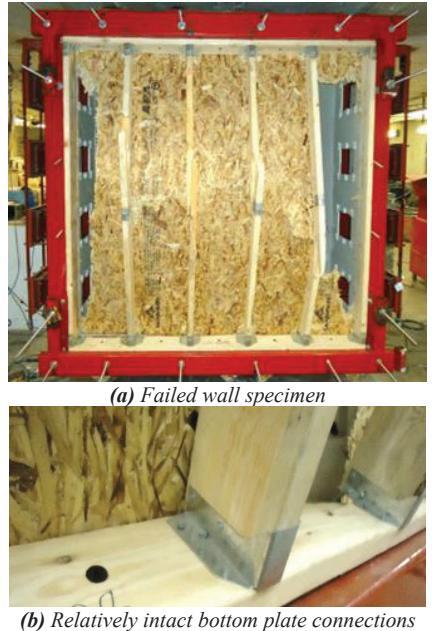
Off-the-shelf joist hangers, typically used in light-frame wood floor systems, as well as simple angle brackets, were used to connect the studs to the boundary elements, as shown in Figure 8. The results showed that while overdesigned connections allowed the studs to achieve their flexural capacities, walls with connections designed to yield in a controlled manner could withstand greater blast pressures and impulses, and exhibit less damage.

Figure 8: Wall specimen with joist hanger connections

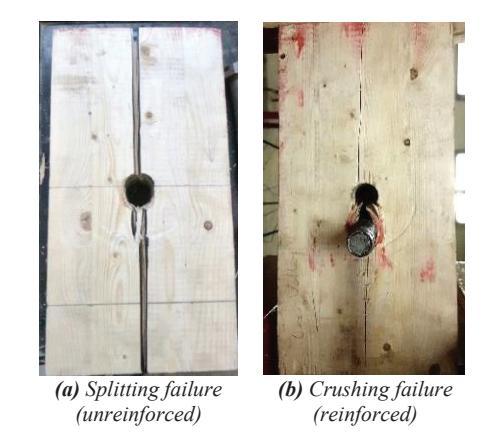
A study was carried out on single-bolt joints of various slenderness ratios in both principal load direction (i.e., parallel- and perpendicular-to-grain), with the aim to investigated high strain-rate effects on the connections. An average dynamic increase ratio of 1.2 was observed on the yield load of connections designed to fail via wood crushing, while no significant dynamic increase on the yield load or stiffness was found for connections designed to fail in bolt bending and yielding. A loss in connection ductility was also noted when comparing static to dynamic loading, and the use of self-tapping screws (STS) as joint reinforcement was proved effective (see Figure 9).

Figure 9: Dynamic stocky bolt specimens (parallel-to-grain)

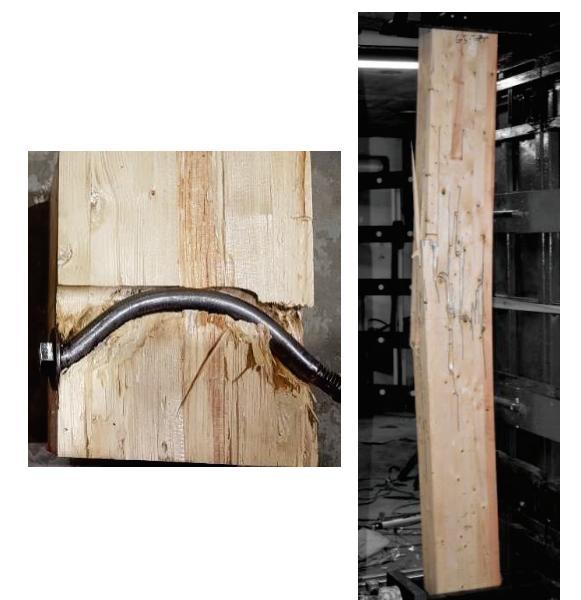
Glulam beams with bolted end connections with slenderness ratio of 10.8 were tested under shock tube simulated blast loads [12]. It was observed that bolted connections designed to yield and undergo significant inelastic deformations (Figure 10a) had enhanced overall energy dissipation when compared to specimens with overdesigned bolted connections, as required by the CSA S850.

(a) Yielding in connection

(b) After blast test

Figure 10: Full-scale bolted glulam specimen

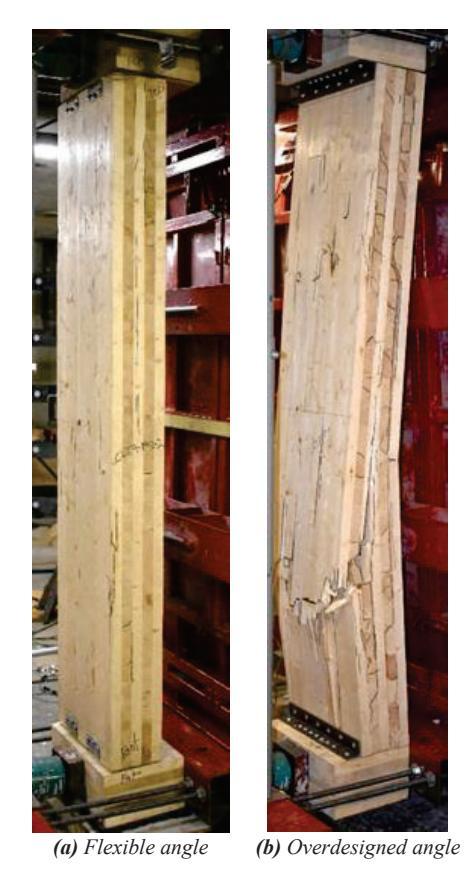
Self-tapping screws (STS) were used in end-grain with full-scale CLT specimens subjected to simulated blast loads. Significant damage was observed in the STS connections, where tension perpendicular-to-grain failure as well as combination of shear and withdrawal failure were prevalent. To take advantage of timber's relatively high capacity in bearing, the use of angle brackets with STS, which are traditionally used for in-plane loading for wind and seismic, were also investigated. Two angle brackets were tested, representing two distinct design philosophies; a thin and flexible angle bracket, designed to undergo significant yielding and wood crushing, and a robust and stiff angle bracket, designed to remain elastic and not cause significant wood crushing. The flexible angle bracket was found to fail in yielding and wood crushing. The overdesigned and stiff bracket exhibited a brittle failure mode when the capacity of the connection was exceeded, namely by rupturing the fasteners that connect the bracket to the base of the test assembly. As shown in Figure 11, full-scale test specimens with the flexible angle brackets were seen capable of absorbing more blast pressure and impulse prior to failure in the CLT panel.

Figure 11: Full-scale CLT specimens with angled connections

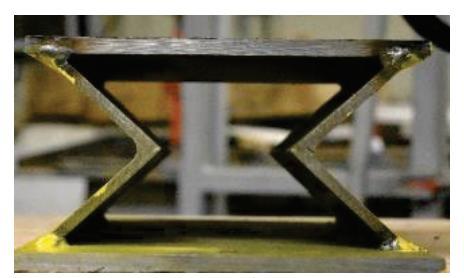
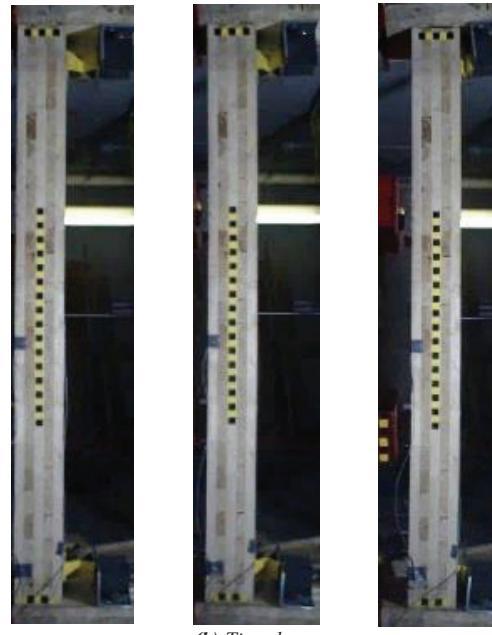
The use of energy absorbing connections (EAC), which are purposefully designed to dissipate energy through controlled deformations of a steel fuse, were observed to improve the capability of a timber assembly to withstand blast explosions. Various configurations of EACs were investigated, all of which comprised of mild-steel shapes with various thickness and dimensions. The connections that were identified to perform optimally were found to exhibit a bi-linear elastic-perfectly plastic behaviour. The connection deemed the most efficient (Figure 12a) was implemented into full-scale glulam and CLT specimens. In comparison to specimens with simply-supported idealized boundary conditions, or overdesigned connections, the EACs were found to provide around 75%-115% increase in total impulse absorbed by the assembly prior to flexural failure of the wood element. A time lapse of a test is shown in Figure 12b.

(a) Tested EAC

(b) Time-lapse

Figure 12: Full-scale CLT specimens with EACs

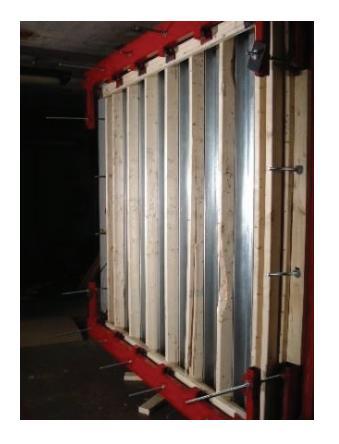
Identified deficiencies found during the research program were used as motivation for investigating possible retrofit options to increase the overall performance of various timber systems. This includes enhancing the performance of sheathing elements, load-bearing elements (i.e., stud, glulam column), boundary connections, as well as minimizing high-velocity flying debris. Stud walls designed according to typical prescriptive requirements often experienced premature failure of sheathing panels [9]. This not only caused flying debris but a loss in structure integrity, where the load-bearing elements cannot achieve their full flexural capacity. The use of thicker wood-based sheathing was found to shift the failures to the studs, while concurrently decrease the amount of sheathing debris. Corrugated steel panels were also tested (Figure 13) and the results showed that they provide significant increase in stiffness and strength.

Figure 13: Corrugated steel panels as sheathing retrofit

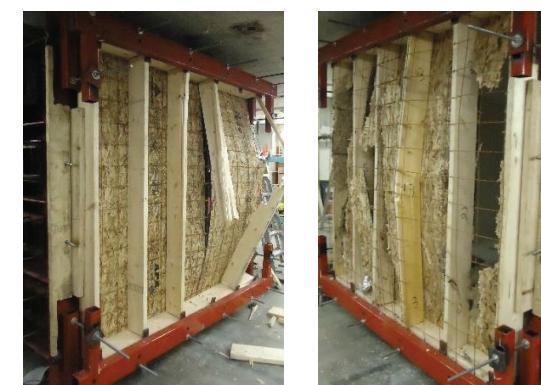
Welded-wire-mesh (WWM) was implemented as a sheathing retrofit, as well as a catcher system. In both applications, it was found to perform adequately well. As a sheathing reinforcement, the WWM acted similar to a skin reinforcement, thus reducing the demand on the panel in bending and minimizing overall damage and fragmentation (see Figure 14a), while as a catcher system, it adequately captured all debris of significant sizes (Figure 14b).

(a) Sheathing reinforcement

(b) Catcher system

Figure 14: Application of welded wire mesh (WWM) as retrofit

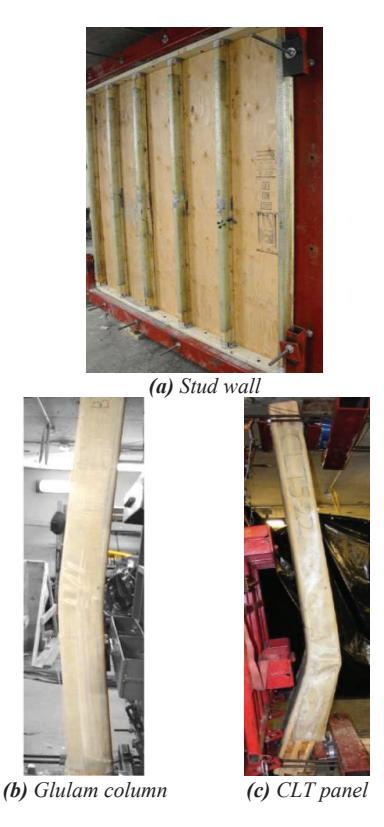
Different retrofit configurations using fibre-reinforcedpolymers (FRP) were investigated for light-frame stud walls, glulam columns, and CLT panels, as shown in Figure 15.

Figure 15: Retrofits using fibre-reinforced polymers

When adequate confinement in tandem with longitudinal tension reinforcement was provided, the application of FRP tended to delay and contain brittle tension parallel-to-grain failure and allowed for the compression-side longitudinal fibres to crush in a ductile manner [20-22]. In general, this allowed for the reinforced specimens to have sustained post-peak capacities, which would otherwise be limited, due to the inherent brittle nature of wood in flexure.
