Advancing Timber for the Future Built Environment

# CONTINUOUS MONITORING OF A FIVE-STORY CROSS-LAMINATED TIMBER BUILDING IN A SEISMIC-PRONE REGION

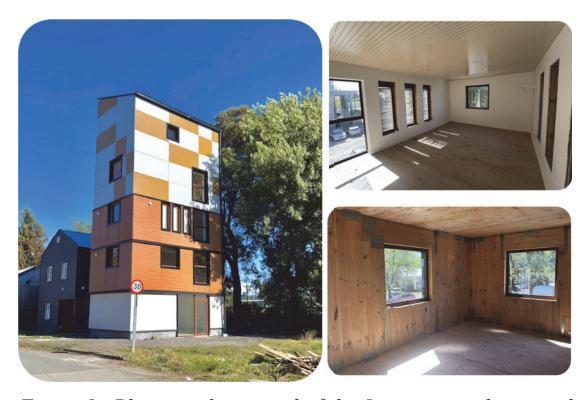
*Figure 1: Photographic record of the 5-story cross-laminated timber (CLT) prototype*

With a floor plan of 4.2 m by 6.6 m and a total height of 14.5 m, the building design considers the alignment of the openings to generate rigid corners. In addition, two construction systems were implemented: the first three levels follow the platform system, while the two upper levels adopt the balloon system. Figure 1 shows a photographic record of the building and Figure 2 shows section views of the building.

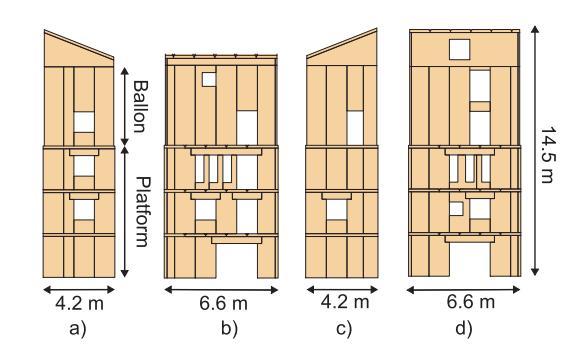
Figure 2: Sections from outside of the CLT building: a) North, b) South, c) West, d) East.

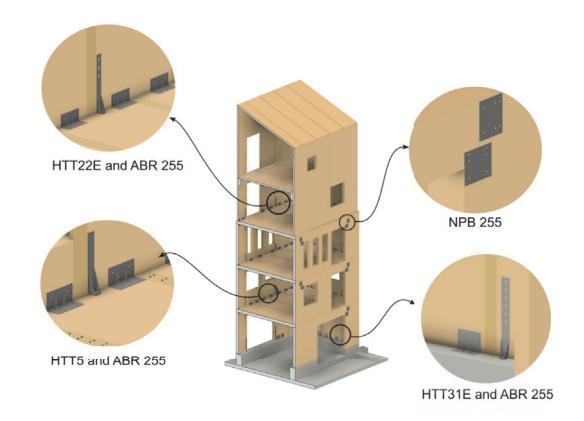
As can be seen in Figure 3, there is a large number of metal connectors. On average, in terms of connectors there are 2 connectors/m<sup>2</sup> and 205 fasteners/m<sup>2</sup> (nails + screws).

Figure 3: Model of the CLT tower with some construction details.

From the structural design point of view, the building was calculated under the method of allowable stresses according to Chilean standards [32, 33], considering a seismic reduction factor of R = 2 and a drift limit of 0.2%. The latter criterion proved to be the most restrictive, conditioning the structure to a large amount of metallic connectors to guarantee its stiffness [29, 34]. The architectural layout and construction details are presented in Figure 3.

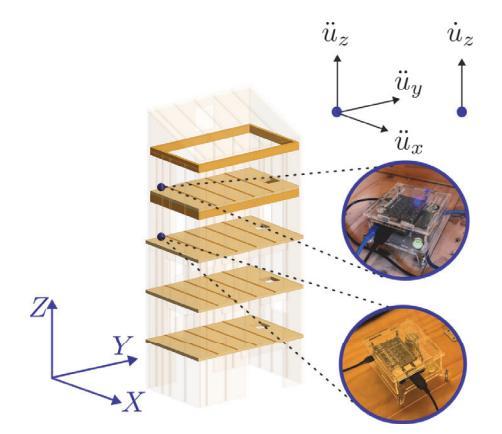
To record accelerations induced by environmental vibrations and seismic events, RaspberryShake R4SD [35] sensors, with a sampling rate of 100 Hz, were used. The devices were installed at the northeast corners of the fourth and fifth levels of the building, as shown in Figure 4. The continuous measurement campaign runs from August 1, 2023 to August 1, 2024. This type of sensor has been validated and tested for continuous monitoring of timber structures [29, 31]. The monitoring scheme, together with the position of the RaspberryShake sensors, is shown in Figure 4

Figure 4: Mounting and location of accelerometers for Continuous Monitoring.

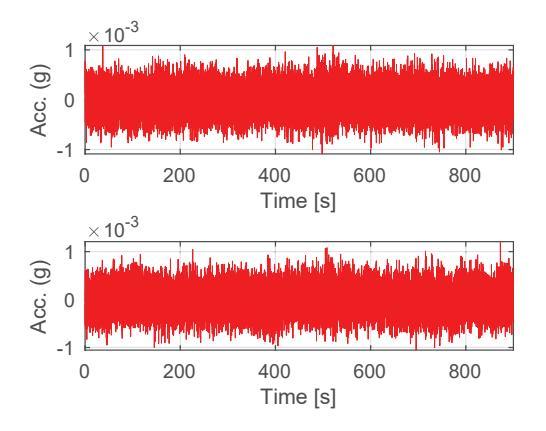
The results shown in Figs. 5 and 6 show that the quality of the signals is good enough to apply the OMA methods, in particular Figure 6 showing how the signals follow a normal distribution, unaffected by clipping, or digital noise.

Figure 5: Accelerations recorded in measurement in the 5th story in the: X (top), Y directions (below).

The results associated with the identification of dynamic properties over time will be shown below. Typical accelerograms obtained during a 15-minute window for environmental vibration measurements are shown in the Figure 5 together with their histograms in the Figure 6.

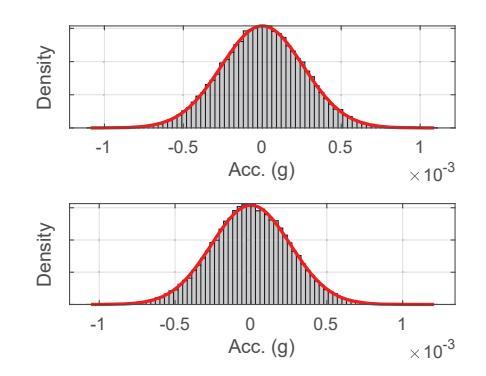
Figure 6: Acceleration histograms with probability density and normal fit.

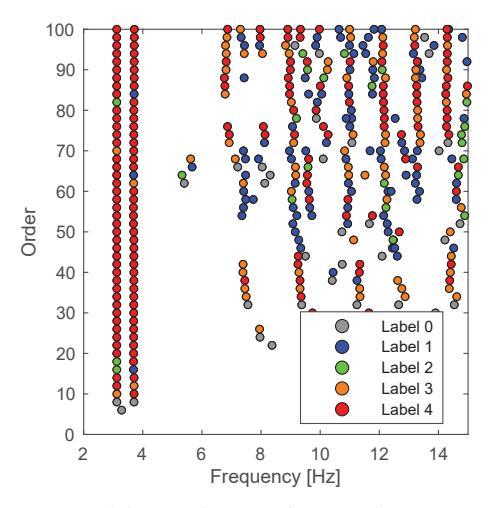
The results show that in general it is possible to identify two stable frequencies for different orders, these frequencies are associated to translational modes in the x and y direction identified in the work of [29]. This process is performed for a whole day, generating a number of 96 identifications for one day. The Figure 8 shows the dispersion of frequencies identified during one day.

Figure 7: Stabilization diagram of estimated state space models for a 15-minute window measurement

A typical stabilization diagram for a 15-minute window is shown in the Figure 7.

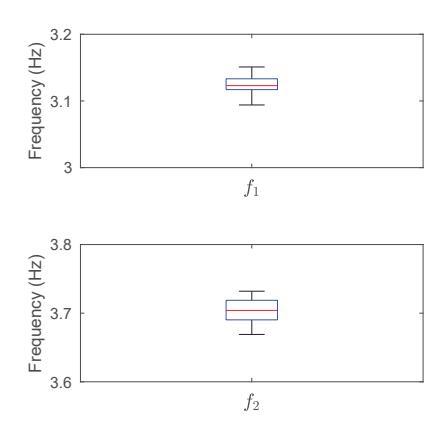
The results shown in Figure 8 indicate minor variations. In the worst-case scenario, differences of up to 1.62% are observed, suggesting that cross-laminated timber remains relatively stable throughout the day compared to the wood light-frame construction system [31].

Figure 8: Variation of the natural frequencies of the fundamental modes  $f_1$  and  $f_2$  on 1 day

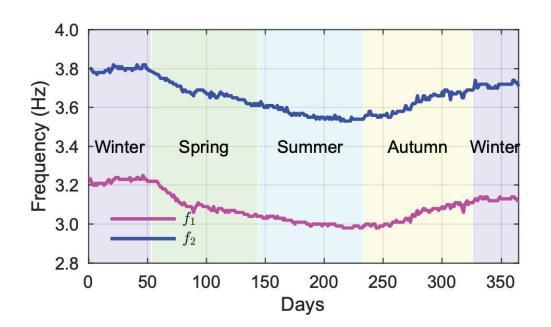
Figure 9: Variation of the natural frequencies of the fundamental modes  $f_1$  and  $f_2$

The frequencies of the fundamental modes  $f_1$  and  $f_2$  vary by 6% and 8%, respectively. These changes in the frequency is explained by Jara-Cisterna et al. [29] that are associated with the moisture content of the panels that can generate swelling and interlocking between the parts of the structural system, which would increase the lateral stiffness and the natural frequencies. Figure 10 shows the comparison between the moisture content of the CLT panels and the identified frequencies.

Once the frequencies during a day have been identified, the average frequencies corresponding to the day are calculated. The natural frequencies of the fundamental modes are shown in Figure 9.

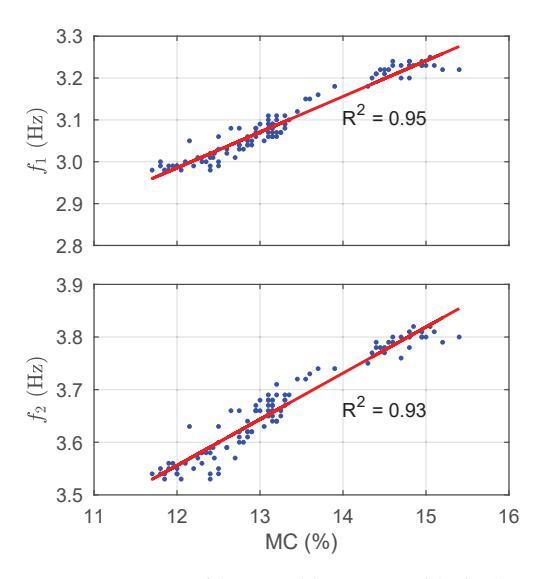
Figure 10 indicates that there are higher correlations for both frequencies, showing the correlation ( $R^2 \ge 0.93$ ) between the identified frequencies over time and the moisture content of the CLT panels.

The results on frequency identification and moisture content measurement indicate that there is a clear seasonal trend in the frequencies, with decreases during drier periods (possible shrinkage of the timber in summer months) and partial recoveries in winter, although without reaching the initial value. For example, differences of up to 4% are found when comparing the initial frequencies and those at the end of 1 year. This suggests that, as the panels dry, the timber may undergo changes that prevent it from fully recovering its original stiffness. To assess what is occur-

Figure 10: Variation of the natural frequencies of the fundamental modes f1 (top) and f2 (bottom) and moisture content.

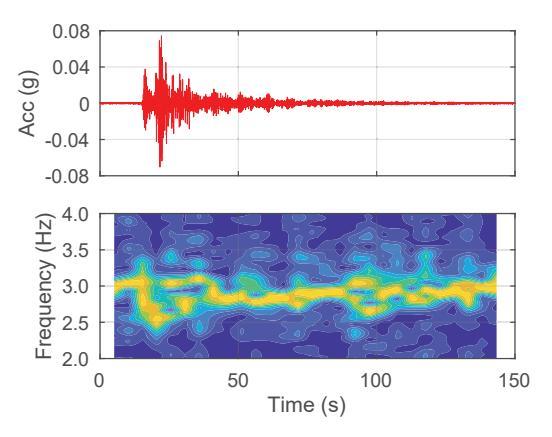
Figure 11: Seismic Acceleration response in X (top) and Shorttime Fourier Transform (below)

The results shown in the Figure 11 show the seismic response at the 5th floor, it is found that accelerations of 0.074 g are reached at the 5th floor. To analyze what happens with the frequency, the spectrogram is shown. The results indicate that the frequency during the seismic event is reduced by 15.3 % but has been restored once the energy has been dissipated, indicating that there is no structural

damage. During the year of continuous monitoring there are more than 10 earthquakes over 4.5  $M_w$  in a range of radius less than 100 km, it is important to note that the frequency before and after earthquakes remains constant as shown above. Additionally, another raspberryshake was incorporated to measure the excitations at the base level, so it is expected to deeper further research on this phenomenon.

From the point of view of the seismic response, the results of a 5.4  $M_w$  earthquake in the East-West component are shown in the Figure 11.
