Advancing Timber for the Future Built Environment

STRUCTURAL FIRE DESIGN WITH AGED RECLAIMED TIMBER: SMALL-SCALE CHARRING PERFORMANCE ASSESSMENT

Johanna Liblik¹, Maria Pernits², Alar Just³, Alar Konist⁴

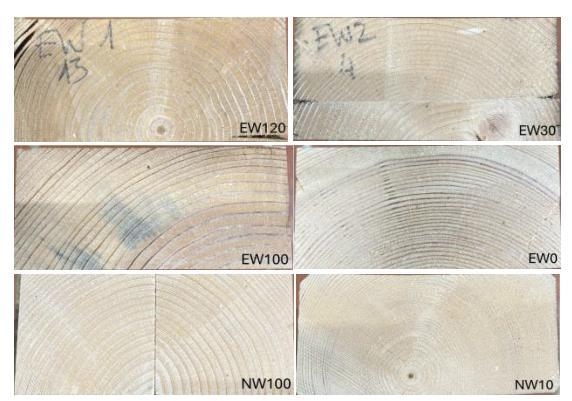
Figure 1. Example of the side view for each test specimen ID.

Due to limitations in the received raw material, it was not possible to cut the total required specimen size for NW100 and NW10. As a result, these test specimens were prepared by tightly fixing two halves together, thereby achieving a total volume highly comparable to that of the other test specimens. The EW30 specimens comprised two timber layers glued together, see Figure 1. Each specimen ID was subjected to three repeated tests, resulting in a total of 36 tests. Each specimen was wrapped into an aluminium tape to prevent heat losses and air flow within the specimen inside the specimen holder [12].

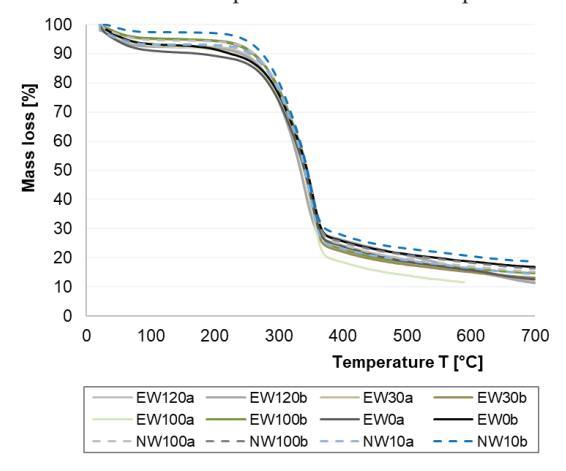
Testing was conducted using two samples of each wood species to identify any discrepancies. Figure 2 presents the results on the relationship between the temperature increase and mass loss. Despite the differences between the wood species (see Table 1), the mass loss trend was closely comparable across all specimens. Table 3 summarizes the main results and mean values for the total mass at 700°C and the total mass and mass loss at 300°C, as this temperature is commonly recognised (e.g., acc. to EN 1995-1-2) as the start time of charring. Figure 3 offers

Figure 2. Test results on the effect of temperature on mass loss obtained from TG analysis.

When comparing the 100-year-old wood samples of different origins, EW100 and NW100, the total remaining mass at 700°C was 13.2% and 15.8%, respectively. In comparison, the remaining mass of new wood (EW0) was 14.7%. Thus, no significant difference

in the decomposition of the wood species at elevated temperatures was observed compared to new timber; however, some variations were noted, e.g. difference in the mass loss between total mass at 300°C and total mass at 700°C between the EW120 and NW100 was about 5%.

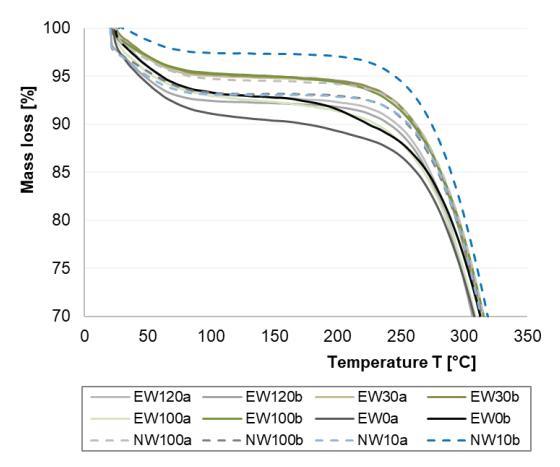
a close-up examination of the mass loss trend up to 300°C, where initial differences between species in mass loss are observed. However, after approximately 280°C, the mass loss patterns start to align across all samples. Considering all test species, the average mass loss at 300°C ranged from 21% to 26%. No clear trend was observed across the different age groups of the wood species. For instance, EW120 and EW0 (new wood) exhibited very similar mass losses of 26.0% and 25.0% at 300°C, respectively. In contrast, the mass loss at 300°C was slightly lower for the other specimens compared to EW120 and EW0. When comparing the residual mass at 700°C, EW120 showed 11.6%, while EW0 showed 14.7%, indicating that the new wood (EW0) experiences a slower rate of decomposition at elevated temperatures.

Figure 3. Test results on the mass loss in relation to the effect of temperature increase until 300°C.

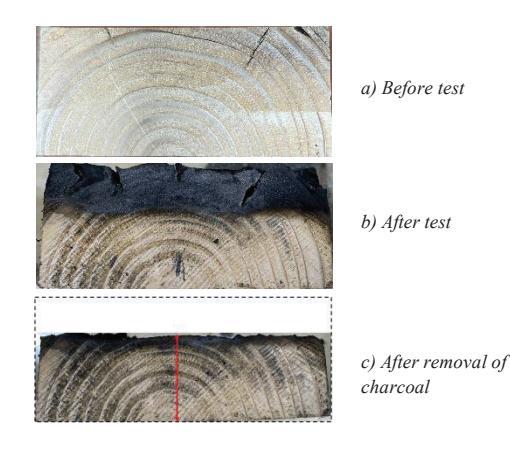
Test specimens were documented and an example of a timber specimen before and after a fire test is presented in Figure 4. The residual thickness of the wooden specimens was measured at the centreline of the specimen (marked with red arrow), after the mechanical removal of the charcoal. The char line along the exposed surface of the wooden specimens was roughly uniform, indicating that the rounded corners did not affect the accuracy of the measurements.

Figure 4. Documentation of a test specimen (EW120) before and after a 15-minute test.

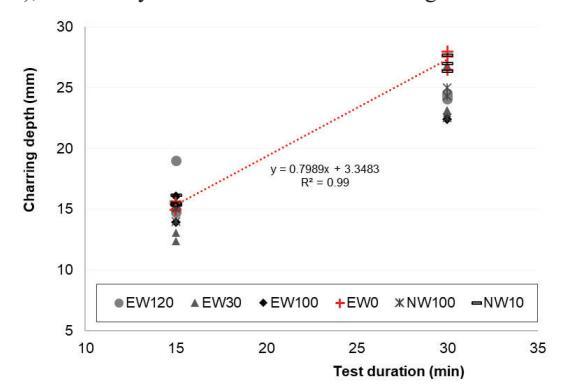
Figure 5 presents the charring depths measured after the removal of charcoal. Notably, the charring depths show an increase with test duration, which was expected. The results indicated in red correspond to the new timber (EW0), which demonstrated a high degree of repeatability in charring depths across all three specimens. By excluding the single highest charring depth determined in the 15-minute test, the charring depths of aged timber were found to closely resemble those of new timber, with some specimens even showing less charring. However, it should be noted that the mean density values differ between new and aged timber, with values of 505 kg/m3 and 451 kg/m3, respectively. Specimens of NW10 demonstrated the least charring, possibly due to prior exposure to mortars or similar materials during its use as a scaffolding material (Table 1), which may have an effect on its charring.

Figure 5. Charring depths obtained from cone heater tests in relation to test duration.

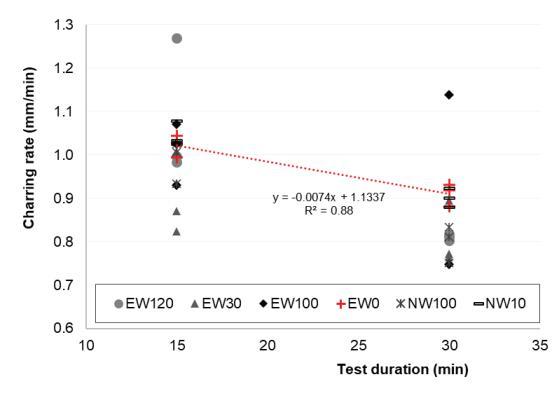
Figure 6 presents the determined charring rates in relation to the test duration. A longer test duration results in a slower charring rate for timber that is related to the formation of charcoal and the stabilization of charring conditions. No clear trend is observed in the charring rates across different age groups and origins of timber. However, somewhat fastest charring rates were determined in specimens older than 100 years (EW120, EW100, NW100), suggesting that significantly older timber may char slightly faster than younger timber. The comparison between new and aged timber should also account for density, although the approximately 50 kg/m3 difference between new and aged timber is not considered substantial to significantly impact the charring rates. It is important to highlight that greater variation in charring rates was observed within a single specimen ID of aged timber, see the individual values in Figure 6 that deviate from the others.

Figure 6. Charring rates of test specimens in relation to test duration.

- 2) The deviation in charring rates among all specimens reduces with a longer test duration, as shown by the comparison of the 15-minute and 30-minute test results. This trend suggests that prolonged heat exposure conditions lead to a more consistent charring behaviour (related to the formation of charcoal) and potentially resulting in a more reliable comparison of test results between different specimens.

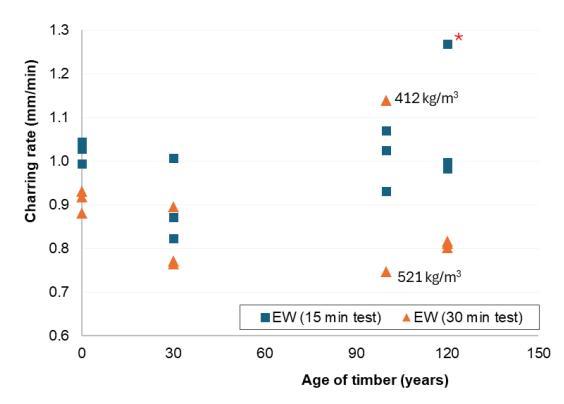
Figure 8 illustrates the relationship between the charring rate and the age of timber for the specimens of Estonian origin (EW). While most specimens of aged timber have comparable density values (see Table 2), the results for the EW30 specimens show significant deviation, which could be foremost attributed the density variations (compare results of 412 kg/m³ and 521 kg/m³), with denser timber indicating slower charring rate. Moreover, the EW30 samples consist of two bonded timber layers (Figure 1), potentially increasing the variation in charring rates within the specimen ID. The highest charring rate, indicated by a red asterisk in Figure 8, corresponds to a specimen from the batch of 120-year-old timber (EW120) that mainly differed from the other two samples in its visual characteristics, see Figure 7 left (i.e., width of the annual rings), despite having a very similar density to other two samples. This result indicates that, when comparing test outcomes, it is essential not only to evaluate factors such as the density of the samples but also to consider the structure of the annual rings, as well as any other defects or cracks that may affect the repeatability of the results (within one specimen ID). It was observed that a batch of aged timber from a specific collection site may exhibit significant variation in the characteristics and quality of the timber material. The variation in test results for new timber appears to be minimal when it (see EW0) was tested, reflecting a higher degree of homogeneity of the material and the lack of significant differences within the batch compared to aged timber.

Figure 8. Charring rates in relation to the age of timber (EW).

Figure 7. EW120 test specimens: Left – Timber sample with a charring result indicated by a red asterisk in Figure 8; right – Timber specimen of the remaining two samples from the same specimen ID.

It is widely recognized in the literature that the charring rate is strongly dependent on the density of the material, with several charring models incorporating density as a key variable [6][13]. This study aimed to reduce the density variation between selected specimens to gain clearer insight into how timber age affects charring (Table 2), although achieving identical density across all specimens was not possible as one would expect with timber material. Figure 12 presents the results of charring rate versus densities of all specimens. The results indicate that, despite variations in the age and slight differences in densities of the aged timber specimens, the charring rates determined in a 15-minute test show larger scatter, whilst in case of 30-minute test, the deviation between charring results is reduced. No clear trend was observed between charring rate and density across the tests. However, in some specific instances, variations in density appeared to influence the charring rate, as previously discussed (see Figure 8).

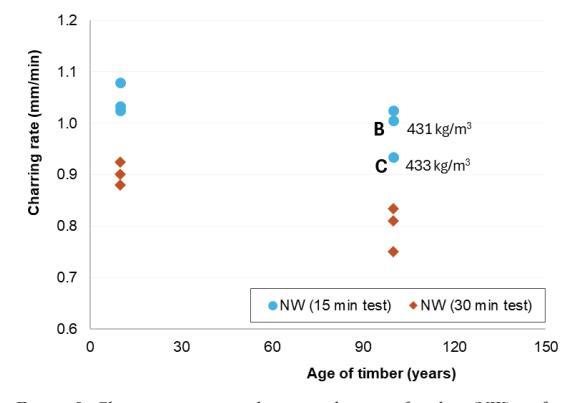
Figure 9 presents results for the specimens of Norwegian origin, where some variation is also observed within a batch of NW100 in case of 15-minute testing, despite the specimens having very similar densities, see Table 2.

Figure 9. Charring rates in relation to the age of timber (NW), refer also to Figure 10.

When analysing the performance of specimens (NW100) based on their visual appearance, as shown in Figure 10, the faster charring rate observed in specimen B (Figure 9) could be attributed to the orientation of the annual growth rings being slightly more parallel to the heat exposure. Also, the width of the annual rings appears to have some influence. This may further suggest that the orientation and slope of annual rings in timber are important factors when comparing different test results (particularly within one specimen ID), highlighting that multiple variables can impact the charring results. Consequently, a comprehensive approach that simultaneously accounts for multiple factors affecting charring performance appears more effective in identifying the dominant influences on fire test outcomes. The NW100 specimens consisted of two halves fixed together. Test results showed uniform charring across the specimen, with negligible influence from this setup compared to other solid specimens.

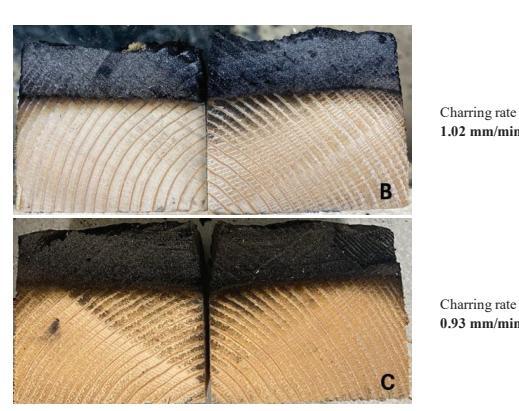
Figure 10. Comparison of NW100 test specimens after 15-minute fire test, refer also to Figure 9.

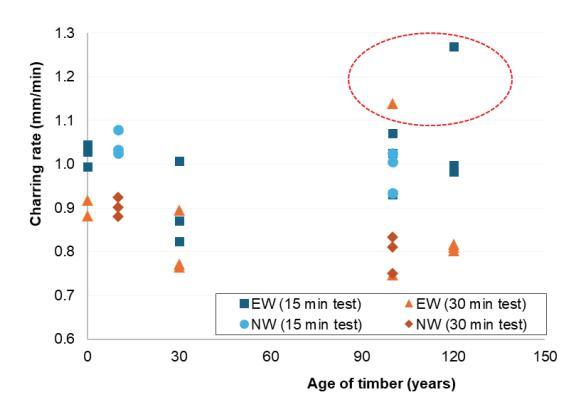
Figure 11 presents a comparison of all test results regarding the relationship between charring rate and the age of timber. The highest charring rates, marked by a red circle, have already been discussed above. When excluding these values from the overall data, the trend shows that charring rates for all timber ages are ranging between 0.75 and 1.1 mm/min. Tests with the oldest samples of timber (EW120, EW100 and NW100) show comparable performance, despite their differences in origins and place of collection (Table 2). Results show that it cannot be concluded that the age of timber has a significant impact on the charring rate, e.g., new timber (0 years) exhibits a charring rate similar to that of timber aged 120 years (compare results of 15-minute tests). The 30-minute tests indicate that older timber demonstrates even a slower charring rate compared to new timber. (Table 2).

Figure 11. Comparison of charring rates to age of timber between EW and NW specimens in all tests.

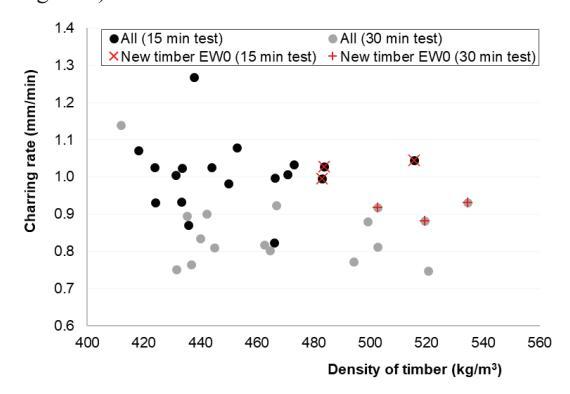
Figure 12. Charring rates in relation to density of timber.

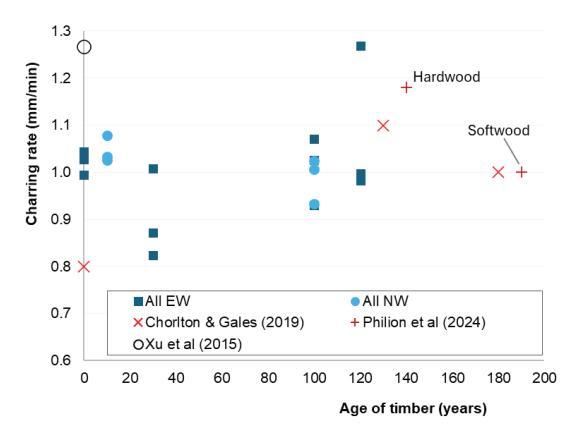
Figure 13 presents the comparison of results with regards to the age of timber and its respective charring rate. The results from [8][11] fall within the charring rate limits determined in this study, while the charring rates of Canadian heritage timber, around 1-1.1 mm/min, are consistent with those observed in 100-year-old and older timber from Estonia and Norway. On the other hand, the charring rates for new timber can vary significantly across tests, as seen in the results in [8] and [14]. In case of 15-minute tests, the charring rates of new timber observed in this current study (~1 mm/min) fall within the range reported in previous research for new timber (0.8 - 1.3 mm/min). This finding reinforces the earlier argument that additional factors (e.g., grain and annual ring orientation) should be carefully considered alongside primary given parameters (e.g. type of species

Figure 13. Comparison of charring rates in relation to the age of timber between different studies determined in a 15-minute test.

The charring rate of approximately 0.8 mm/min reported by [8] aligns well with the results obtained by Mikkola [19], who tested new timber specimens of 38 mm thickness (490 kg/m3 spruce and 560 kg/m3 pine) at 10% moisture content. Given that the moisture content was somewhat higher in case of [19], lower moisture content should result in a slightly higher charring rate than 0.8 mm/min. In this current study, the results for new timber (EW0, moisture content 9%) were around 1.0 mm/min. This difference to other studies (compare 0.8 mm/min [8] and 1.3 mm/min [14]) likely arises from multiple influencing factors, despite similar testing methods and specimen sizes, raising questions about the comparability of these results, as discussed in the next section. Figure 14 presents the comparison of results in view of the density of timber. Results from the study by Chorlton & Gales [8] for the heritage timber agree well to the dataset of charring rates obtained in this current study with similar densities. A significant difference is observed between the results of new timber in this study and [8] which may be influenced by the orientation of annual growth rings relative to heat exposure, as the density and the moisture content are highly comparable.

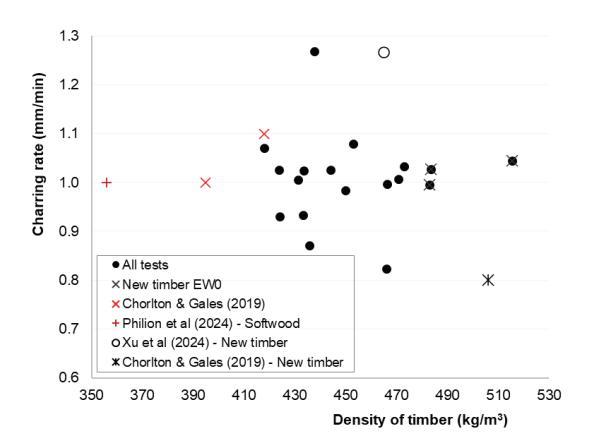
faster than new timber. It was also noted in [8] that the older timber was less dense than the contemporary timber (Table 4), a factor that should be considered when interpreting the results. However, information on the orientation of annual rings of the timber specimens related to heat exposure was not provided, and only mean charring test results were reported. This suggests that more comprehensive data should be provided for these types of tests to enable reliable comparisons between studies worldwide, despite the use of similar test method and test specimens.

Figure 14. Comparison of charring rates in relation to the density of timber between different studies determined in a 15-minute test.
