Advancing Timber for the Future Built Environment

EXPERIMENTAL FIRE TESTING OF STS-RETROFITTED GLULAM BEAM CONNECTIONS WITH MINIMAL FIRE PROTECTION

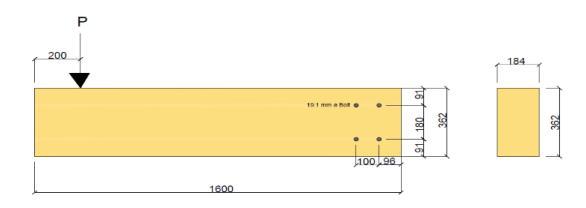
Figure 1: Details of the beam-end connection configuration with bolts arranged in the first pattern (P1).

In the connection configuration with the first bolt pattern (4BP1R), two rows of bolts, each of two bolts, were symmetrically positioned near the top and bottom sides of the beam section. In the configuration with the second bolt pattern (4BP2R), the bottom row of bolts was shifted upward to be located at the mid-height of the beam section, further contributing to the moment-resisting capacity of the connection. In both configurations, the metal connecting components, bolt heads, nuts, and steel plates were protected with wood plugs and strips to

Figs. 1 and 2 show details of the beam-end connection configurations with four connecting bolts in two different arrangements (i.e., P1 and P2), respectively.

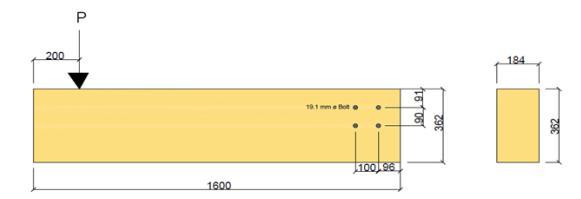
Figure 2: Details of the beam-end connection configuration with bolts arranged in the second pattern (P2).

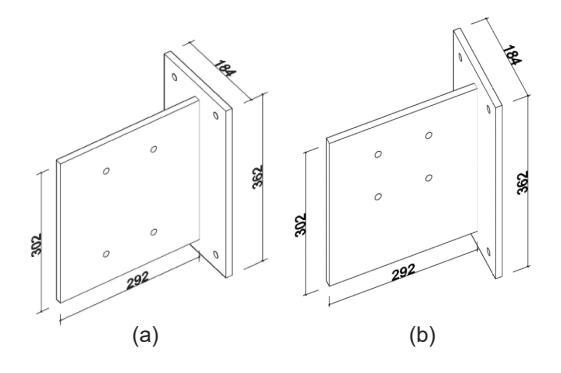
Figure 3. Schematic of the T-stub steel brackets utilized in the two connections, (a) Configuration with the first bolt pattern (P1); (b) Configuration with the second bolt pattern (P2) (dimensions in mm)

To connect the glulam beam section to the steel supporting column, a T-stub bracket made of a 12.7-mm (1/2") thick steel plate of grade 300W was utilized. Fig. 3 illustrates an isometric view of the steel T-stub bracket for each connection configuration.

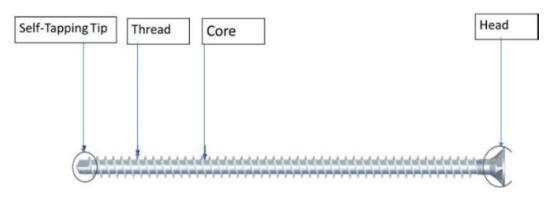
Figure 4. SWG ASSY VG plus CSK self-tapping screw (Adapted from [15])

The STS used to retrofit the glulam beam-end connections were SWG ASSY VG plus with certified properties as per the Canadian Construction Materials Centre report [15]. The screws had a length of 300 mm and 8 mm thread outer diameter. Fig. 4 illustrates the details of the STS used.

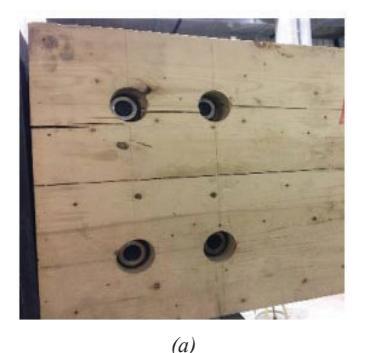
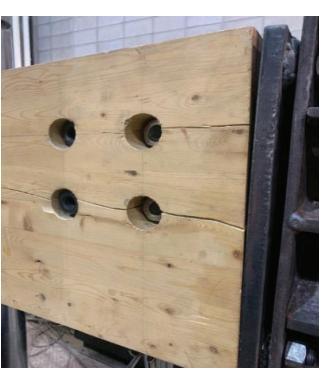
Figure 5. Failure mode of the WSW connection configurations tested at ambient temperature, (a) Configuration with the first bolt pattern (P1); (b) Configuration with the second bolt pattern (P2).

The beam-end connections were deliberately loaded under bending moment and indirect shear force until failure, when splits started to develop in the connections along the top and bottom rows of bolts. Fig. 5 illustrates the typical failure mode of the WSW connection configurations, which was observed when the ambient test was terminated [7, 8].

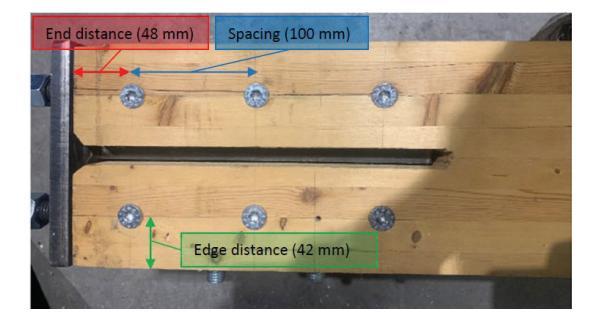
Figure 6. Typical STS arrangement.

After the beam-end connections were damaged in ambient tests, they were retrofitted using STS in preparation for the fire tests of the present study. Six STS were used to reinforce the beam sections at their end connections perpendicular to the wood grain. Fig. 6 shows the top side of an STS-retrofitted glulam beam specimen. The STS were installed in pairs and spaced at 100 mm such that the first pair is centred between the beam end and the first column of bolts, the second pair is centred between the two columns of bolts, and the third pair is 50 mm beyond the second column of bolts into the beam away from its connected end.

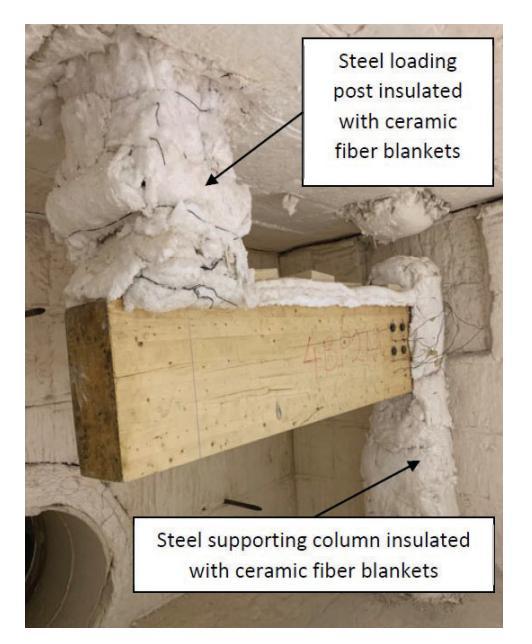
Figure 7. A typical glulam beam test assembly installed inside the fire testing furnace at LUFTRL.

The two retrofitted connection configurations were then exposed to elevated temperatures following the CAN/ULC-S101 standard fire time-temperature curve [17], while being subjected to a bending moment (14.8 kN·m) equivalent to 100% of the ultimate design moment capacity of the weakest, undamaged, unreinforced connection configuration (4BP1). The fire endurance tests of the retrofitted beam-end connections were conducted in the large-size fire testing furnace located at Lakehead University Fire Testing and Research Laboratory (LUFTRL). The setup of the fire tests is similar to that of the ambient tests, except that 1.0-inchthick ceramic fibre blankets were used to insulate the steel supporting and loading attachments along with the top side of the beam to simulate the existence of a slab above the beam as it would be the case in an actual construction configuration. Accordingly, the glulam beams were exposed to fire on three sides only, as the top side was protected from fire by the applied insulating ceramic fiber blankets. Fig. 7 shows one of the glulam beam test assemblies installed inside the fire testing furnace, with all instrumentation and fire-insulating layers in place. During fire tests, the connection failure criterion was set to a maximum beam end deflection corresponding to a connection rotation of 0.1 radians. However, fire tests were continued beyond this point until the beam could no longer sustain the applied loads.

During the fire tests, the applied load was maintained at 10.5 kN, resulting in a bending moment of 14.8 kN \cdot m at the beam-end connection. This is the same load level applied to the identical but undamaged, unreinforced connection configurations experimentally tested by [7, 8] under standard fire conditions. Consistency in applying the same load level enabled a direct comparison of the fire resistance test results from the present study with those of prior related studies [7, 8]. The load was applied using a loading cylinder connected to a manual hydraulic pump. A load cell was placed outside the furnace, on top of the loading steel post, and under the piston of the hydraulic loading cylinder, to precisely measure the magnitude of the applied loads during fire tests.

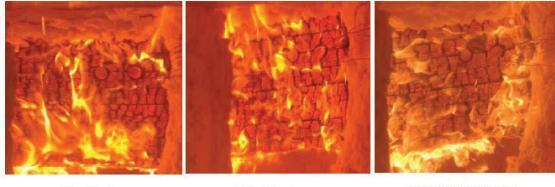
After 15 minutes
 After 30 minutes
 At failure (43 minutes)

Figure 8. Fire testing timeline of the STS-retrofitted connection configuration that utilized four bolts in the first bolt pattern (4BP1R).

The STS-retrofitted connection configuration with the first bolt pattern (4BP1R) had a fire resistance time of 43 minutes and failed due to excessive charring. The fire resistance time of the identical undamaged, unreinforced connection, which was tested twice [7, 8], was 56 and 42 minutes (an average of 49 minutes). The 14 minutes less fire resistance time of the connection examined in the second test compared to the same connection examined in the first test can be attributed to the sudden wood splitting that occurred at a glue line due to delamination [7, 8]. Therefore, the damaged, STS-retrofitted

connection achieved a lower fire resistance time by 13 minutes compared to the undamaged, unreinforced connection, which did not experience glue line delamination. It also had a 1-minute greater fire resistance time than that of the identical undamaged, unreinforced connection in which the glue line delamination caused failure. Based on the above-mentioned results, it can be concluded that the STS restored 77% of the beam's original fire resistance time and prevented the wood splitting failure due to the glue line delamination. Images of the retrofitted connection with the first bolt pattern (4BP1R) taken during fire testing are shown in Fig. 8.

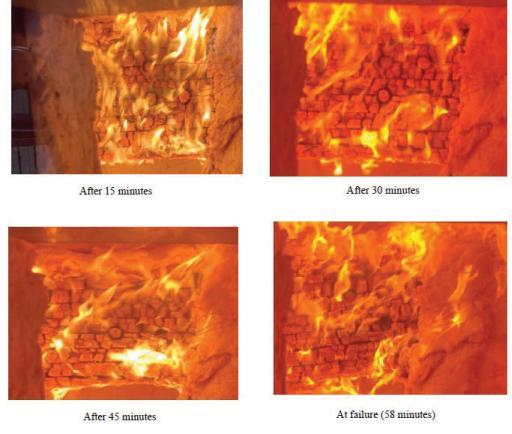
Figure 9. Fire testing timeline of the STS-retrofitted connection configuration that utilized four bolts in the first bolt pattern (4BP2R).

For the connection configuration with the second bolt pattern (4BP2R), the fire resistance time was 58 minutes, and it failed due to excessive charring. The identical undamaged, unreinforced connection tested by [7, 8] had a fire resistance of 48 minutes, and it failed due to wood splitting resulting from glue line delamination that occurred along the top row of bolts. Therefore, the STS retrofitted connection had 20% surplus fire resistance time compared to the unreinforced connection. The significant increase in the fire resistance time of the STSretrofitted connection compared to that of the undamaged, unreinforced connection tested by [7, 8] is primarily due to the STS preventing wood splitting as a result of glue line delamination, which was common in the fire experiments conducted by [7, 8]. Images of the retrofitted connection (4BP2R) taken during fire testing are shown in Fig. 9.

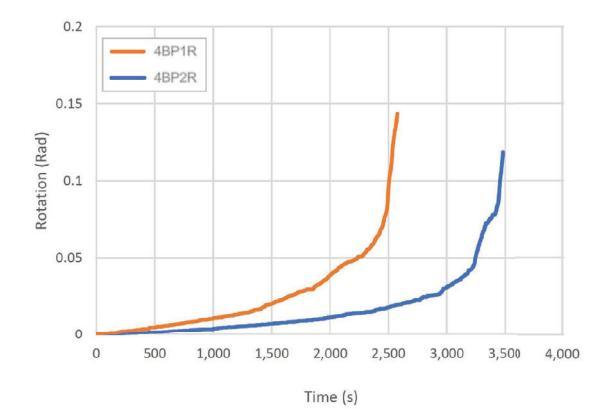
Figure 10. Time-rotation relationships of the STS-retrofitted connection configurations that utilized four bolts in the first (4BP1R) and second bolt patterns (4BP2R).

For the STS-reinforced connection with four bolts arranged in the first bolt pattern (4BP1R), the rotation increased linearly for the first 23 minutes. Afterward, the rotation rate increased more rapidly, following an exponential trend, until failure at 43 minutes (Fig. 10). In contrast, the connection configuration with four bolts arranged in the second bolt pattern (4BP2R) exhibited linearly increasing rotations for most of the fire test duration. The rotation increased linearly for the first 50 minutes, and then it began to increase more rapidly, following an exponential trend, until failure at 58 minutes. It should be noted that for the configuration that utilized four bolts in the first bolt pattern (4BP1R), the initial split of the beam formed along the top row of bolts before fire testing had a width of approximately 3 mm, whereas the STS-retrofitted configuration that utilized four bolts in the second bolt pattern (4BP2R), the initial split exhibited by the connection before fire testing had a width of less than 1 mm. The wider initial split of the configuration 4BP1R resulted in greater heat penetration into the core of the beam section, leading to accelerated localized wood charring. As a result, configuration 4BP2R exhibited an extended linear time-rotation trend and a fire resistance time that was 8 minutes longer.

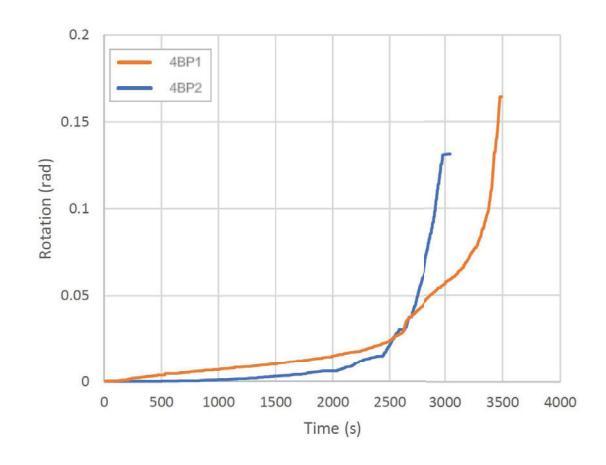
Figure 11. Time-rotation relationships of the undamaged, unreinforced, connection configurations that utilized four bolts in the first (4BP1) and second bolt patterns (4BP2) [7, 8].

For the undamaged, unreinforced connections tested by [7, 8], it was noticed that for the configuration with four bolts arranged in the second bolt pattern (4BP2) the connection experienced a sharp exponential increase in its rotation after 40 minutes into the fire test, which was a results of the immediate, brittle failure caused by the delamination occurring at the glue line at the top row of

bolts. In contrast, the similar connection configuration with four bolts arranged in the first bolt pattern (4BP1) exhibited linearly increasing rotations for a more extended period compared to the 4BP2 configuration, resulting in a longer fire resistance time. It is worth noting that the time-rotation curve shown for the 4BP1 configuration is for the first test, which had a 56-minute fire resistance time and did not experience any brittle glue-line failure. No time-rotation curve is presented for the second test, which experienced a sudden glue line failure and had a fire resistance time of only 42 minutes.
