# FULL-SCALE EXPERIMENTAL STUDY OF COMPARTMENT FIRES IN MASS TIMBER STRUCTURES

**ABSTRACT:** The Canadian Wood Council partnered with key stakeholders to conduct five full-scale fire tests under the Mass Timber Demonstration Fire Test Program (MTDFTP) aimed toward advancing current understanding of compartment fire dynamics, fire safety during construction, and impact of exposed mass timber surfaces on fire severity and duration. The fire tests featured varying degrees of encapsulation, ventilation conditions, and fuel loads, and were performed in a two-storey structure constructed of cross-, dowel- and glued-laminated mass timber elements. The test structure's configuration and content intended to represent a mass timber building undergoing construction and areas with residential and open-plan office uses in a finished building. All fire tests were conducted without sprinkler protection or firefighter intervention, illustrating rare scenarios wherein suppression operations would be ineffective in controlling the size and spread of a fire. While the results for each test are discussed in greater detail, the following are some key observations common to all tests: the mass timber t

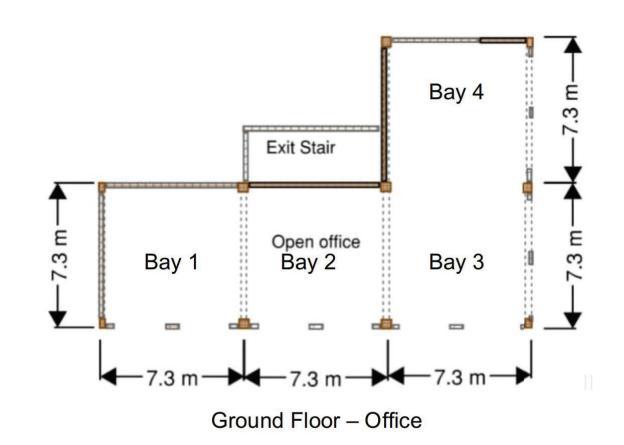
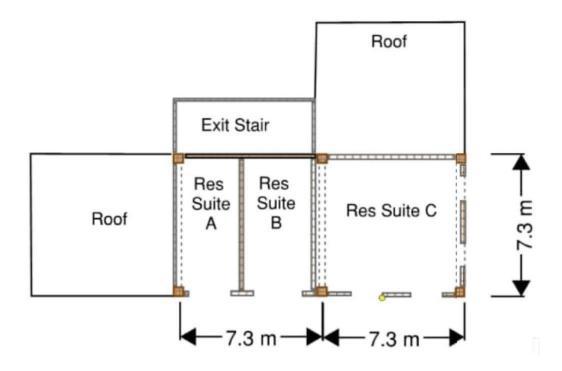
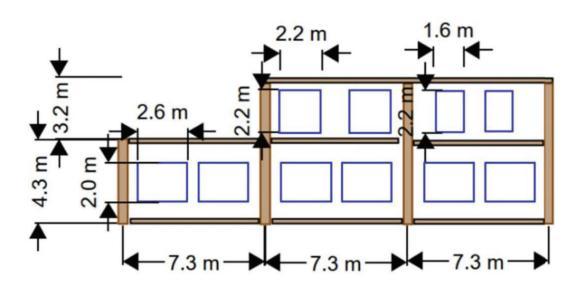
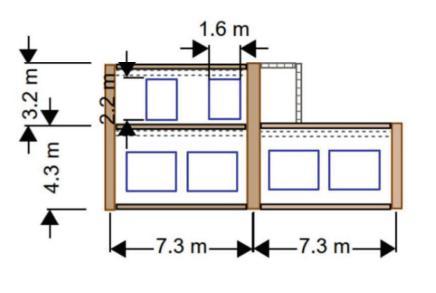
Figure 1. Mass timber test structure: schematic floor and elevation plans [7].

The test structure's layout (Fig. 1) and content intended to represent a mass timber building undergoing construction, as well as areas of a finished building with an open-plan office space and residential suites. More specifically, the first storey of the L-shaped mass timber test structure was configured as a four-bay open-plan office area, with each bay measuring 7.3 m by 7.3 m (24 ft by 24 ft), while the second storey was laid out as three separate residential units – suite 'A', 'B', and 'C' – located above the two middle bays on the first storey. A more comprehensive description of the structure's design details can be found in [7].

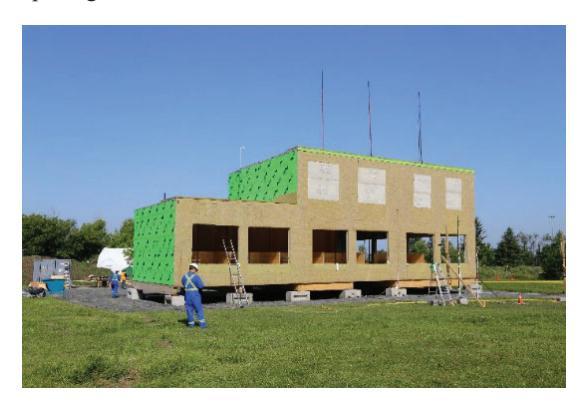
Figure 2. Photograph of the finished mass timber structure prior to the first scheduled test.

The finished structure (Fig. 2) featured 1-hour fireresistance rated exterior wall assemblies, constructed in accordance with cUL Design No. U419 [13], with ten window openings on the first floor, and six window openings on the second floor.

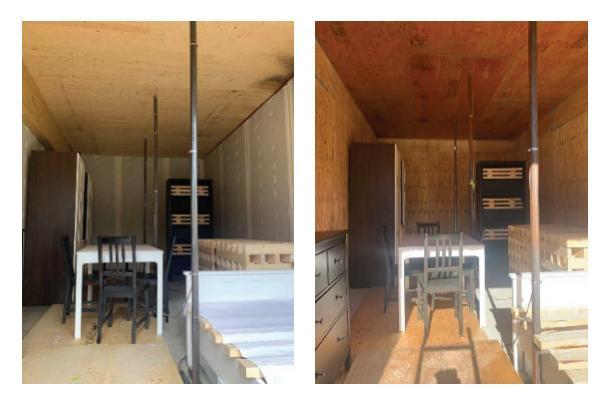
Figure 3. Photographs of the finished mass timber residential suites 'A' (Test 2), left image, and 'B' (Test 1), right image.

The fire compartment was fully outfitted with consumer furniture representing a studio apartment with sleeping, living, and dining areas, as shown in Fig. 3. The combustible content in suite 'B' had a fuel load density of 613 MJ/m<sup>2</sup> (54,000 BTU/ft<sup>2</sup>), which was 10% higher than the similar fuel packages reported in previous tests [14–16]. The ventilation factor in suite 'B' was around 0.07 m<sup>1/2</sup>. The purpose of this test was to provide baseline results for comparison to a similar fire in a residential unit of an encapsulated mass timber building (Test 2) with some exposed mass timber surfaces.

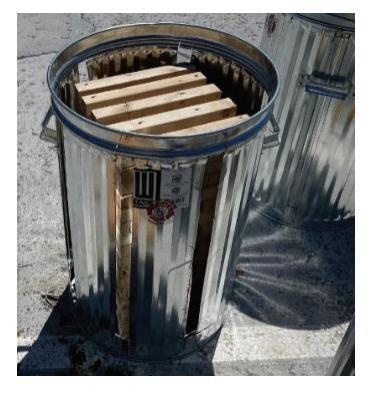
Figure 4. Garbage bin fire source employed in Test 3.

The garbage bin fire source employed in this test was arranged by filling a 105-litre (28 gallon) steel garbage bin with a single 17 kg (38 lbs) wood crib, as shown in Fig. 4. The wood crib was constructed of 38 mm (1  $^{1}/_{2}$  in) square softwood lumber pieces cut to 300 mm (1 ft) in length with five pieces placed in a row such that the following row was perpendicular to the adjacent row, until the crib reached a total stack height of 17 layers. The garbage bin fire source, which provided a movable fuel load density of 15 MJ/m<sup>2</sup> (1,300 BTU/ft<sup>2</sup>), was placed 25 mm (1 in) away from the base of the mass timber shaft wall located at the rear of suite 'B'. This garbage bin fire source a peak heat release rate of 300 kW and a free burning time of 27 minutes.

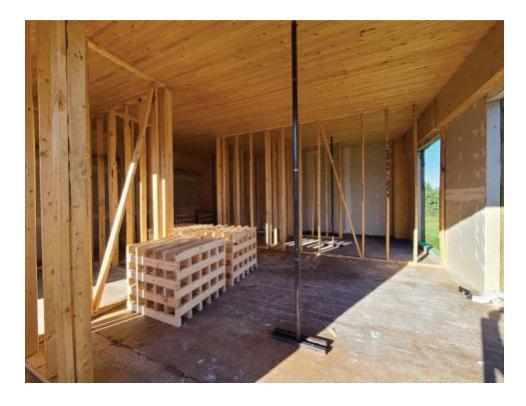
Figure 5. The movable fuel load employed in Test 4.

The movable fuel load employed in this test consisted of unprotected wood-framed interior wall partitions and six large wood cribs, each weighing approximately 50 kg (110 lbs), as shown in Fig. 5. The exposed interior partition walls were constructed using 300 kg (660 lbs) of 38 mm by 89 mm (1  $^{1}/_{2}$  in by 3  $^{1}/_{2}$  in) wood studs. The wood cribs were constructed of 38 mm by 89 mm (1  $^{1}/_{2}$  in by 3  $^{1}/_{2}$  in) softwood lumber pieces cut to 800 mm (2.6 ft) in length with six pieces arranged in a row such that the following row was perpendicular to the adjacent row, until each crib reached a total stack height of 8 layers [17]. The combustible content used in this test had a fuel load density of 224 MJ/m<sup>2</sup> (19,700 BTU/ft<sup>2</sup>), which is higher than that typically found on mass timber construction sites. The ventilation factor in suite 'C' was around 0.11 m<sup>1/2</sup>.

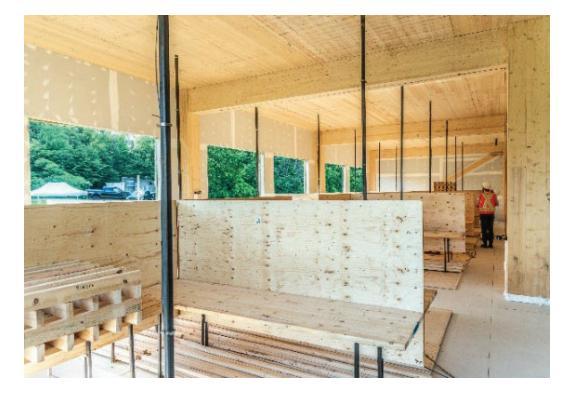
Figure 6. Photograph of the open-plan office space in Test 5.

The open-plan office space was fully-furnished with eighteen cubicles (i.e., workstations simulated with wood materials) separated by privacy partitions made of 19 mm  $(^{3}/_{4}$  in) thick plywood sheets, as shown in Fig. 6. The workstations were outfitted with wood table tops

constructed of nominal 38 mm by 140 mm ( $1^{1}/_{2}$  in by 5  $1/_{2}$  in) and 38 mm by 184 mm (1  $1/_{2}$  in by 7 in) dimensional lumber, while the floor covering in each cubicle area was lined with 19 mm  $(^{3}/_{4}$  in) thick plywood sheets, placed over the gypsum board, to replicate carpeting and similar textile flooring and underlayment typically used in a contemporary office. Other consumer furniture (e.g., upholstered office chair) and ancillary office supplies (e.g., paper, electronic equipment, shelving unit, waste basket) were substituted with discrete piles of 25 kg (55 lbs) wood cribs providing an equivalent calorific content [17]. As such, each cubicle featured a small wood crib constructed of 38 mm by 89 mm by 800 mm (1  $^{1}/_{2}$  in by 3  $^{1}/_{2}$  in by 2.6 ft) softwood lumber pieces arranged in rows of six and stacked to 4 layers high. Additional strips of 38 mm by 38 mm by 2.4 m  $(1 \frac{1}{2} \text{ in by } 1 \frac{1}{2} \text{ in by 8 ft})$  softwood lumber pieces were distributed across all cubicles and placed below the table tops. The combustible content used in this test had a fuel load density of 362 MJ/m<sup>2</sup> (31,900 BTU/ft<sup>2</sup>), which was within the historical range of fuel packages reported in the literature [18, 19].

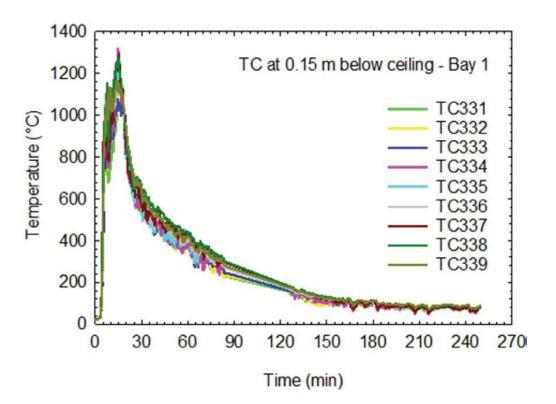
The initial fire growth, from ignition to flame impingement on the ceiling, took 3 minutes and 40 seconds, as can be seen from the temperature-time plot shown in Fig 7. This rapid fire progression was likely caused by the aggressive ignition source, high fuel load and ventilation openings in the test. Fig. 8 shows a plume due to the ignition source alone impinging on ceiling by design, which significantly accelerated the initial fire growth.

Figure 7. Temperature vs. time in the upper region of the fire compartment, recorded across multiple locations in Bay 1 (fire origin), 0.15 m below the ceiling level [7].

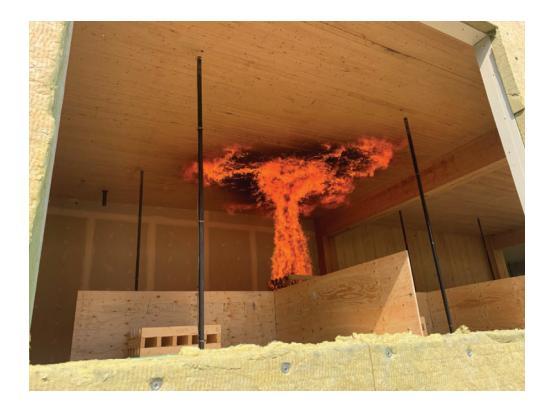
Once the flames from the fire impinged on the ceiling (Fig. 8), they spread across the exposed ceiling surface within 2 minutes at an average speed of 140 mm/s (5.5 in/s). The radiative heat feedback from the ceiling flames to the fuel bed on the floor was sufficiently large to ignite the cubicles consecutively at an average speed of 100 mm/s (3.9 in/s). Similarly, the aggressive ignition source and high fuel package used in this test, along with abundance of oxygen supply, likely accelerated the rate of flame spread across the ceiling. The entire open-plan office area, from floor to ceiling, was fully engulfed in flames during 7 to 18 minutes following the onset of ignition. During this time, large fire plumes issued from

Figure 8. Photograph of the flame impingement on the exposed mass timber ceiling in Bay 1 (fire origin).

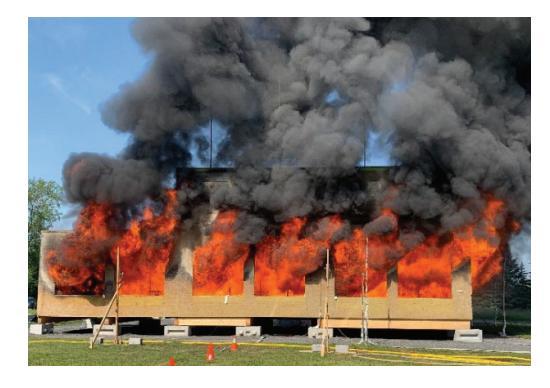
the window openings, as shown in Fig. 9, extending up to 7.5 m (24.6 ft) high and 10 m (32.8 ft) out the openings.

Figure 9. Photograph of the fire plumes ejected from the window openings during Test 5.

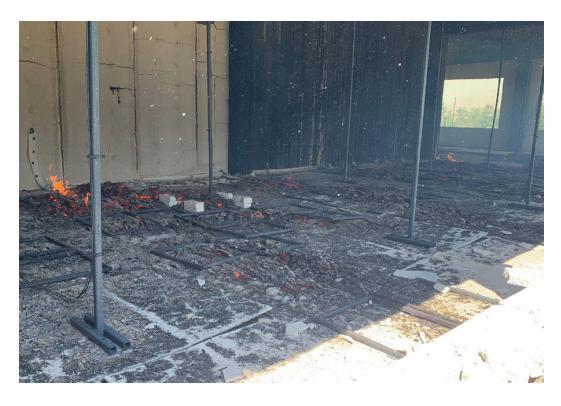
During the subsequent three hours of the test, the openplan office space continuously cooled down, yet smouldering in several mass timber joints appeared to persist as the temperatures recorded in the mass timber connections continued to rise due to thermal lags. Some portions of the cross-laminated timber ceiling panels near the shaft experienced localized delamination after 190 minutes, yet this phenomenon did not cause re-ignition or fire regrowth.

Figure 10. Photograph of the glowing fuel bed debris on the floor.

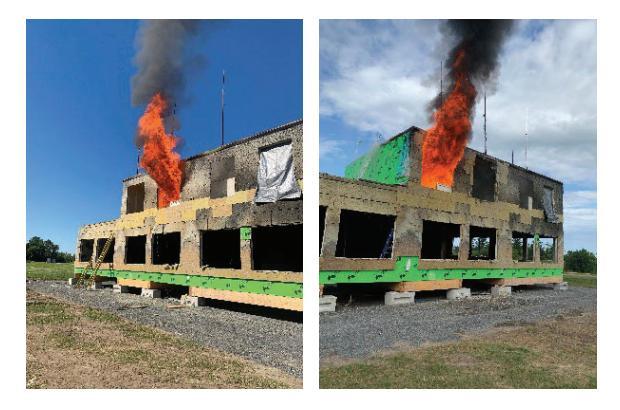
Overall, the fire development across these tests was quite similar. Following the onset of ignition, compartment flashover occurred at nearly the same time in both tests (4 minutes 48 seconds in Test 1 and 4 minutes 44 seconds in Test 2), accompanied by over 6 m (19.7 ft) high fire plumes emerging from the window openings, as shown in Fig. 11. During the fully-developed phase of the fire, the compartment temperatures in both tests reached 1,200°C (2,190°F) (Fig. 12). The compartment fire entered the decay phase as the combustible content in both tests approached near-full consumption. The fire began to decay earlier and more rapidly in Test 2 compared to Test 1, at 25 and 30 minutes after ignition, respectively, due to the additional fuel from the plywood linings in Test 1. By the end of both tests, compartment temperatures decreased to below 200°C (392°F). Due to the large quantity of combustible interior linings used in Test 1, the remaining debris continued to burn on the floor with glowing embers until the end of the 4-hour test. In contrast, Test 2 showed no sustained flaming on the mass timber elements after 45 minutes, although small flickering flames intermittently appeared on the exposed ceiling and beam surfaces. While some portions of the exposed cross-laminated timber ceiling panels experienced localized delamination during the cooling phase of the fire in Test 2, this phenomenon did not result in re-ignition or fire regrowth. Overall, the fire environment in the mass timber residential suite (Test 2) appeared to be less severe than that in the Codeconforming noncombustible baseline scenario (Test 1). The temperatures measured in the mass timber exit stair shaft remained below 32°C (90°F) for the entire duration of the tests, indicating that the compartment fires in either test did not adversely affect the tenability conditions in the adjacent stairwell.

Figure 11. Photographs of the peak fire plumes issued from the window openings during Test 1 (left image) and Test 2 (right image).

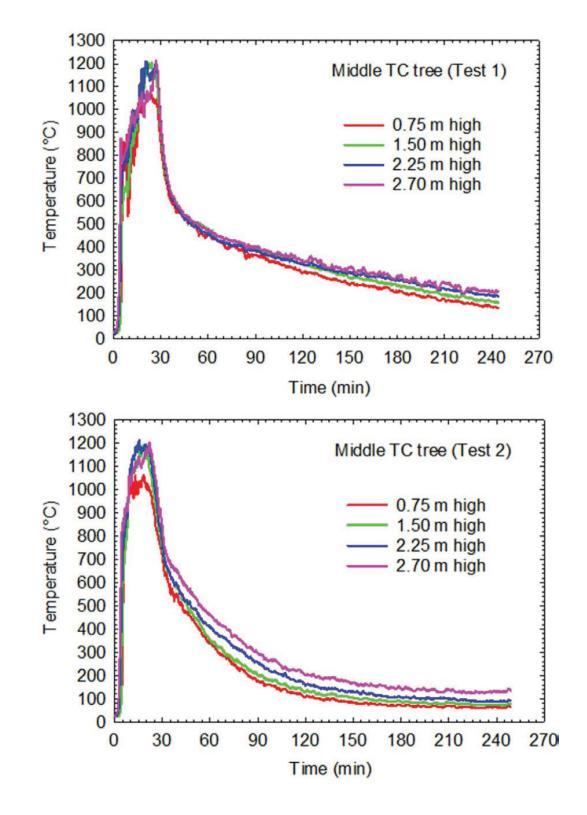
Figure 12. Time-histories of room temperatures in Test 1 (top plot) and Test 2 (bottom plot), recorded at four measurement positions on the middle thermocouple rake [7].

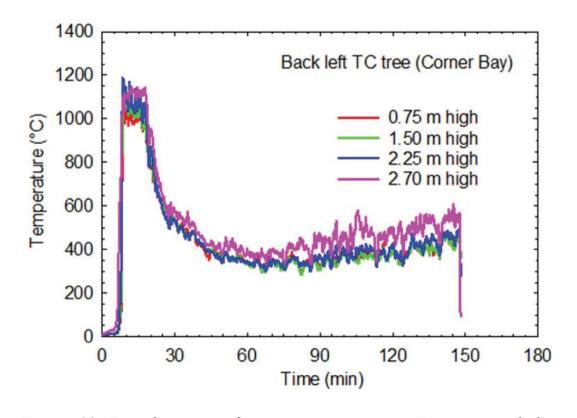
Figure 13. Time-histories of room temperatures in Test 4, recorded at four measurement positions on the rear left (corner bay) thermocouple rake, closest to the fire origin [7].

Following the onset of ignition, the fire grew in size for about 8 minutes, transitioning into the fully-developed stage where sustained flaming remained at its peak extent for almost 10 minutes (Fig. 13). During this period, the temperatures recorded in the compartment exceeded 1,100°C (2,012°F), while fire plumes issued from the window openings reached over 6 m (19.7 ft) high, as shown in Fig. 14. The fire started to decay at around 18 minutes after ignition when virtually all combustible content was either consumed or fallen onto the floor. By 19 minutes, the flames ceased to eject from the openings, and, by 30 minutes, no visible flaming was observed on exposed mass timber surfaces. The compartment temperatures decreased to between 300°C and 400°C (572°F and 752°F) around one hour after ignition. However, the fire did not reach a point of complete selfextinguishment as the compartment temperatures gradually ascended to around 600°C (1,112 °F) and intermittent flaming persisted in the mass timber wall-toceiling junctions. The test was terminated at around 2.5hour mark and all deep-seated localized hot spots were manually extinguished by the fire brigade on site. The test was terminated earlier than planned due to smoke migrating toward the occupied buildings on site. The temperatures recorded in the mass timber exit stair shaft were below 22°C (72°F) throughout the entire test, demonstrating that the fire severity in the adjacent compartment did not compromise the tenability conditions experienced in the stairwell.

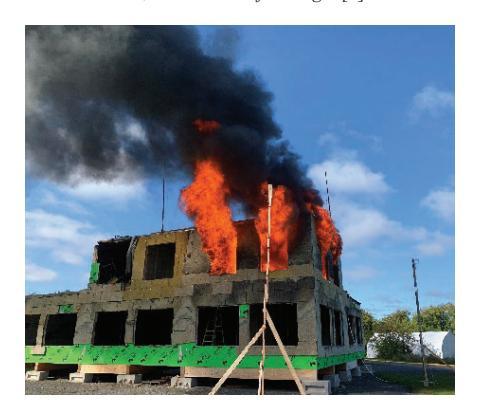
Figure 14. Photograph of the peak fire plumes issued from the window openings during Test 4.

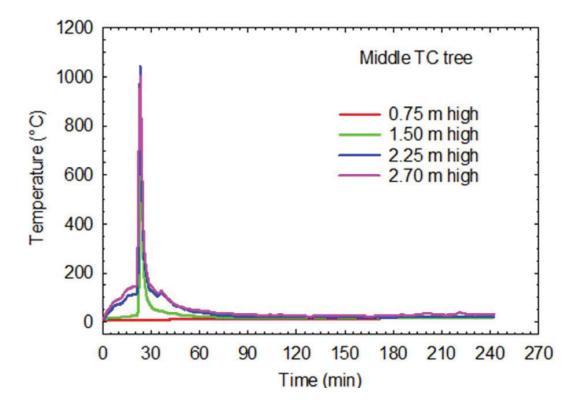
Figure 15. Time-histories of room temperatures in Test 3, recorded at four measurement positions on the middle thermocouple rake [7].

Following the onset of ignition, it took over 20 minutes for the flames of the garbage bin fire to grow and impinge on the exposed mass timber ceiling. Flame spread on the ceiling of the compartment and subsequent flashover was observed at around 23 minutes after ignition with the room temperatures rising to above 1,000°C (1,832°F) almost instantaneously (Fig. 15). However, the compartment flashover was short-lived as the flames significantly diminished in size within only a minute, ceasing to eject from the window opening. By 25 minutes after ignition, there was no visible flaming on the mass timber ceiling, and, as can be seen from Fig. 16, by 30 minutes, the compartment temperatures dropped to below 160°C (320°F). It was evident that the garbage bin fire source did not have sufficient quantities of fuel to sustain prolonged steady-state burning in the compartment. The remaining debris in the waste bin selfextinguished by 35 minutes. At the end of the 4-hour test, the room temperatures were well below 30°C (86°F). At no point during the test did the temperatures measured in the mass timber stairwell exceed 18°C (64°F).

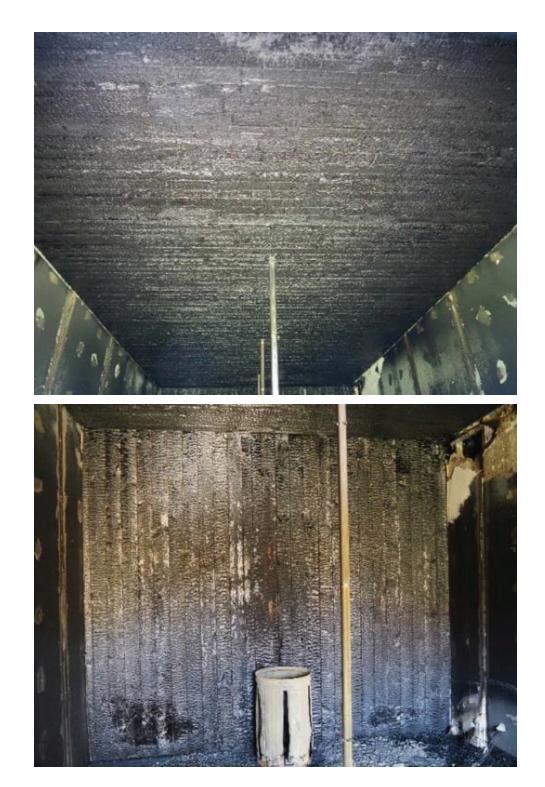
Figure 16. Test 3: the post-fire state of exposed mass timber ceiling (top image) and shaft wall (bottom image) surfaces [7].

During the test, the exposed mass timber ceiling, floor, and wall surfaces experienced less than three minutes of sustained flaming exposure, which resulted in minimal char depths; mostly surface charring of just a few millimetres, as shown in Fig. 16. However, the char depth was up to 20 mm ( $^{25}/_{32}$  in) on the ceiling directly above the garbage bin, along the junction of the mass timber ceiling and wall. In the top right rear corner of suite 'B', where the mass timber ceiling and two walls met, the char depth exceeded 20 mm ( $^{25}/_{32}$  in), with localized hot spots and glowing combustion still remaining in these junctions at the end of the test. Thorough firefighting operations were conducted after the test to ensure that all hot spots were fully extinguished.
